Preview of PCI's New Zealand earthquake reconnaissance team report

Precast concrete structural design in New Zealand

Case study: PricewaterhouseCoopers office building

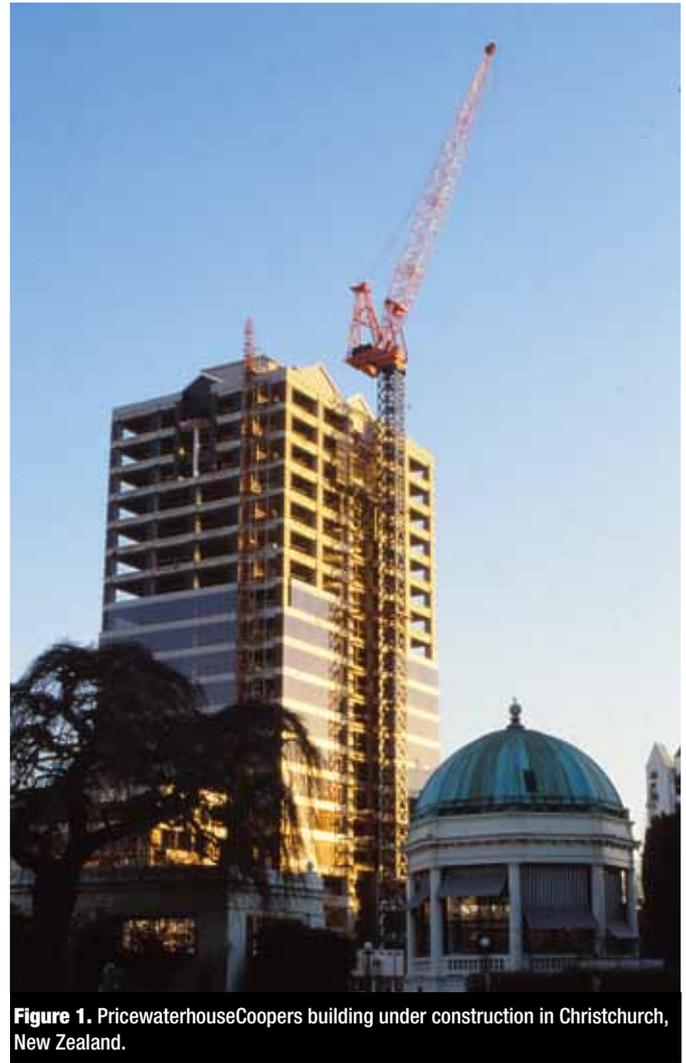
Figure 1. PricewaterhouseCoopers building under construction in Christchurch, New Zealand.

The 21-story PricewaterhouseCoopers office building was constructed in the 1980s (**Fig. 1**). It was designed with an exterior moment-resisting frame and constructed using a detail in which the precast concrete joint (**Fig. 2**) is placed over the column below. Vertical ducts in the precast concrete joint allow the vertical reinforcement from the column to be threaded through and into the column above. The ducts are grouted once the joint is in place.¹
