**EVALUATION OF NDT METHODS FOR CONDITION ASSESSMENT
OF POST-TENSIONING TENDONS
IN PRECAST BALANCED CANTILEVER CONCRETE BOX GIRDER BRIDGES**

Juan José Goñi, Ph.D., P.E., DMJM+HARRIS, Inc., Tallahassee, FL
Rafael Foinquinos, Ph.D., P.E., DMJM+HARRIS, Inc, Coral Gables, FL
Larry Sessions, P.E., Florida Department of Transportation, Tallahassee, FL

BRIDGE DESCRIPTION – RAMP D FORT LAUDERDALE-HOLLYWOOD INTERNATIONAL AIRPORT

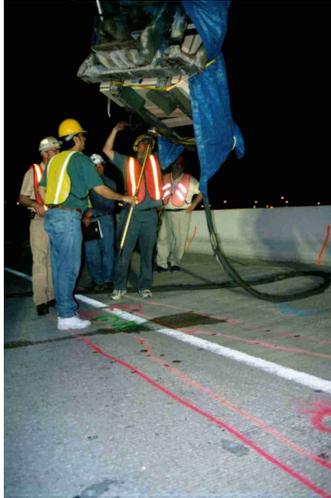
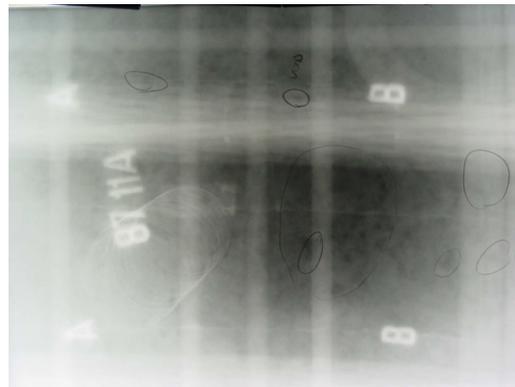
Figures 19 and 20 – Linear Accelerator suspended by the forklift and X-Ray film

Seg.	Hole I.D.	Defects Reported by HESCO	Defects Reported by Consultant
89	S1	Broken and cut strands, voids in grout	A 10"x8" saw cut in deck was made at trumpet location, trumpet was cut open and 21 wires (3 strands) were cut.
88	SS1	Voids in grout, ground strands	An 8"x6" saw cut in deck was made at trumpet location, trumpet was cut open and 11 wires (1.5 strands) were cut.
88	13C	Voids in conduit at left, voids in concrete	Void reported by impact-echo.
88	13D	Voids in grout, ground strands, strands have been separated, broken conduit casing	Point tested with impact-echo and void was not evident.
87	11A	1" x 1/2" void in center of film w/smaller 1/4" voids surrounding, possible broken cable B-B, coil of wire	Void reported by impact-echo.
86	SS3	Cable has been ground/cut in two, partial pcs of rebar, pulled back conduit sheeting is visible	An 8"x6" saw cut in deck was made at duct location, duct was cut open and 14 wires (2 strands) were cut.

86	SS9	Cable conduit on right contains large void and is ground and cut, cable in center of view is ground and cut, missing sections of cable, strands of center cables or broken at bottom of view. Partial pcs of rebar, large "staple" in lower left also electrical wire, voids in grout	An 8"x6" saw cut in deck was made at duct location, duct was cut open and 10 wires (1.5 strands) were cut.
85	5A	Film moved, not readable	Void reported by impact-echo.
79	SS9	Saw cut from A to A, cable conduit and some cable cut, missing section of rebar, saw cut from B to B, voids in concrete	An 8"x6" saw cut in deck was made at duct location, duct was cut open and 10 wires (1.5 strands) were cut.
79	5B	Small voids in grout	Void reported by impact-echo.
79	13A	Large void in concrete by wire IQI, breaks in conduit wall, broken cable strand below "B" on right, voids in grout	Void reported by impact-echo.
77	11B	Voids in concrete, cable in center has large strands	Void reported by impact-echo.
