SURPRISES INSIDE POST-TENSIONING DUCTS AND REMEDIES

Vijay Chandra, P.E., Parsons Brinckerhoff Quade & Douglas, Inc., New York, NY
Anthony L. Ricci, P.E., Massachusetts Turnpike Authority, Boston, MA
Daryl Sargent, Bechtel Corp., Boston, MA

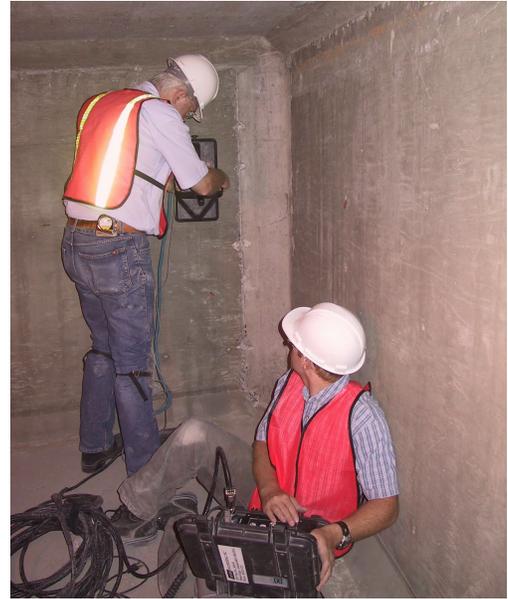
Fig. 16: GPR investigation in progress.

Several companies had demonstrated their capabilities using GPR—with marginal results. As a test, they were asked to locate the ducts along given sections (see Fig. 16). They were also provided with drawings to assist them. After the areas were inspected and the locations of ducts marked, the concrete was drilled to determine if the ducts were correctly located.

The degree of accuracy achieved using GPR was not any better than by solely using the drawings. In fact, in many cases, it was worse. GPR, which is extremely operator dependent, is also influenced by the amount of reinforcing present in an area as well as the proximity of other ducts. In fact, only one contract has used GPR to locate ducts with a good degree of accuracy. This was on a cast-in-place structure with ducts in vertical web walls. However, this same contract could not locate transverse ducts located in the top flange, which had a denser reinforcing pattern.

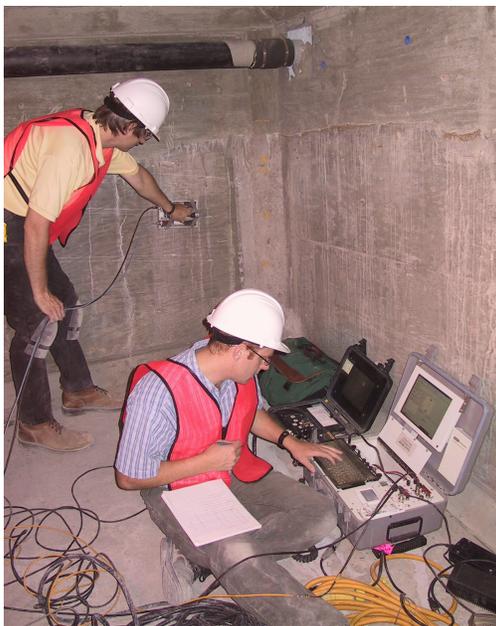
Fig. 17: Echo-impact testing underway.

EI was investigated by having a company test ducts that had previously been inspected by drilling holes into them. The test was “blind” in that the testing firm was not informed of the condition of any of the ducts (see Fig. 17). Results, however, have been mixed.

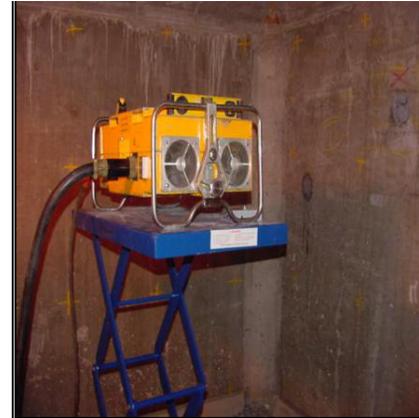
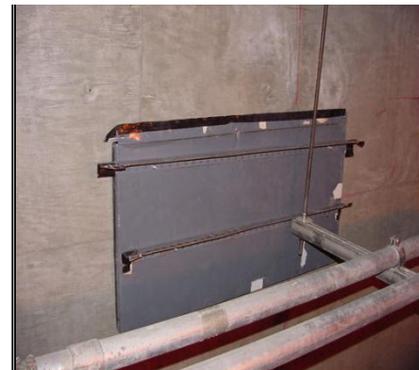
Fig. 18: X-ray equipment set-up

X-rays were also used as part of a blind test on ducts in the web walls of a cast-in-place structure (see Fig. 18). These were draped metal ducts, 4 inches in diameter that were centered in a web wall that was approximately 12 inches thick. Sixteen separate test areas were examined. The results of this testing method were found to be very accurate for all areas being evaluated. X-rays were able to show the degree of voiding and water in the ducts (see Fig. 19). The system has other positive features in that the equipment used is relatively portable; the film can be developed on site and used to guide any necessary excavations; interpretation of the film is not as complicated as some other testing methods; and the testing time is faster than drilling.
