INNOVATIONS REDUCE COST AND SCHEDULE ON US-24 BRIDGE REHABILITATION OVER LOWER ROUGE RIVER

Robert R. Breen, PE, Wade Trim Associates, Inc., Taylor, MI

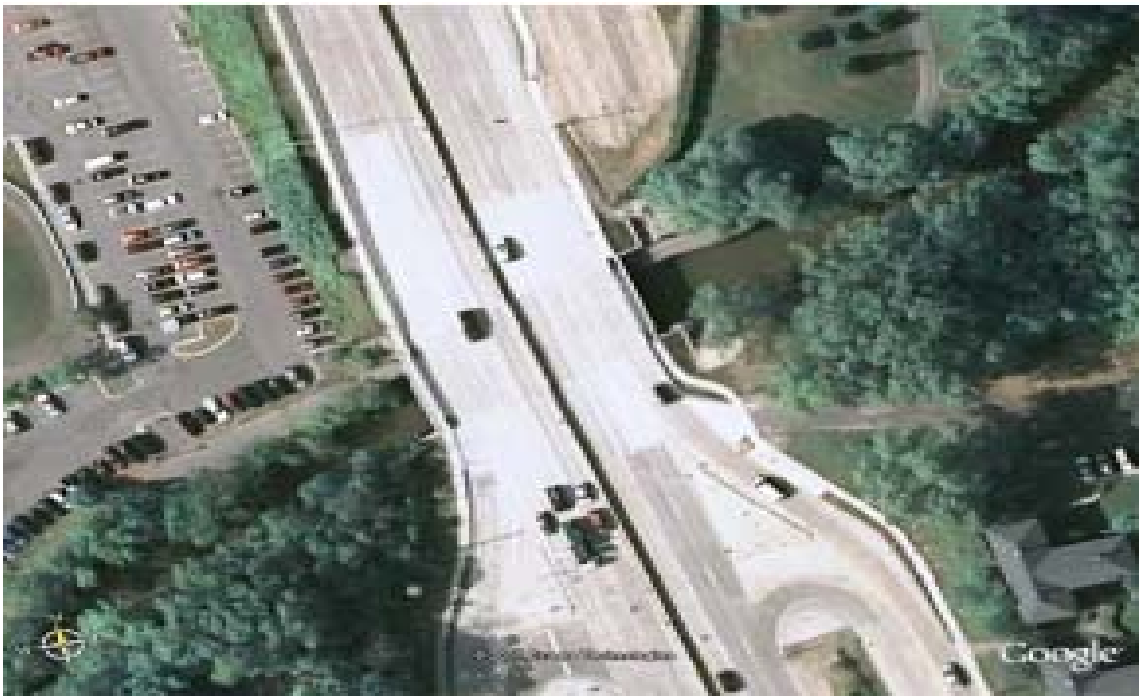
Structure B01 is a 60-foot-long, single span, simply supported bridge that carries US-24's four lanes of traffic in each direction over the Lower Rouge River in Dearborn. Three through lanes are included on each side plus ramp lanes for nearby WB US-12. The existing bridge consisted of rolled steel multi-stringers with a concrete deck supported by tall cantilevered abutments. The abutments are founded entirely on timber piling. In addition to spanning the river, the bridge also spans a golf course cart path bridge that parallels the north abutment. This can be seen in Figure 1.

Fig. 1 – Aerial View of B01 Bridge

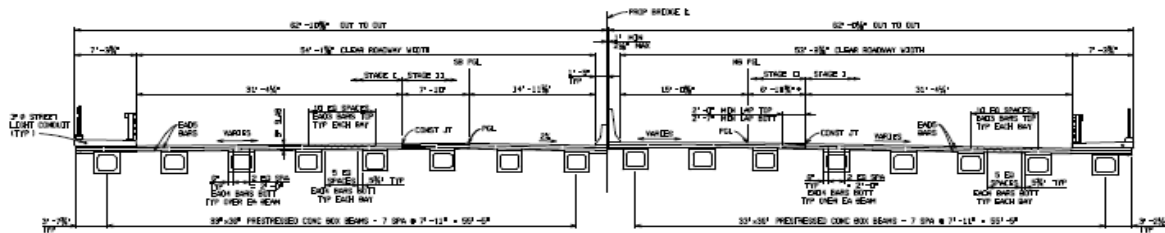
Figure 6 shows the cross section of the proposed superstructure. Due to the requirement to maintain US-24 traffic, superstructure construction and abutment repair was performed in two stages. The first stage consisted of maintaining one through lane of traffic in each direction on the outside and one lane of exit and entrance lanes for nearby westbound US-12, which crosses over US-24 a few hundred feet south of the project site. The inside portion of the bridge consisting of nine beams and deck were removed. The top three feet of the abutments were partially saw cut and removed to provide a horizontal surface for the installation of the post-tensioned rods into the abutments. The existing reinforcement was left in place where still useable, and new reinforcement was added along with galvanized anodes to protect the existing reinforcement. Temporary sheeting was placed between the active construction stage and the in-use roadway on each side to retain the approach backfill under the active roadway.

Fig. 6 – Typical Deck Cross Section
