I-90 EASTON BRIDGE REPAIR

Evan Grimm, PE, Washington State Department of Transportation, Olympia, WA

Precast concrete girders were used to replace a bridge span over eastbound I-90 that was severely damaged by an over-sized truck load near the city of Easton, Washington. The damaged span was to be replaced under an emergency contract that required the bridge to be operational in 45 days. WSDOT met that challenge using non-standard precast prestressed deck bulb tee girders, which made the accelerated construction possible and limited temperature-sensitive construction in the freezing and snowy mountain region. The bridge design and construction moved rapidly within the short time frame using in-place production tools. Working directly with the precast concrete industry, the bridge design office streamlined the fabrication and construction schedule of the replacement span.

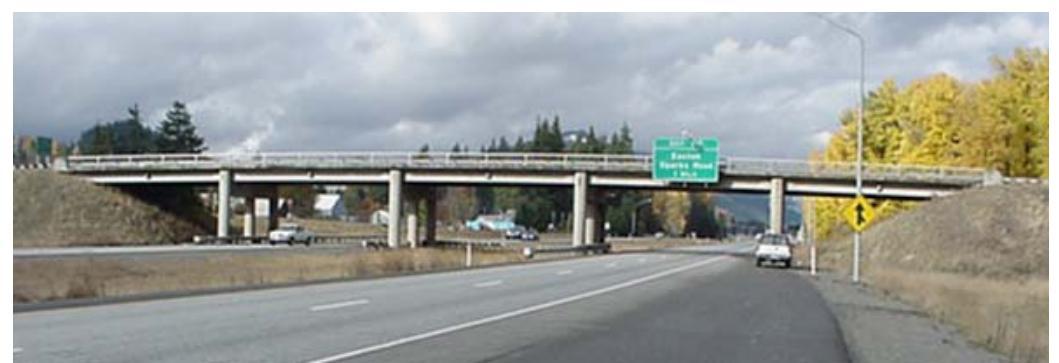
Fig. 2 Easton Bridge Prior to Damage

Built in 1959, the bridge consists of a series of five 50 ft simply-supported spans. Each span is comprised of precast pretensioned concrete girders with a cast-in-place concrete deck. Figure 2 shows the bridge before it was damaged.
