## **FULL SCALE DESTRUCTIVE TESTING OF AN ADJACENT PRESTRESSED CONCRETE BOX BEAM BRIDGE**

**Eric Steinberg, PhD, PE**, Associate Professor, Civil Engineering, Ohio University, Athens, OH  
**Richard Miller, PhD, PE, FPCI**, Professor, School of Adv. Struct., Univ. of Cincinnati, Cincinnati, OH  
**Jon Huffman**, Graduate Research Assistant, Civil Engineering, Ohio University, Athens, OH  
**Tyler Stillings**, Grad. Research Assist., School of Adv. Structures, University of Cincinnati, Cincinnati, OH

### **ABSTRACT**

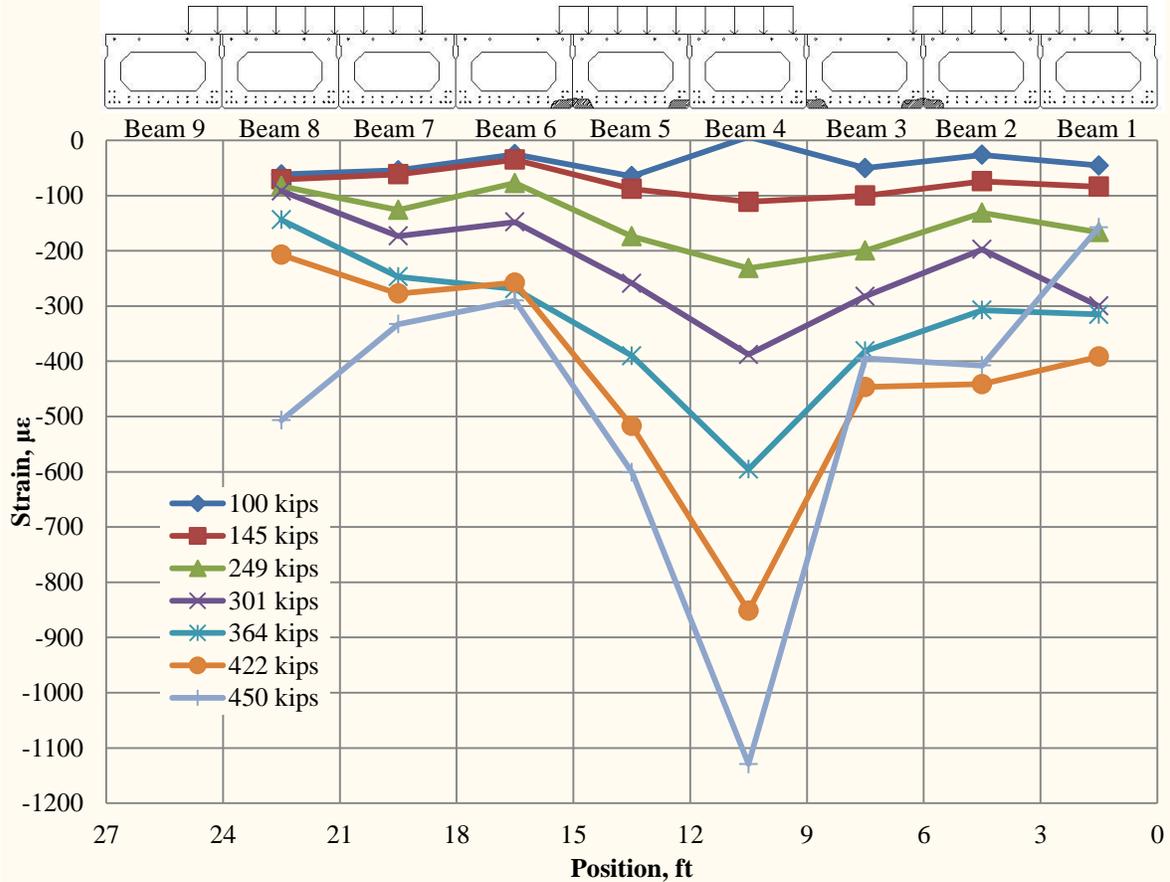
Figure 13: Top Strain Profile Instrument Line H

The top strains along instrument line H across the width of the bridge while loading was applied to all cylinders is shown in Figure 13. Strain was not monitored in Beam 9 since the poor condition of the concrete did not allow the mounting of a top gage to the beam. In general, the strains increase with increasing load. However, Beam 4 has significantly higher strain as the total loading increased above 249 kips. Table 1 provides the cylinder loads for each strain plot in Figure 13. The cylinders are numbered based on the Beam they were primarily above. Though the load is highest on cylinder 5 for some of the total load plots, it is not significantly higher than the load in cylinder 2 or 8. At the 364 kip total load, the load on cylinder 5 is even lower than the load on cylinder 8. Therefore, it is concluded that a larger portion of the load is being transferred into Beam 4. This makes sense since Beam 4 was not damaged.

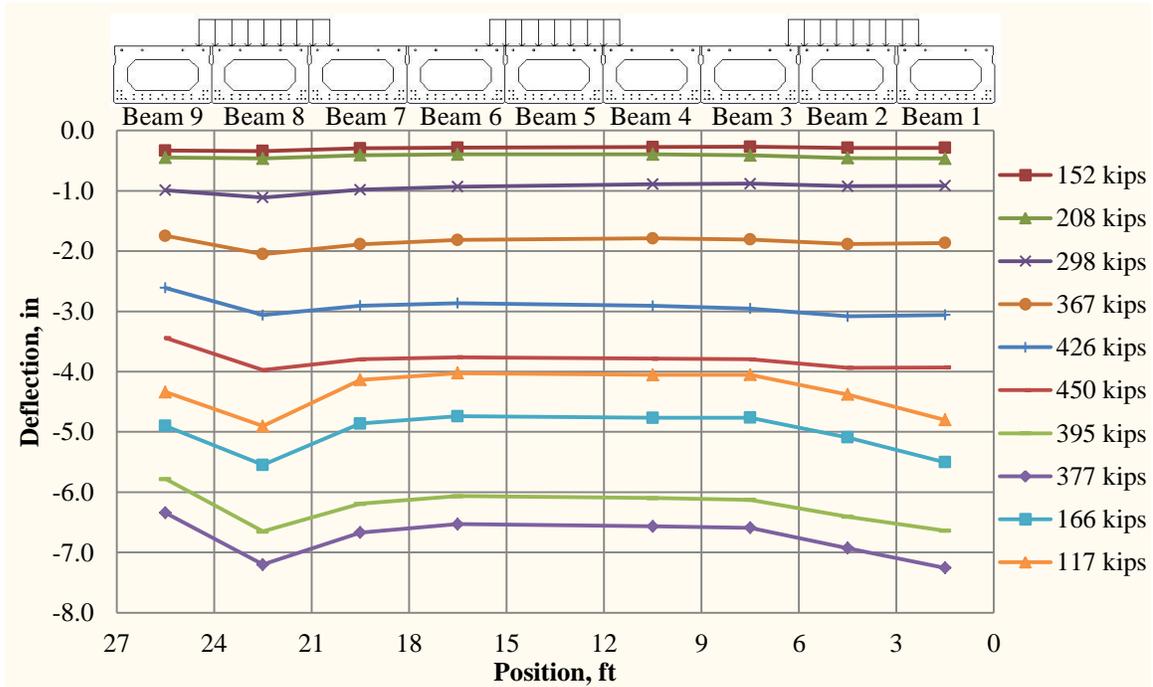
**Figure 17: Total Load and Instrument Line E Deflection (Center Span)**

Figure 17 shows the deflection across the bridge at instrument line E as the total load from all cylinders increased. Table 2 provides how the total load was distributed from the three cylinders. When the maximum load of approximately 450 kips was obtained, the bridge was no longer able to support higher total load and deflections increased. Initially, the deflections are fairly consistent across the width of the bridge. However, after the maximum load was

reached Beams 1, 2 and 8 showed slightly higher deflections even though more load is applied from cylinder 5 to the middle bridge beams compared to the outside beams. The deflection profile remained the same even after the load was decreased. The deflection across the width of the bridge is much higher at lower loads after the peak loading was reached, resulting in permanent deformation. It should be noted that the data for the string potentiometer attached to Beam 5 was not usable from the test.

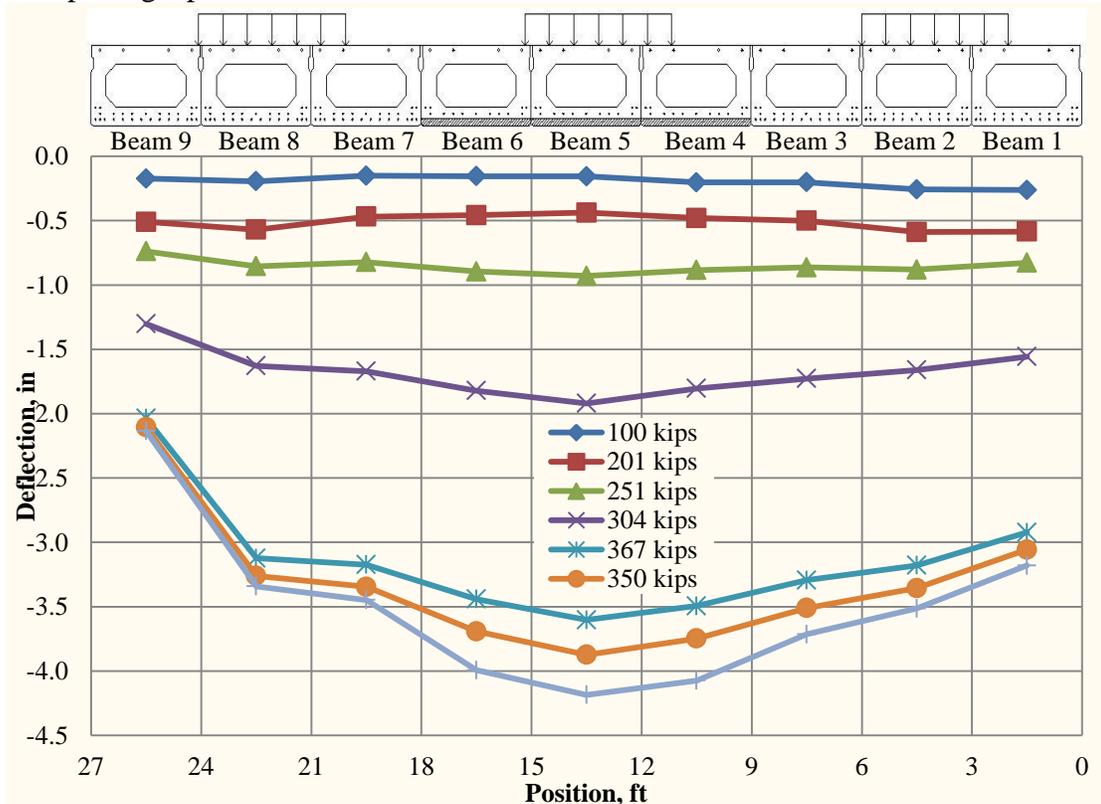
Figure 20: Total Load and Instrument Line A Deflection (West Span)

Figure 20 shows the deflection across the bridge at instrument lines A as the total load from all cylinders increased. Table 3 provides how the total load was distributed from the three cylinders. When the maximum load of 363 kips was obtained the bridge was no longer able to support higher total load and deflections increased. Initially, the deflections are fairly symmetric about Beam 5. The deflection of Beam 9 begins to show less of an increase in deflection compared to all the other beams after a total load of 251 kips. At the maximum

load and loads afterward, the deflection of Beam 9 relative to the remaining beams is very noticeable. The behavior is likely due to loss of the shear key for Beam 9. Beams 4-6 show the largest deflection as the load is highest in cylinder 2. With the exception of Beam 9, the deflection is relatively uniform across the bridge even after the maximum load has been reached.

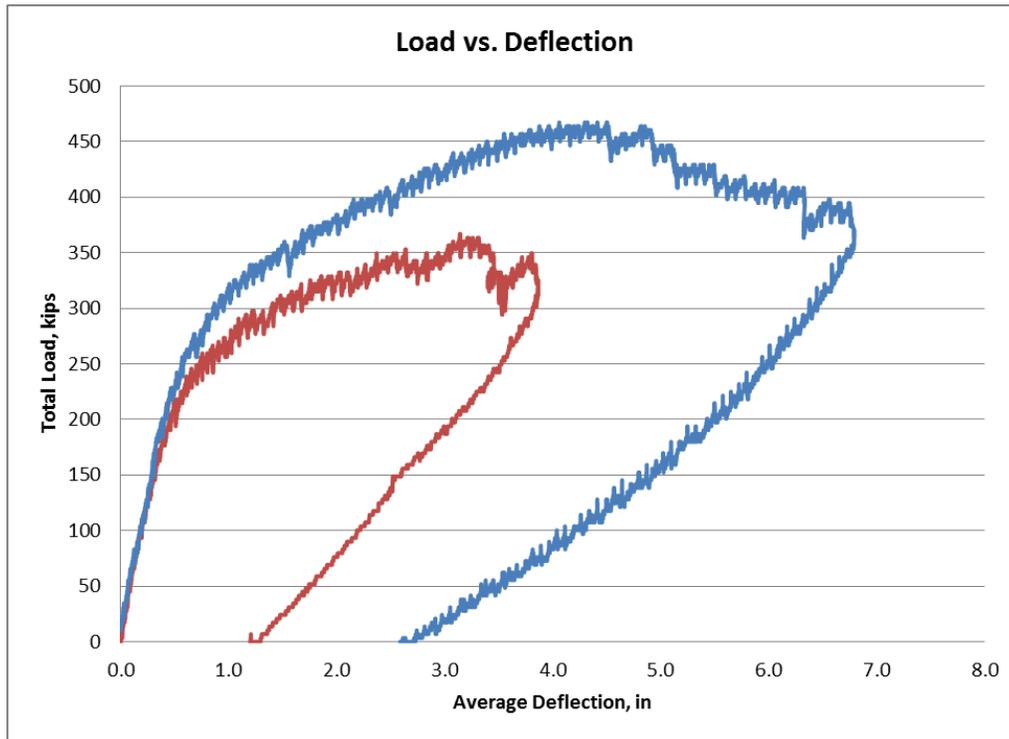
**Figure 25: Average Mid-span Deflections vs. Load (Center & West Spans)**

In order to compare the destructive test results for the different spans, the plots of the average midspan deflection for the Center and West spans versus the total applied load was created and is provided in Figure 25. As shown, both spans behave in a similar linear manner up to approximately 175 kips even though the West span had significantly more damage. After approximately 175 kips, the West span begins to become nonlinear as the Center span continues to be linear to approximately 225 kips. At larger loading, the West span shows more average deflection. At the peak load for the West span, the average deflection is

approximately twice that of the Center span. The Center span obtains the deflection of West span peak load at approximately 70 additional kips (430 compared to 360).

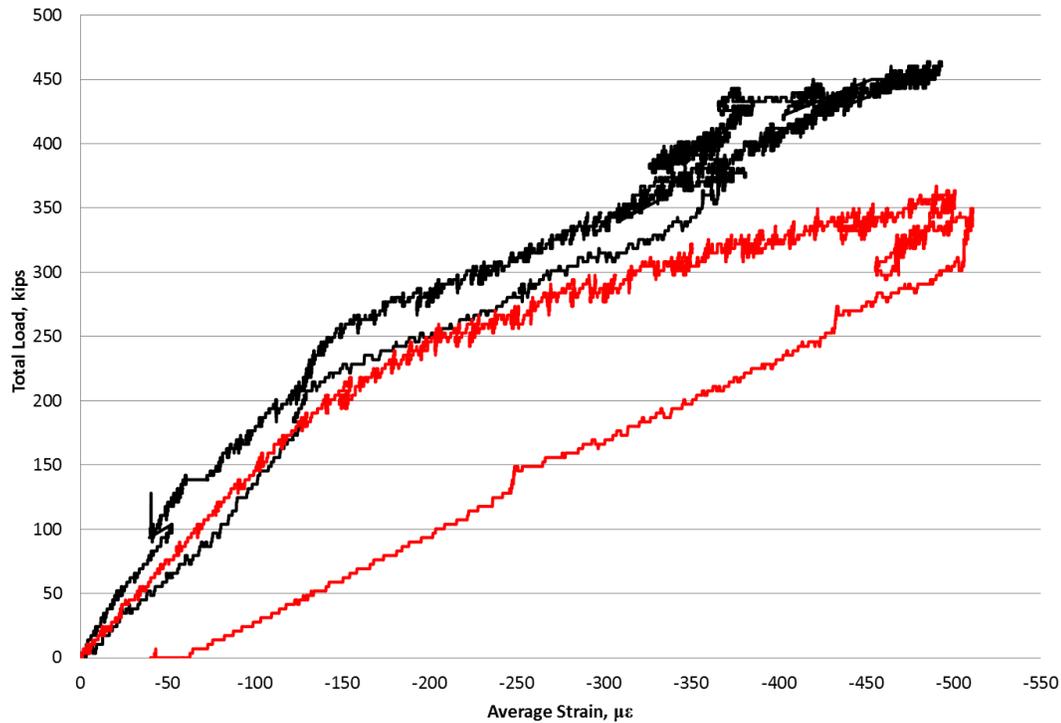
**Figure 26: Average Mid-span Strain vs. Load (East & West Spans)**

In order to compare the destructive test results for the East and West spans, the plots of the average midspan top strain versus the total applied load was created and is provided in Figure 26. As shown, both spans show initial linear behavior with the East span being slightly stiffer than the West span. The slope of both curves then change to another approximately linear portion with the East span again being stiffer than the West span. The change in stiffnesses occur at approximately 260 kips for the East span and approximately 225 kips for the West span. These differences can be attributed to the more severe damage in the West span compared to the East span.
