## **RESIDUAL STRENGTH ASSESSMENT AND DESTRUCTIVE TESTING OF DECOMMISSIONED CONCRETE BRIDGE BEAMS WITH CORRODED PRETENSIONED REINFORCEMENT**

**Rhys A. Rogers, BE**, University of Auckland, Auckland, New Zealand  
**Liam Wotherspoon, PhD**, University of Auckland, Auckland, New Zealand  
**Allan Scott, PhD**, University of Canterbury, Christchurch, New Zealand  
**Jason M. Ingham, AP**, University of Auckland, Auckland, New Zealand

## **TIWAI POINT BRIDGE**

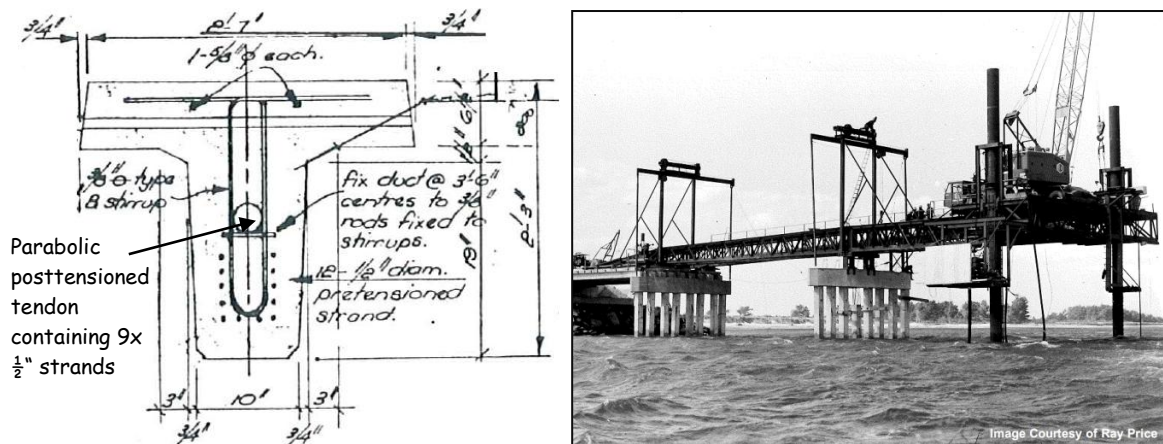
Fig. 1: Typical beam cross-section<sup>4</sup> and image of Tiwai Bridge launcher in operation

A typical cross section of a beam is given in Fig. 1. An important feature of the design was that the shear reinforcement does not enclose the pretensioned strand. This detail causes the more critical pretensioned longitudinal reinforcement to corrode first and leads to a number of durability concerns<sup>3</sup>.

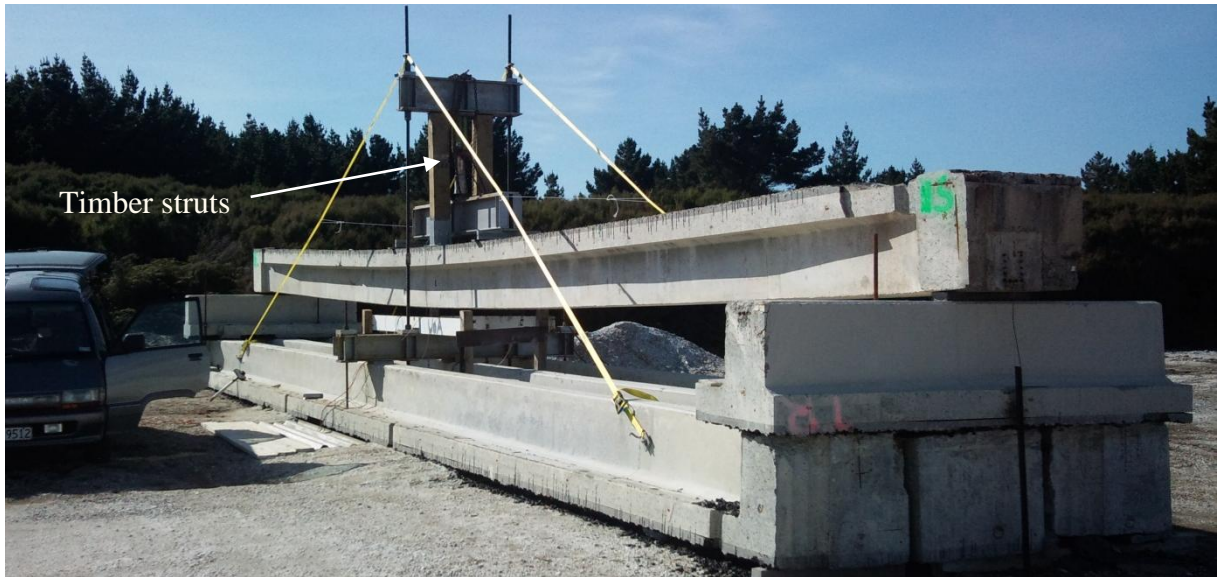
Fig. 9: Test rig and deflected beam 4C

The loading procedure for the beams was complicated by the stroke of the hydraulic ram. The stroke capacity of the jack was approximately 250 mm and the beams failed at deflections of around 400 mm. For this reason the beams were loaded to full stroke and then propped using the timber struts shown in Fig. 9. The hydraulic ram was then retracted and a packer inserted, allowing the load to be reapplied through the packer once the timber struts were removed. This process was repeated until sufficient deflection capacity was made available. This resulted in the load reading dropping to zero as the load was transferred to the timber struts while the beam remained deflected. This portion of the data has been removed from the load deflection graphs to reduce clutter, but is evidenced by the two small drops in load at approximately 225 mm and 250 mm deflection.

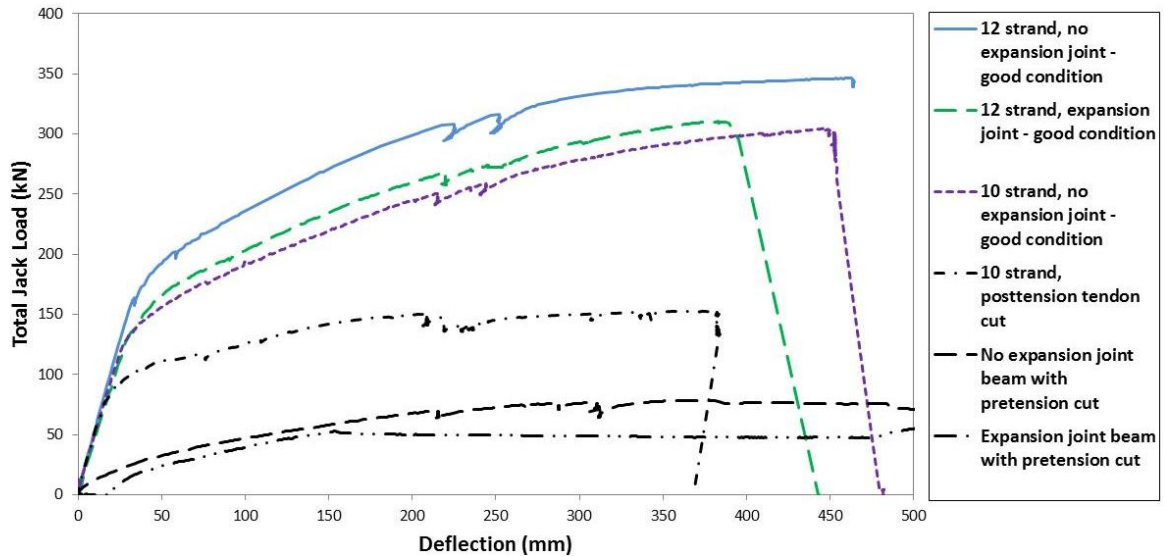
Fig. 12: Control test results and prestressing arrangement comparison

Destructive testing was performed on three of the four different prestressing arrangements existing on the bridge. Fig. 12 below shows a comparison between beams in good condition containing each of the three different prestressing arrangements that were subjected to testing. These beams displayed similar ductility characteristics and a 12% difference in ultimate load between the strongest and weakest of those tested, with the fourth prestressing type expected to be the weakest.
