Precast-Prestressed Concrete Bridge Girders Damaged by Over-Height Load Impacts

Richard Brice, P.E., Washington State DOT, Olympia, Washington

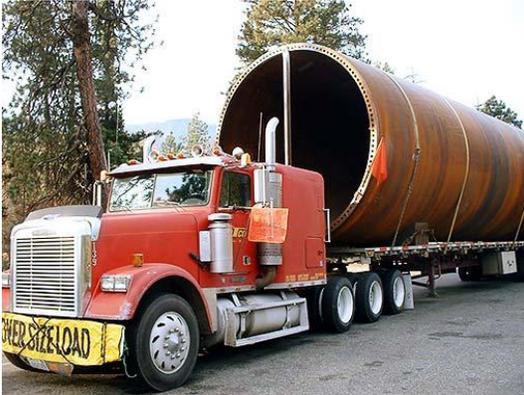
Figure 5 Over-height load that damaged the Easton Road Bridge

structure is 17.0 ft. The over-height load, shown in Figure 5, was a support column for a wind turbine structure.

The impact caused a complete loss of structural integrity in one span of the bridge. The bottom flange and web of all six of the girders in the cross section were damaged beyond repair. The damaged structure is shown in Figure 6. The collision forced the closure of the I-90 eastbound lanes and traffic was detoured onto the Easton interchange ramps. WSDOT crews and an emergency contractor demolished the damaged bridge span and re-opened the eastbound lanes of I-90 within 24 hours of the collision. Secretary of Transportation Paula Hammond challenged WSDOT engineers to “get creative – get this bridge replaced as quickly and effectively as possible.” WSDOT met the challenge and opened the structure in 45 days.

This structure is located in a mountain pass and winter weather conditions are common in late fall. Placement of concrete in cold weather conditions was a major concern. WSDOT designers selected decked bulb tee girders rather than in-kind replacement of I-girders with cast-in-place deck. This eliminated a substantial quantity of cast-in-place concrete and accelerated the construction of the replacement span. With the availability of high performance concrete and 0.6” diameter prestressing strands, five precast-prestressed decked

bulb tee girders replaced the six original I-shaped girders. The total cost of the replacement contract was \$703,000. This equates to a cost of \$2,379 per foot of girder.
