REHABILITATING PRECAST CONCRETE HISTORY USING DESIGN-BUILD DELIVERY

Matthew J. Lengyel, PE, SE, David Evans and Associates, Inc.

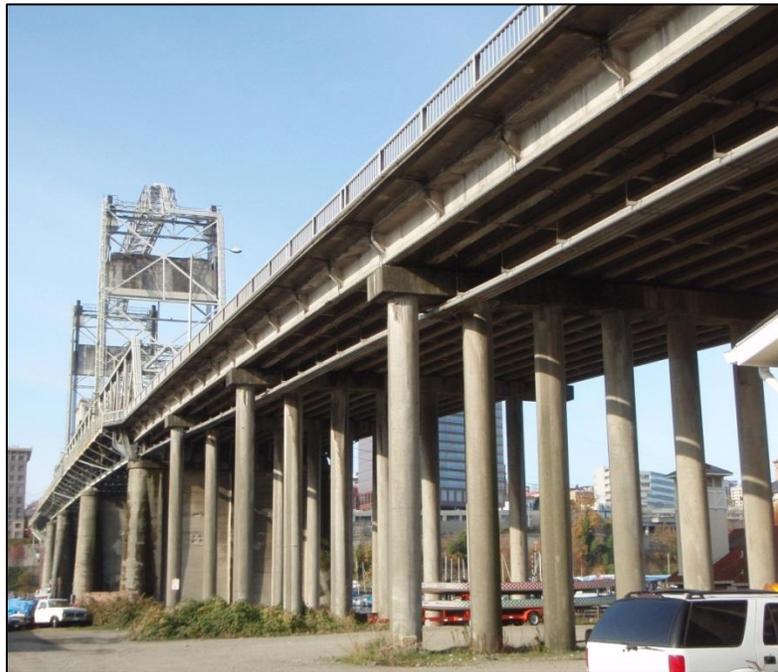
Fig. 1 Precast Port Approach of the Murray Morgan Bridge

Unfortunately, after more than 50 years of service in a marine environment, the Port Approach was beginning to show signs of deterioration. Cracking and spalling were seen in many of the high stress areas, such as at the tops of the hollow precast concrete columns (see Figure 2), and in areas regularly exposed to weather, such as exterior girders. Also, a few of the high strength post-tensioning rods that ran through the precast superstructure diaphragms had failed at the anchorage locations on the fascias of the bridge.

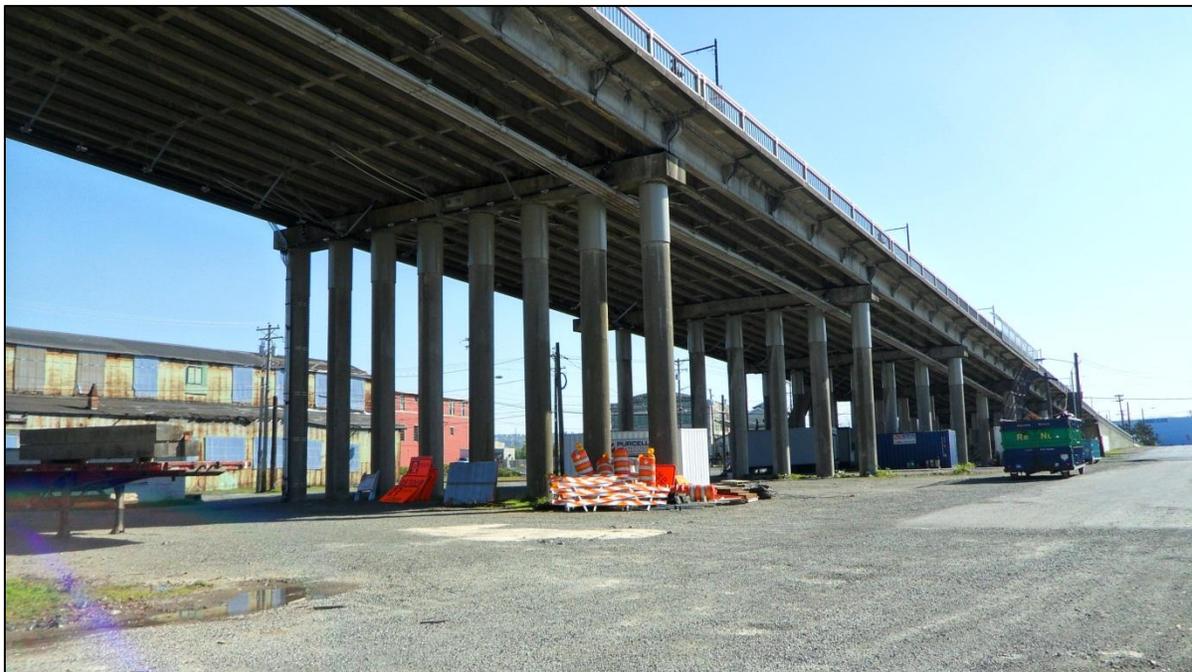
Fig. 12 Rehabilitated Port Approach

It is important to note an RFP requirement regarding the preconstruction inspection that worked very well. The design-builder was required to complete a pre-construction inspection before beginning work on an element of the bridge. The pre-construction inspection confirmed the deficiencies listed in the RFP documentation, and was also intended to document deficiencies that were not in the RFP documentation. If the undocumented deficiencies affected the final rating of the bridge, then they needed to be repaired in accordance with the Unknown Major Deficiency provisions of the RFP. In the Port Approach, roughly \$300,000 worth of additional work was discovered during the pre-construction inspection. The owner was able to work with the design-builder early on in the project to include the additional work efficiently in the first set of Issue for Construction IFC drawings for the Port Approach. Having very early knowledge of potential and subsequent additional work (which is common on rehabilitation projects) was a very important feature that contributed to the success of the project, and allowed for repairs to the Port Approach to be completed in the fall of 2012 (see Figure 12).
