LIVE LOAD TEST OF A 54-YEAR OLD PRESTRESSED CONCRETE VOIDED SLAB BRIDGE

Bernard L. Kassner, Ph.D., P.E., Virginia Center for Transportation Innovation and Research, Charlottesville, VA

Soundar S.G. Balakumaran, Ph.D., Virginia Center for Transportation Innovation and Research, Charlottesville, VA

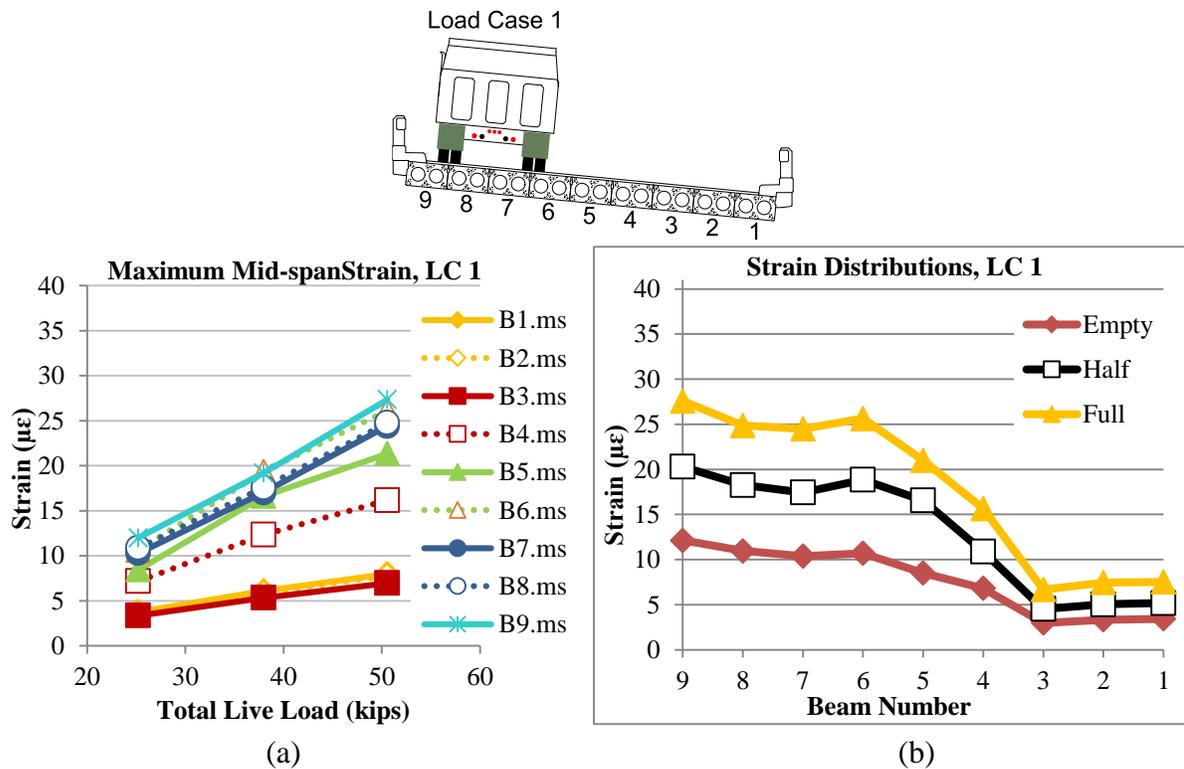
Fig. 12 Average (a) maximum strain and (b) strain distributions at mid-span for all beams [at maximum strain] for Load Case 1.

Refer back to Figures 12 and 14, where a wheel line from the load truck was positioned on top of the longitudinal joint between the fascia beam and the first interior beam. These two orientations are the most direct loading on the fascia beams during the entire load test. In both cases, note how the strains were greater in the exterior beams than the interior beam. These larger strains are indicative of the fact that the exterior beams did not benefit from having adjacent members on both sides of the given beam in distributing the load in the same manner as the interior beams. However, the exterior beams did have a parapet, which could have increased the stiffness of those exterior members. In the case of the Adkins Road bridge, the railing and curb were continuous along the length of the span. The question is whether or not there was substantial composite action occurring between the beam and the parapet to further augment the beam stiffness.

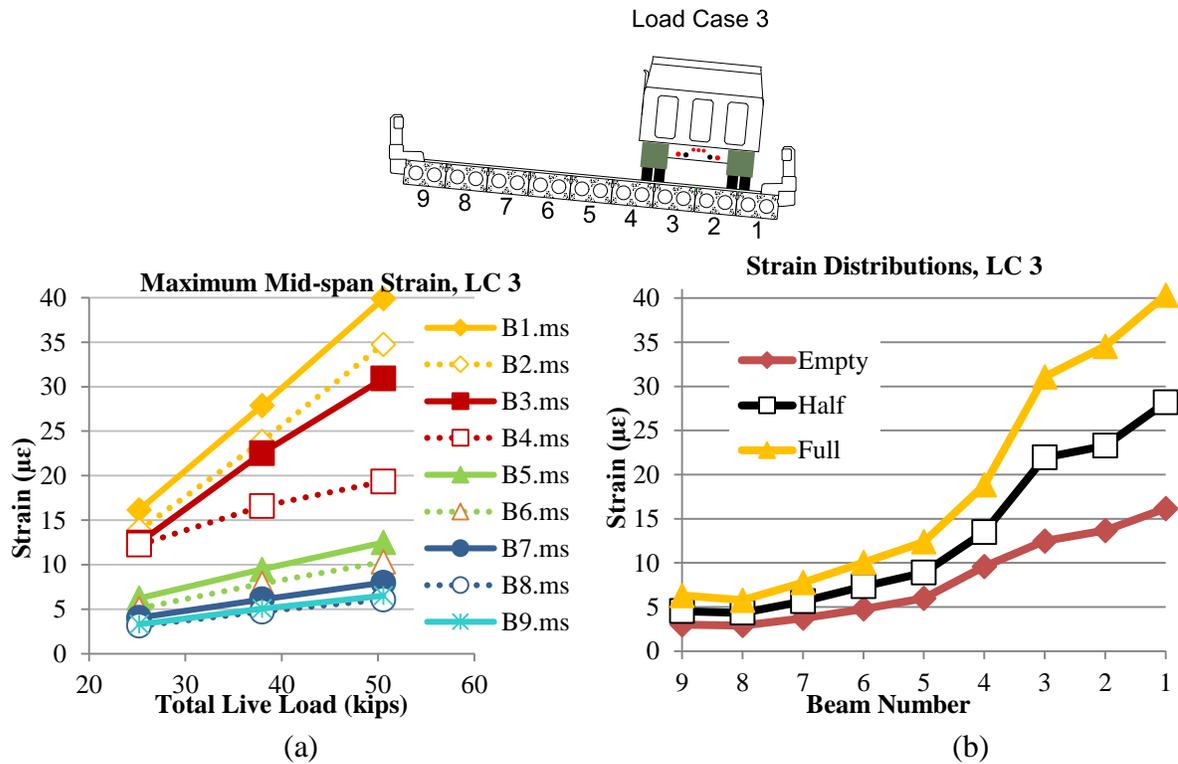
Fig. 14 Average (a) maximum strain and (b) strain distributions at mid-span for all beams [at maximum strain] for Load Case 3.

The largest average maximum strain recorded during the entire testing was $40 \mu\epsilon$, which was for Beam 1 in LC 3 using the Full truck. If one were to assume a compressive strength of 4 ksi and a unit weight of concrete of 0.145 kcf in Eq. 5.4.2.4-1 of the 2012 *AASHTO LRFD Bridge Design Specifications*² for calculating the concrete’s elastic modulus, this level of strain would equate to 0.15 ksi of tension in the bottom of the beam due to live load. If assuming simple supports, a girder distribution factor that was slightly larger than the AASHTO-calculated factor (as discussed later in this paper), and a larger moment of inertia for the exterior beam compared to an interior beam (also discussed later in this paper), the theoretical stress due to live load for the given load truck would have been 0.26 ksi. One reason for the discrepancy between theoretical and tested results is that the ends of Beam 1 were not truly simply supported, but had some rotational stiffness that helped to strengthen the beam at mid-span. Nevertheless, if one were to take the prestress losses of $26 \frac{3}{8}$ -in.

diameter, Gr. 250 stress-relieved strands into account along with the live load stresses as measured in the field, the total stress in the bottom of Beam 1 would have still been in compression, far from any concerns about cracking. The same was true for the interior beams that had smaller strains due to live load but also smaller section moduli. This result is consistent with the strain versus load graphs in subfigure (a) for Figures 12 through 17, where the strains measured at mid-span increased fairly linearly up to the weight of the Full truck. These linear results show that the structure remained within its linear elastic limit up to 25 tons during the load test, which was about 18 tons less than the inventory rating for a single-unit vehicle on this particular bridge, as listed in the 2011 inspection report.

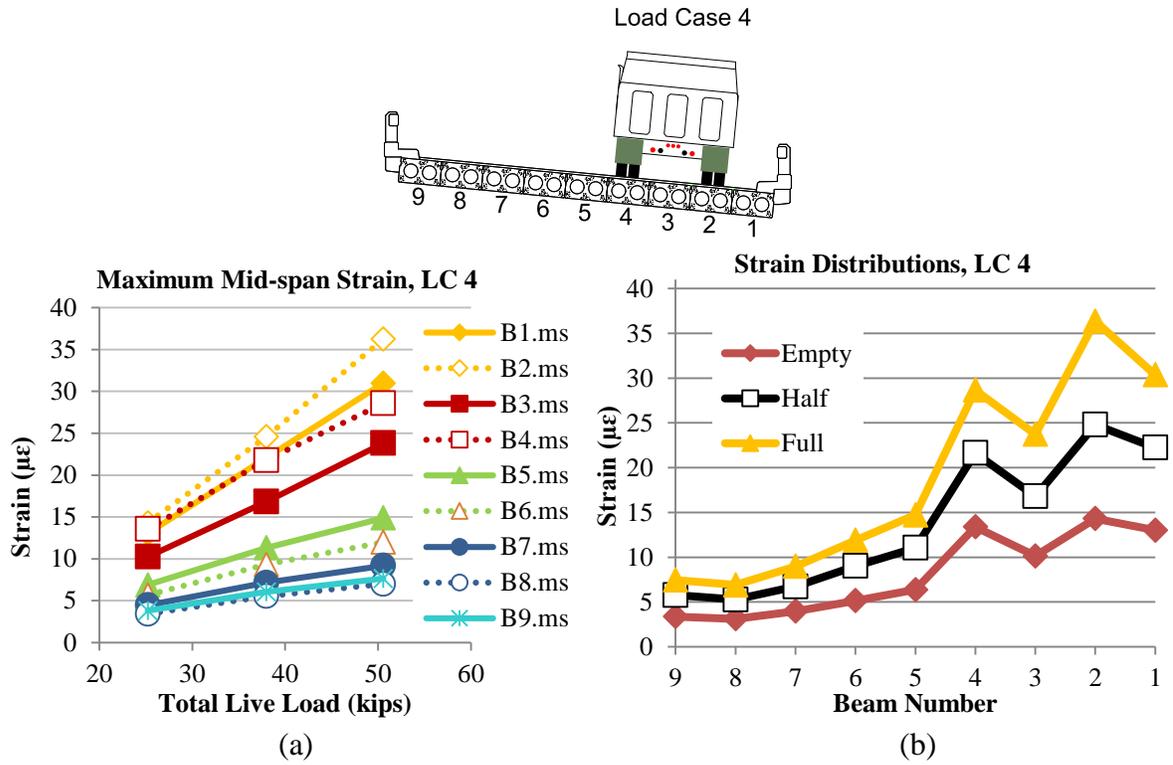
Fig. 15 Average (a) maximum strain and (b) strain distributions at mid-span for all beams [at maximum strain] for Load Case 4.

The exceptions to this linearity in load-strain behavior were Beam 5 in LC 2 [Fig. 13(a)] and Beam 3 in LC 6 [Fig. 17(a)], and to a lesser extent, Beam 6 in LC 2 [Fig. 13(a)] and Beam 2 in LC 4 [Fig. 15(a)]. In these cases, the rate of increase in strain between the Half Truck and the Full Truck was greater than the increase going from the Empty Truck to the Half Truck, on a strain per unit load basis. Recall that Beam 5 had the spall with exposed and broken strand. Interestingly, the non-linearity instances with Beams 5 and 3 occurred when a truck wheel line was adjacent to the beam in question, as opposed to being directly on top. However, the deviation from the linear strain increase for Beams 5 and 3 was only about 5 µε, which is negligible. There were some cases where the rate of strain increase was lower as the amount of load increased. These latter instances, however, occurred in beams that were adjacent to the more directly loaded beams. So, these anomalies may be attributed to minor changes in load distribution as the loading increased. Interestingly, Beam 4 appeared to indicate fairly consistent strain linearity as the load increased. This observation suggests that

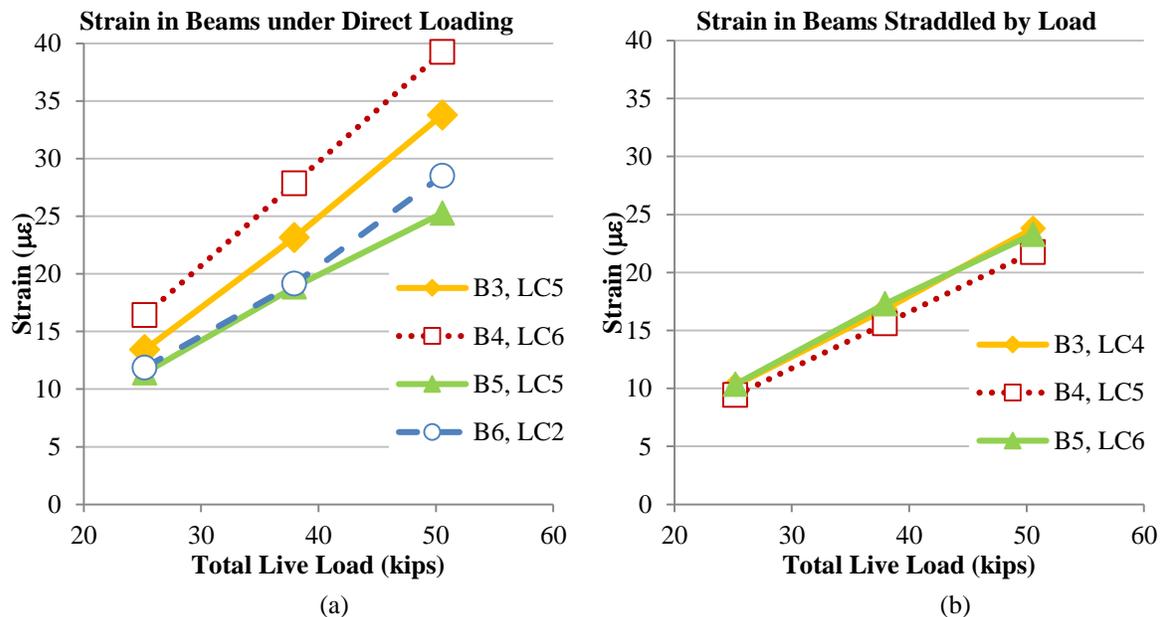
Fig. 18 Given similar loading conditions, a comparison of the strain in (a)

Another way to view the strain results in Figures 12 through 17 is to compare beams that experienced similar loading conditions, albeit in different load cases. For instance, take the plots in Fig. 18, which compare the average maximum strains for four beams in select load cases that were under similar loading conditions. Note that the difference between subplots (a) and (b) is that (a) shows data when a wheel line was directly on the centerline of the indicated beam as opposed to the having wheel loads straddle the given beam. The measured strains in each comparison were virtually identical, where the largest difference was about 5 $\mu\epsilon$ when the left wheel line was on top of Beam 3 versus Beam 4, again indicating that the corroded strands in Beam 4 did not have a large impact on the strength of the beam. Beam 5 did have the lowest recorded strains in this comparison, even though this member did have the exposed and broken strand near the quarter-span, as previously mentioned. The driver-side wheel line was directly over Beam 5 in LC5, as opposed to the passenger-side wheel line in the other cases.

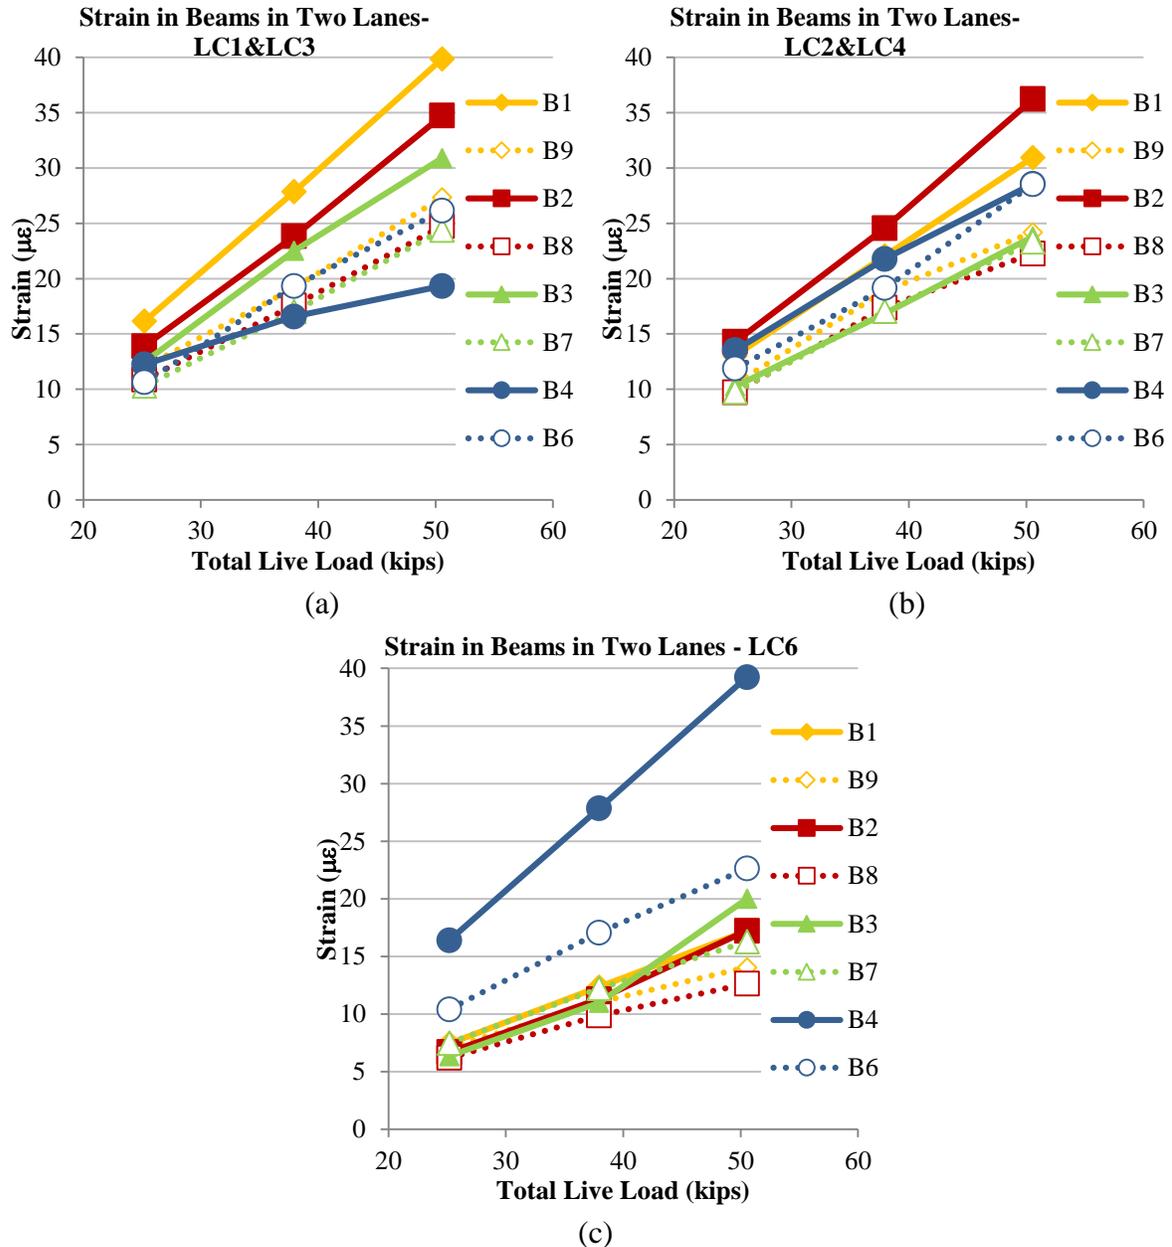
Fig. 19. Comparison of strains in beams symmetric to the bridge centerline for (a) Load Cases 1 and 3, (b) Load Cases 2 and 4, and (c) Load Case 6.

For another comparison, consider the graphs in Fig. 19, which pairs a beam in the southbound lane with one from the northbound lane that was symmetric to the bridge centerline and subjected to a similar load pattern. Note that the beams in this figure are paired together in the legend according to their symmetric location, and plots for the beams in the southbound lane are solid lines whereas the beams in the northbound lane are dotted lines. Furthermore, note that Fig. 19(c) is simply a reconfiguration of the results for Load Case 6 in Fig. 17(a). For the most part, the scenarios in Fig. 19 demonstrate that the peak strains in the

beams in the southbound lane were generally slightly greater than those in the northbound lane. Note that the southbound lane is the lane on the lower end of the super-elevation. Thus, the southbound lane was likely the side of the bridge where snow would pile up during snow removal, and certainly the side subjected to more chloride during snow melts and rain run-off. Thus, the beams in the southbound lane could conceivably have had a greater degree of deterioration, and thus be the reason why that lane exhibited larger strains during the load test.

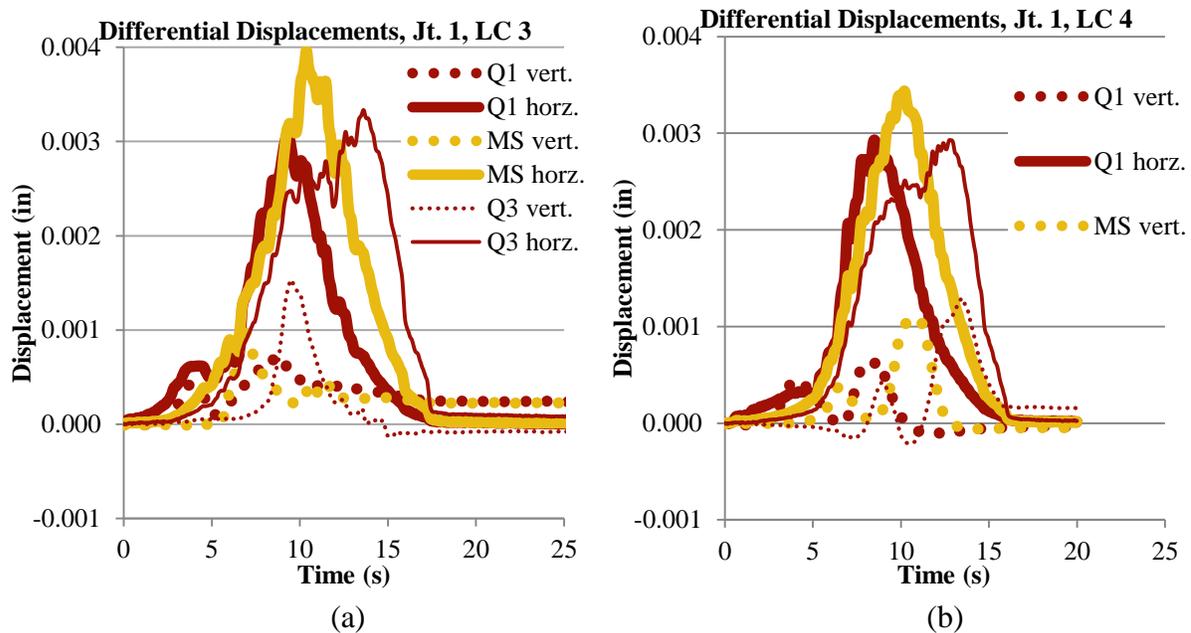
Fig. 22 Differential displacements between Beams 1 and 2 for (a) Load Case 3 and (b) Load Case 4.

Looking solely at Joint 1, Fig. 22 is a typical comparison of the movement between Beams 1 and 2 under two different load scenarios. Fig. 22(a) looks at the behavior when a wheel line from the load truck was positioned directly over the joint, whereas Fig. 22(b) is the result of having a wheel line centered on a beam adjacent to the joint. The measurements in these plots are quite small, with the differential vertical displacement being less than the horizontal movement. As expected, the movement between Beams 1 and 2 in the horizontal direction tended to be less when the wheel load was located adjacent to the longitudinal joint (that is, LC 4) compared to when the wheel load was directly over the joint, as in LC 3. Furthermore, the differential horizontal movement at mid-span was slightly greater than at the two quarter-points. On the other hand, the vertical differential displacement was marginally greater for LC 4.
