## **ASSESSMENT OF A PARKING GARAGE WITH A BROKEN PRESTRESSED SPANDREL BEAM**

**Bishal Parajuli, EIT**, Dept. of Civil Engineering, University of Toledo, USA  
**Seyedowjan Hashtroodi, EIT**, Robert Darvas Associates, Ann Arbor, MI  
**Douglas K. Nims, PhD, PE**, Dept. of Civil Engineering, University of Toledo, USA

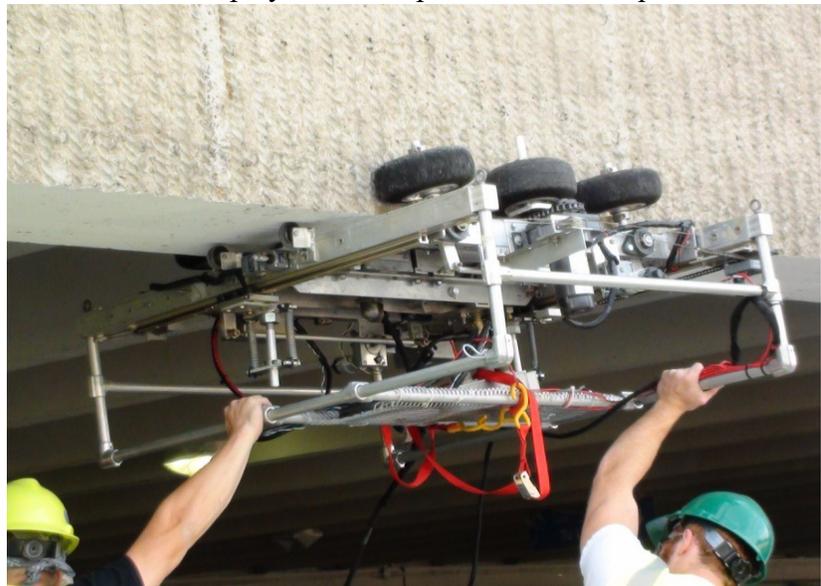
MFL is particularly well suited to this application because it uses a permanent magnet which is much lighter than the electromagnets required by the main flux and residual magnetism methods. The magnet and Hall-effect sensors are mounted on robotic beam traveler which can hang from the lower flange of the beam. The movement of this beam traveler can be controlled from the ground. As it travels along the length of the beam, it scans the condition of steel strands inside the beam. As the traveler scans, the flux data is acquired by a PC based data acquisition system. A graph of the data is displayed to the operator as it is acquired. The sensors can cover only half width of the beam so two passes had to be made. Thus, for a particular beam, the full width scan result comprises of the scan result of east half and west half. As can be seen in figure 16, the tires of the robotic beam traveler gripped the exterior faces of the beam while it moved. The wheels are angled upward to keep the traveler from slipping down.
