EVALUATION OF DAMAGED PRESTRESSED CONCRETE BRIDGE BOX BEAMS

Eric Steinberg, Ph.D., P.E., Ohio University, Athens, OH

Richard Miller, Ph.D., P.E., FPCI, University of Cincinnati, Cincinnati, OH

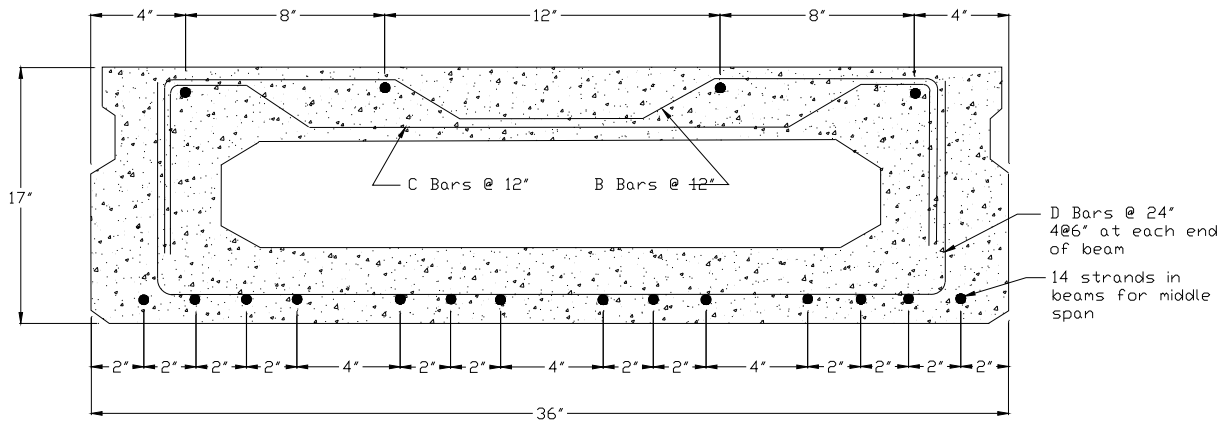
Fig. 4: Box Beam Cross Section

As shown in the figures, a variety of deterioration levels exist for the 36 prestressed concrete beams from limited deterioration to those with severely exposed and broken strands hanging down from the bridge. The beams are 17" deep by 36" wide and contain 14 - 1/2" diameter strands for the center span and 8 - 1/2" diameter strands for the end spans. The strands are outside the stirrups. A typical cross-section of the beams for the center span is shown in

Figure 4. The 2nd, 4th and 6th strand from each side are eliminated from the strand pattern shown to arrive at 8 strands for the end spans.

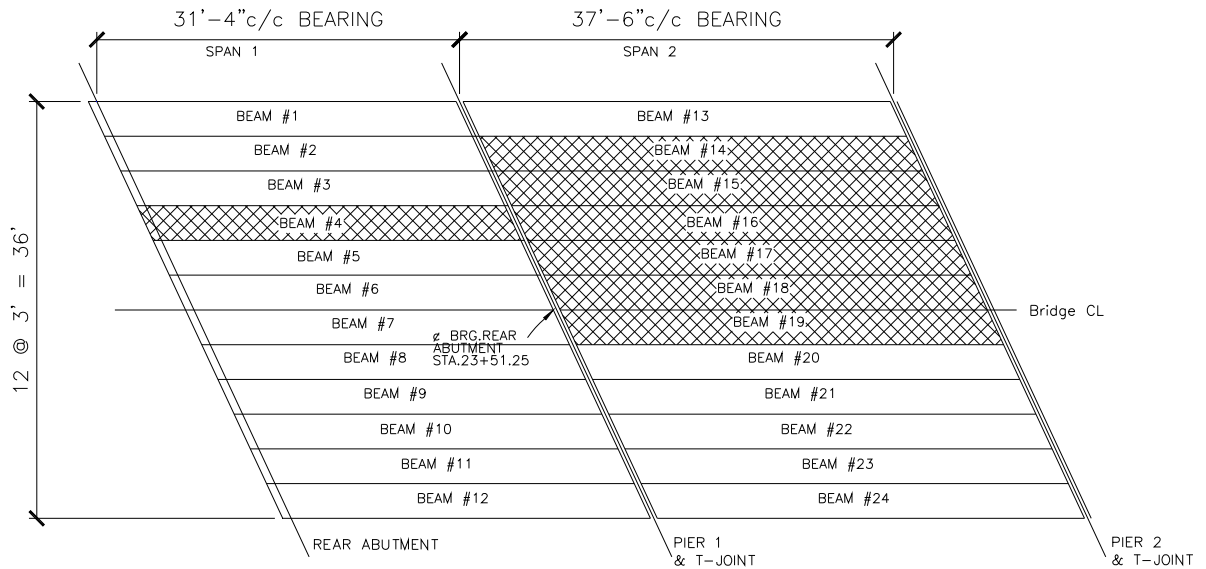
Fig. 5: Box Beams for Testing

The beams removed for testing included six beams from span 2 and one beam from span 1. The span 1 beam was the 4th beam from the western edge (3rd interior beam). The six beams from span 2 were all the interior beams closest to the western edge. This resulted in all interior beams on the western portion from the bridge's longitudinal centerline and one beam east of the bridge's centerline. Figure 5 provides a plan view of the bridge's 1st and 2nd spans along with the beams taken for examination. Ohio University obtained beams 4, 15, and 18 for forensic investigation. Beams 14, 16, 17 and 19 were transported to the University of Cincinnati for full scale destructive testing.
