SHAKE TABLE TESTING OF A FULL-SCALE FIVE-STORY BUILDING: SEISMIC PERFORMANCE OF PRECAST CONCRETE CLADDING PANELS

In April and May 2012, a landmark test of a five-story building constructed at full-scale and completely furnished with nonstructural components and systems (NCSs) was conducted at the University of California, San Diego (UCSD) Network for Earthquake Engineering Simulation (NEES@UCSD, 2013) facility. The project, coined *Building Nonstructural Components and Systems (BNCS)* was realized by a unique collaboration between Academe, Industry and Government and hundreds of individuals with expertise in structural and nonstructural design, earthquake engineering, and construction and management practices⁹. The full-scale building-NCS system was seismically tested in a base isolated and fixed based configuration on the Large High-Performance Outdoor Shake Table (LPOSHT) at the UCSD-NEES facility. Wrapping the exterior of this building were two types of façades, namely light weight metal stud balloon-framing overlaid with a synthetic stucco finish (first three floors) and precast concrete cladding panels (PCC panels) (two upper floors).

This paper will focus on the PCC panels

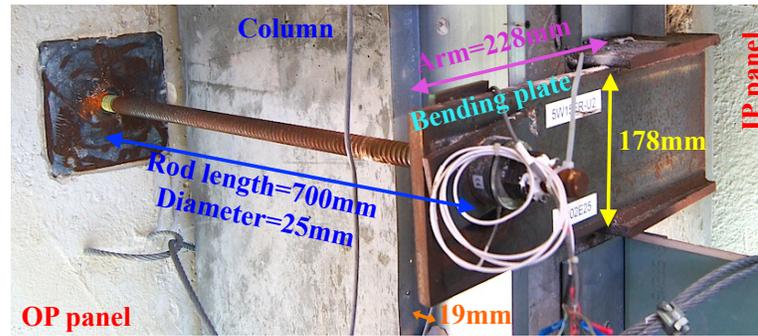
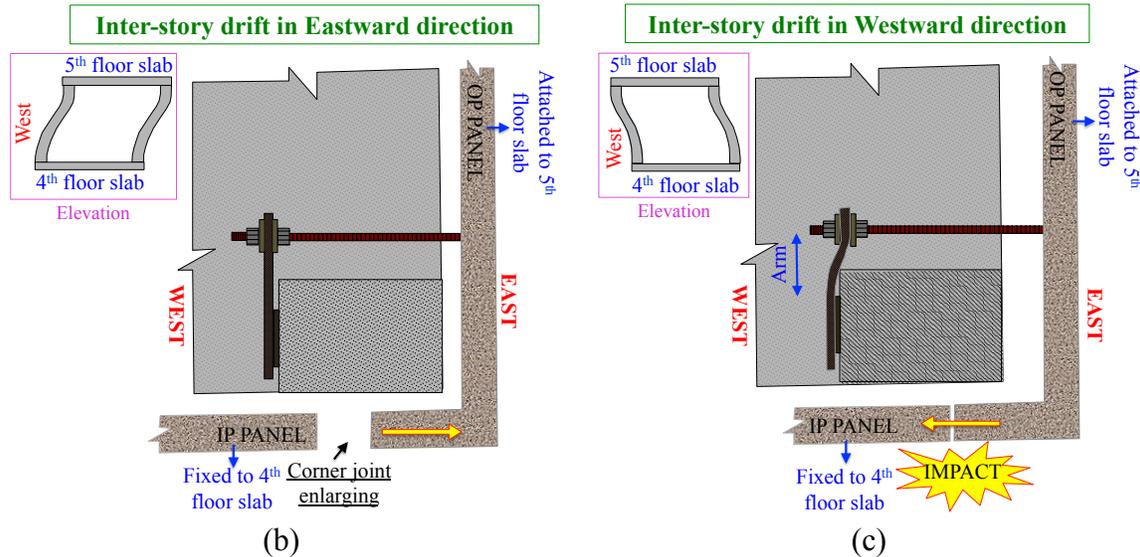
Fig. 4 Push-pull corner connection with ductile fuse on the OP panels (a) photograph, (b), (c) conceptual schematic showing the desire behavior of a corner connection in the 4ES panel during Eastward and Westward motion

- *Elastic drifts* are absorbed by the closing of the vertical corner joint, with the joint sized sufficiently to avoid impact; and
- *Inelastic drifts* are larger than the vertical corner joint and therefore intended to result in impact of the joint. However, upon impact the ductile fuse is designed to prevent connection overload through the fuse mechanism, ensuring that the panels remain attached to the building after the event. In this work, the ductile fuse was in the form of a cantilevering bending plate that deformed during impact. At the same time, it was sized to avoid damage to the other parts of the panel/connection. A picture of this connection is shown in Fig. 4a. A schematic of the corner system during inelastic drift demands for the South-East (SE) corner is shown in Fig. 4b and c.

was reduced by dividing the drift by the code deflection amplification factor $C_d (=5.5$ for special moment concrete frames), resulting in a minimum gap size of 13mm. Both types of corner joints were sized to allow this drift, with a joint size selected as 25mm for the butt-return joint and 19mm for the miter joint (ID allowed~27mm due to the inclination of the joint).

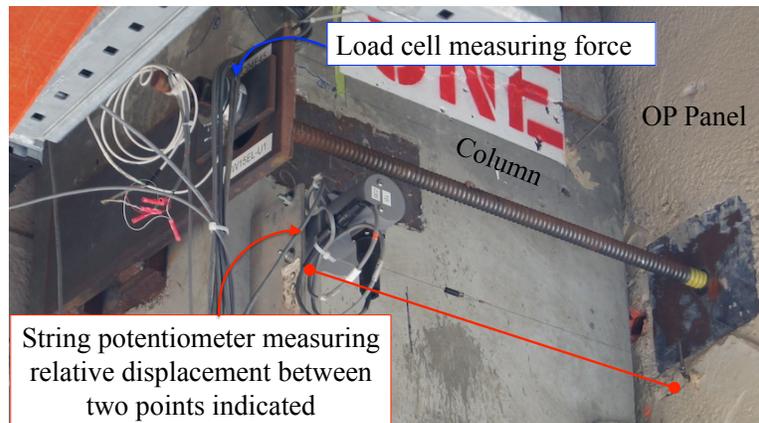
Fig. 5 Analog sensors monitoring the behavior of the behavior of a PPDF connection

- The relative displacement of the OP panel respect to the structural column at the location of the push-pull connection with ductile fuse (PPDF): the sensor (string potentiometer) measuring this displacement is shown in Fig. 5. This sensor was installed as close as possible to the connection so that its measurement provides only the part of displacement absorbed by the connection itself (namely due to the bending of the plate since the axial deformation of the rod is a much stiffer mechanism);
- The force in the connection rods: the load cell measuring the force in the rod is indicated in Fig. 5 and it was able to measure only tension in the rod.

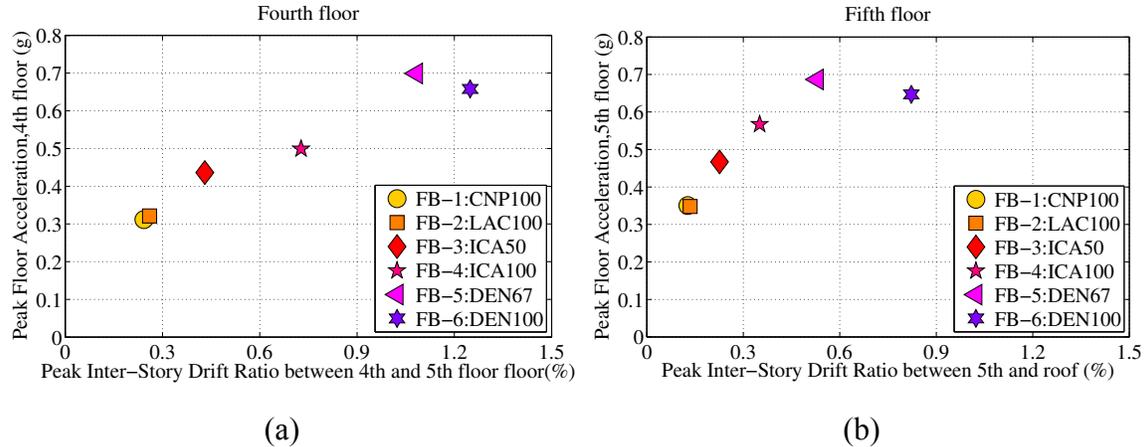
Fig. 6: Peak interstory drift ratio versus peak floor acceleration achieved while the building was fixed at its base: (a) fourth floor, (b) fifth floor

Fig. 6 shows the peak floor accelerations (PFA) and peak interstory drift ratios (PIDR) of the building at its fifth and fourth floor recorded during the FB motions. It is noted that accelerations were measured at every corner of each floor of the building, and displacements were obtained by double integration of these accelerations. The peaks in Fig. 6 are the average of the maximum values of each of the four corners. The maximum value of PFA was obtained during motion FB-5: DEN67, when the structure observes considerable plastic deformation. The largest PIDRs obtained on levels 4-5 and 5-roof were observed during the final motion FB-6: DEN100, with 1.2% and 0.8% attained on levels 4-5 and 5-roof, respectively. These values were lower anticipated, as soft story mechanism developed in the lower levels of the building, with very large PIDRs approaching 6% for the first two floors¹⁴.
