EVOLUTION AND PERFORMANCE OF BOX BEAM BRIDGES IN INDIANA

Ryan T. Molley, MS, KPFF Consulting Engineers, Seattle, WA

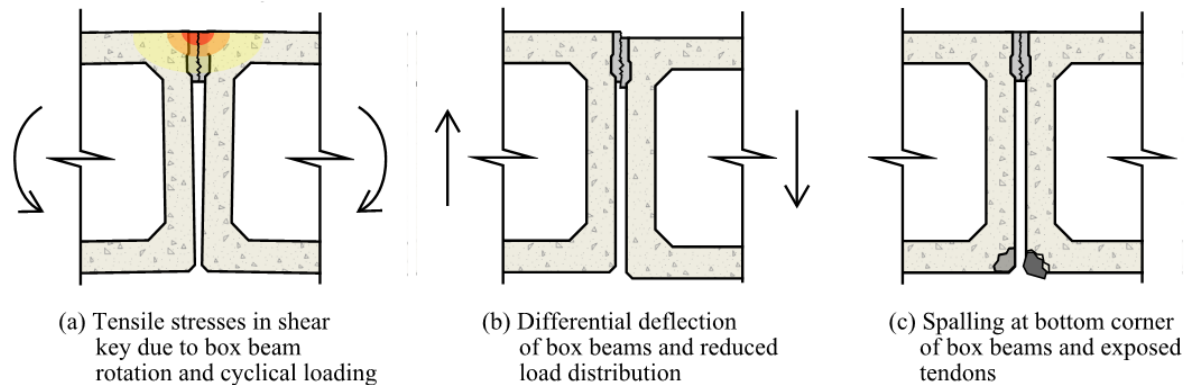
Fig. 2 Deterioration Mechanisms of Adjacent Box Beams

longitudinal cracking can propagate down the key (Figure 2(a)). In turn, deteriorated shear keys can impact the load distribution between adjacent beams (Figure 2(b)). Moreover, a completely fractured key allows salt water to ingress through the joint and curl onto the underside of the box beams. This phenomenon promotes corrosion of the prestressing strands and spalling at the bottom corners of the members (Figure 2(c)).

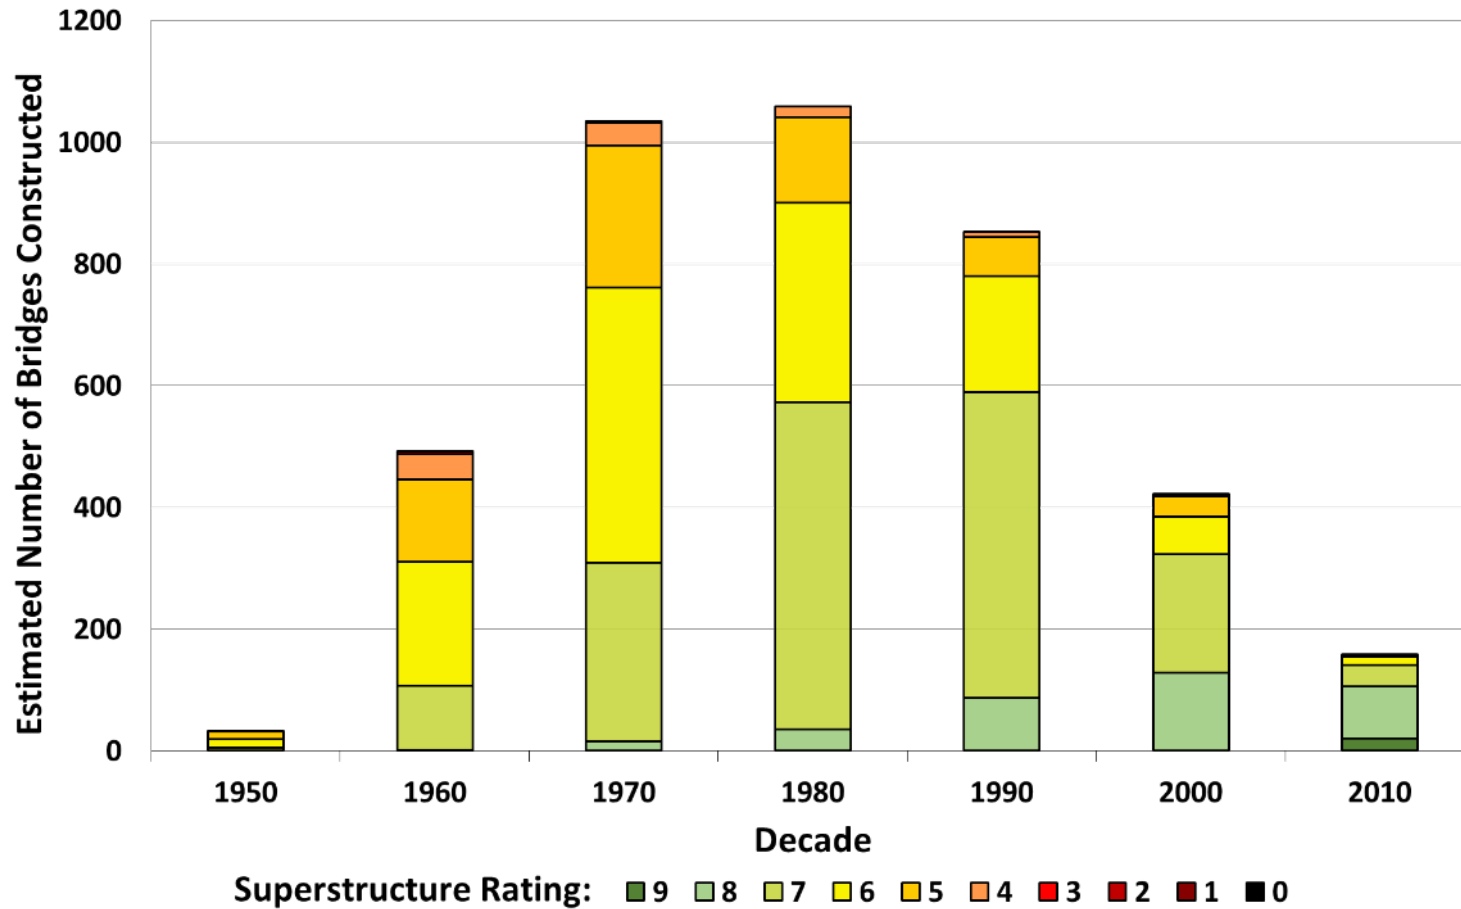
Fig. 4 Estimated Number of Box Beam Bridges Built Per Decade by Superstructure Rating

Figure 4 shows the correlation between the estimated year built and the superstructure ratings for all bridges in the state. As expected, the superstructure condition decreases with increased age.

The most frequent condition rating, or the rating corresponding to the largest percentage of bridges in each decade, can be determined from Figure 4. For the bridges built in the 1980s, 1990s, and 2000s, the most frequent condition rating is 7. The percentage of bridges with this rating in each decade are 51%, 59%, and 46%, respectively. For older bridges constructed in the 1960s to 1970s, the most frequent condition rating decreases to a value of 6. This rating accounts for 41% of bridges built in the 1960s and for 44% of bridges built in the 1970s. The trend continues for bridges built in the 1950s with the most frequent rating split between 5 and 6 with 39% of bridges corresponding to each rating. Moreover, a significant decrease can be seen in the frequency of ratings with a value of 8 over the past five decades (54% - 2010s, 31% - 2000s, 10% - 1990s, 3% - 1980s, and 1% - 1970s). The decrease of condition rating, in terms of frequency, highlights a lack of durability.

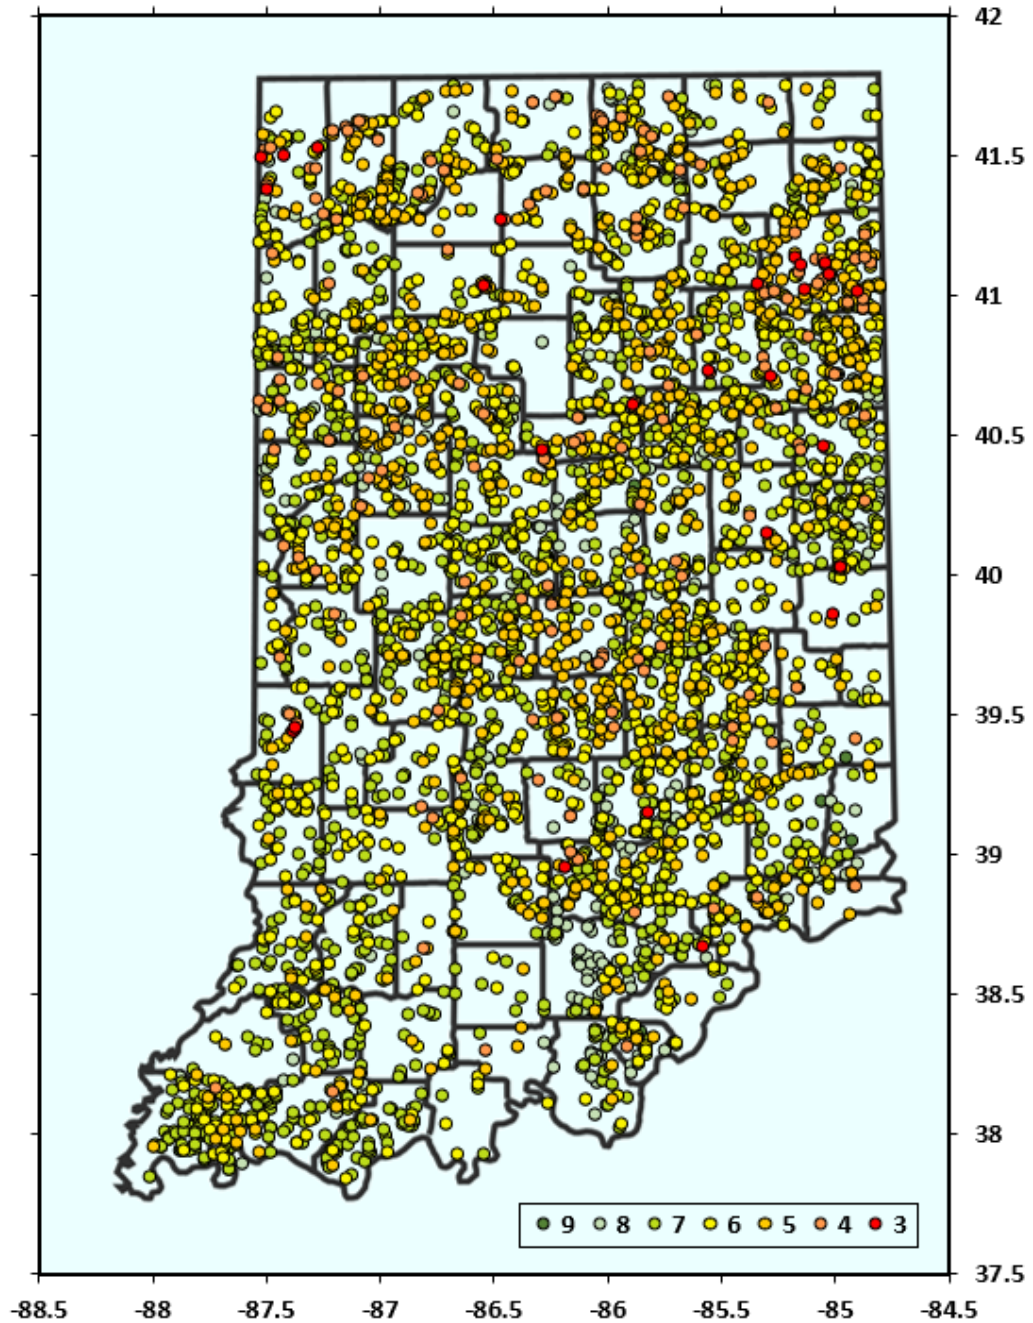
Fig. 5 Mapped Superstructure Condition of All Adjacent Box Beam Bridges¹²

The winter weather conditions of Northern Indiana tend to be more severe than the winter weather in Southern Indiana. The difference in severity has the potential to translate into more salt on the wearing surface of bridges and exposure to more freeze-thaw cycles within a given winter season. Bridge coordinates accessed through the BIAS database were used to map the locations of all the adjacent box beam bridges as shown in Figure 5. Each dot in the figure represents a box beam bridge and is colored based on the logged superstructure condition rating in the most recent inspection report. As indicated in Figure 5, the northern part of Indiana is primarily covered with orange and red dots. Despite a few dark orange and red dots, the majority of the bridges in central Indiana have a condition rating of 5 to 7. The bridges in Southern Indiana are primarily represented by a mix of yellow and light green dots. Because the northern bridges, on average, have lower condition ratings, it appears that the location of box beam bridges plays a role in the extent of deterioration.

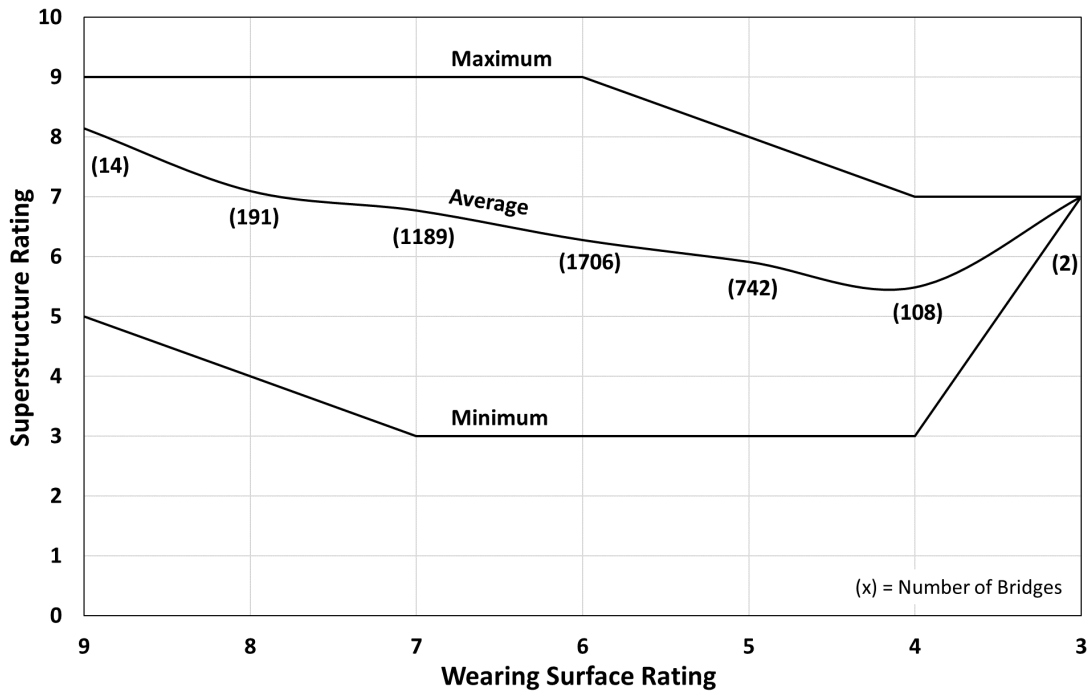
Fig. 6 Correlation of Superstructure Rating and Wearing Surface Rating

To further evaluate if the wearing surface has an influence on overall deterioration, the rating of the superstructure was plotted with respect to the rating of the wearing surface in Figure 6. The number of bridges with each wearing surface condition rating is noted. In general, the condition of the wearing surface has a direct correlation to the condition of the superstructure. Figure 6 shows an approximately linear decline in the average superstructure rating as the wearing surface rating declines. The increase in the average superstructure rating as the wearing surface rating decreases from 4 to 3 is explained by the small sample size (two bridges) that have a wearing surface rating of 3. From the data presented in Figure 6, it can be reasonably concluded that the condition of the wearing surface impacts the condition of the superstructure.
