The Cause of Cracking in Post-Tensioned Concrete Box Girder Bridges and Retrofit Procedures

Walter Podolny, Jr.

Bridge Division
Office of Engineering
Federal Highway Administration
Washington, D.C.

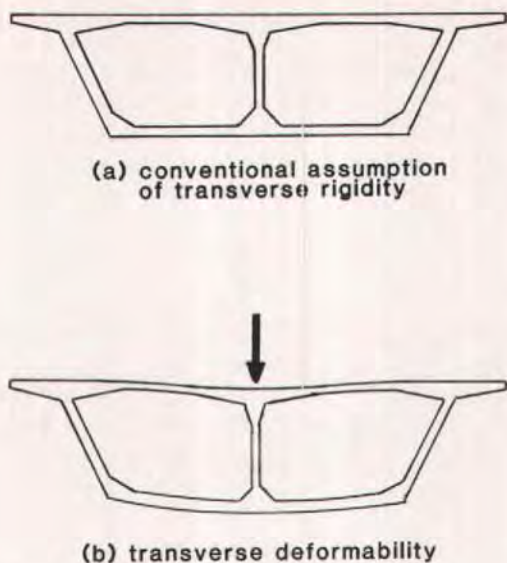
Fig. 8. Transverse stiffness of a two-cell box.

cross section was rigid and transversely undeformable (Fig. 8a). However, depending upon the stiffness of component parts of the cross section this assumption may be erroneous (Fig. 8b). Conventional analysis, assuming a rigid undeformable cross section, assumes that a centered loading is evenly distributed among the webs. In fact, a center loading induces a transverse deformation in the top and bottom flanges with a displacement of the center web larger than that of the external webs. Fig. 9 indicates influence lines for shear in the center web and the external web. The transverse behavior appears very different from that of a transversely undeformable section and may produce cracking in the bottom flange as indicated in Fig. 10. For any particular cross section, a more rigorous analysis is indicated than that usually conducted.

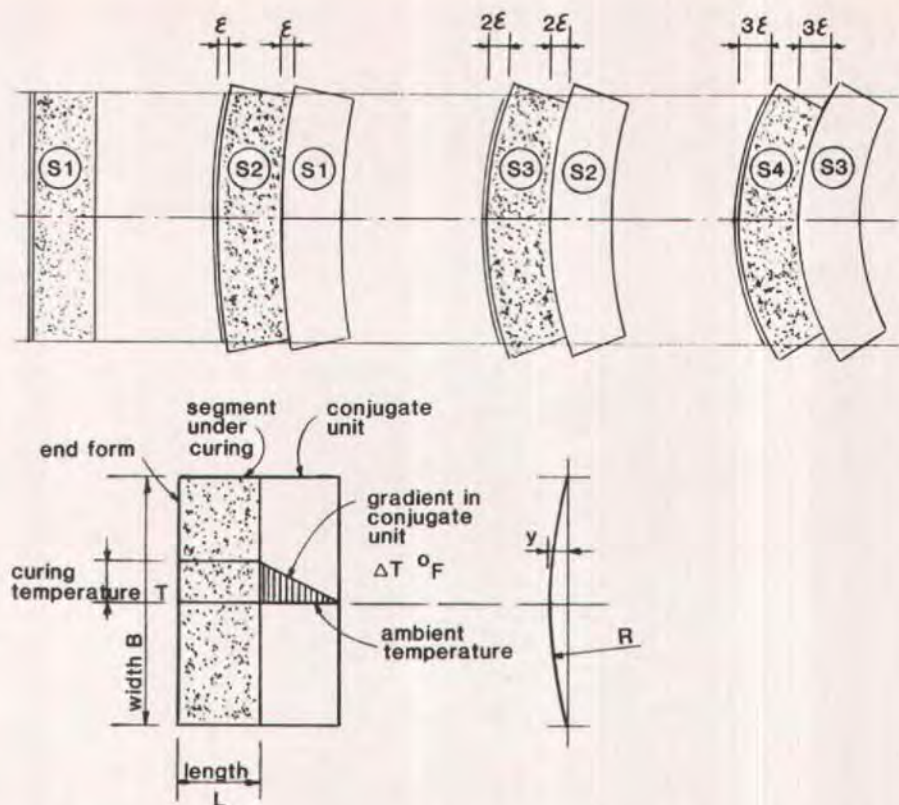
Fig. 25. Effect of improper curing of segments in short-line casting.

Another difficulty during curing is that resulting from large temperature differences between the curing environment of the segment being cast and the outside environment of the cast-against segment (Fig. 25). If a temperature gradient exists across the cast-against segment, its shape will change. The segment will return to its original shape when the temperature gradient falls back to zero.

This will result in match cast surfaces that are not necessarily parallel full length. This condition is evidenced in the top slab joints; the joints will be tight at the curbs and a small gap may be noticed at the center. The problem becomes cumulative if this condition exists for subsequent castings. With the tremendous prestressing force, the segments develop longitudinal cracks as the segments are seated against each other.

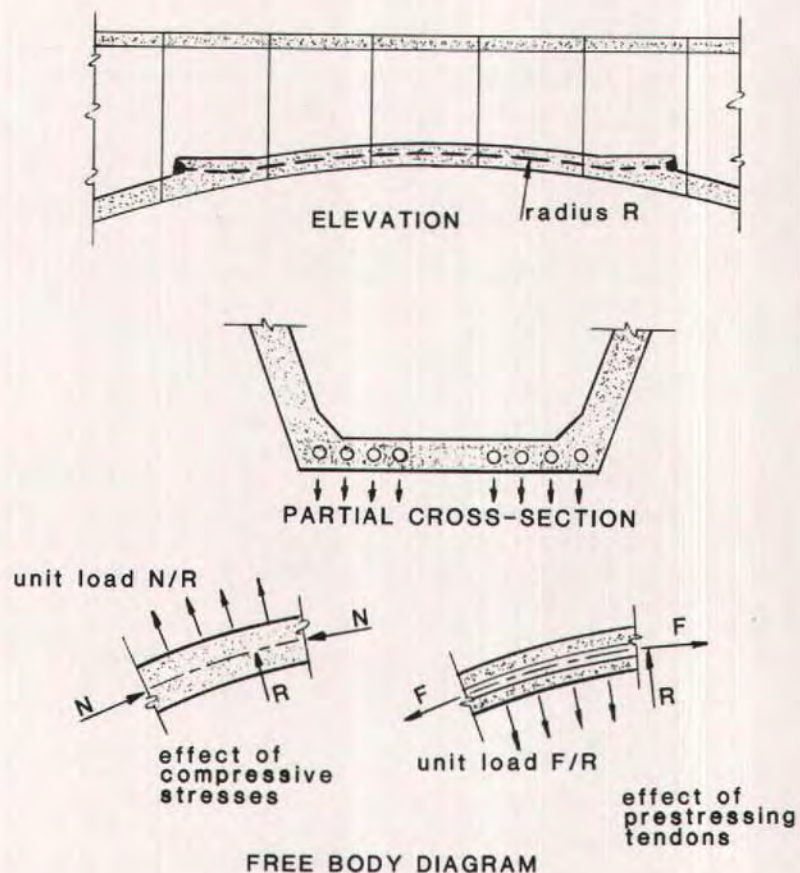
Fig. 35. Vertically curved tendon.

flange proper. When a variable depth girder is used, the bottom flange has a curvature in the vertical plane, which must be followed by the prestressing tendons (Fig. 35).

Unless careful consideration is given to that fact at the concept and detailed design stages, difficulties are likely to develop. This is indicated in Fig. 35, which shows the free-body diagrams of stresses in the bottom flange due to the curvature. Curvature of a tendon induces a downward radial force, which must be resisted by transverse bending of the bottom flange between the webs.³

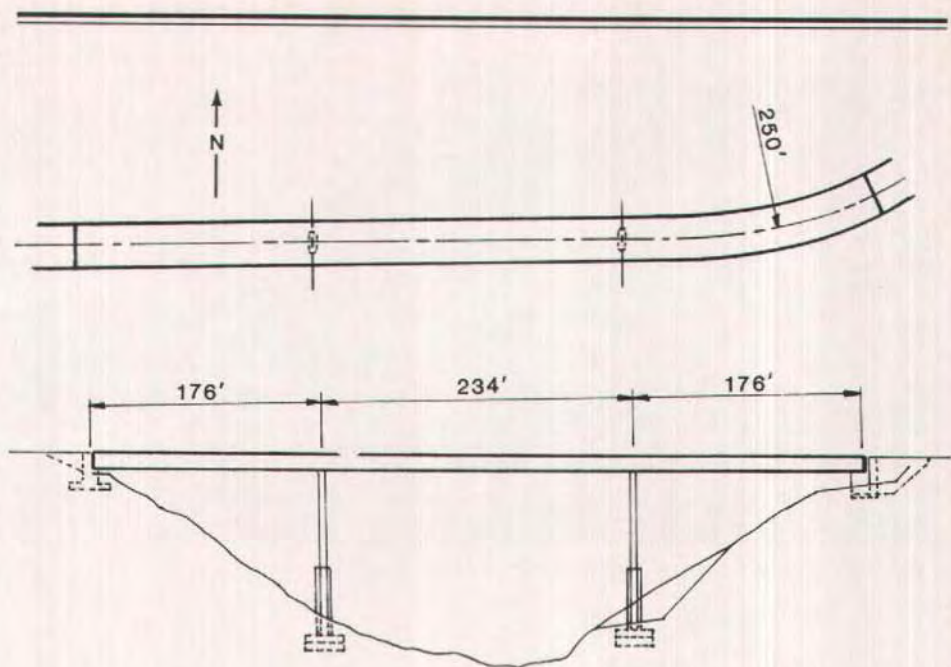
Fig. 37. Bridge elevation and plan.

An immediate inspection of the structure indicated that the horizontally curved tendons, exerting a radial horizontal pressure, had overloaded the reinforced concrete webs. This overload

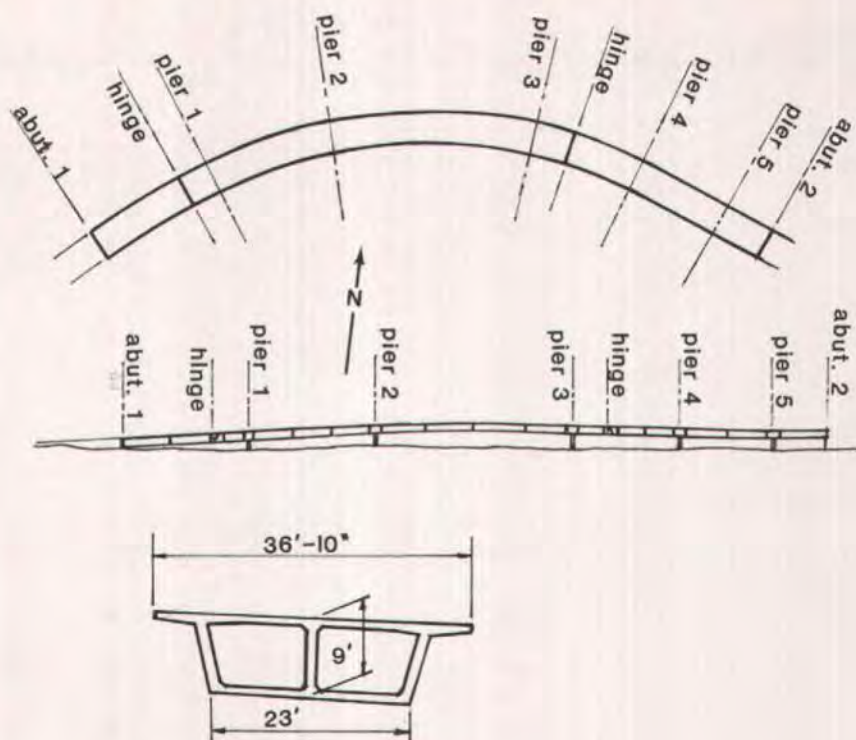
Fig. 42. Plan, elevation and section.

The second example* occurred on an interchange ramp (Fig. 42). This structure is a post-tensioned, cast-in-place, continuous, two-cell concrete box girder, constructed essentially on a curve with a radius of 540 ft (164.6 m). The structure, between expansion hinges, experienced concrete spalling and cracking during construction on the south web of the box along the curve as indicated in Figs. 43 and 44.

During the first post-tensioning operations, four tendons out of six in each web were fully post-tensioned, then noise was heard and cracking and spalling were observed along the south web.

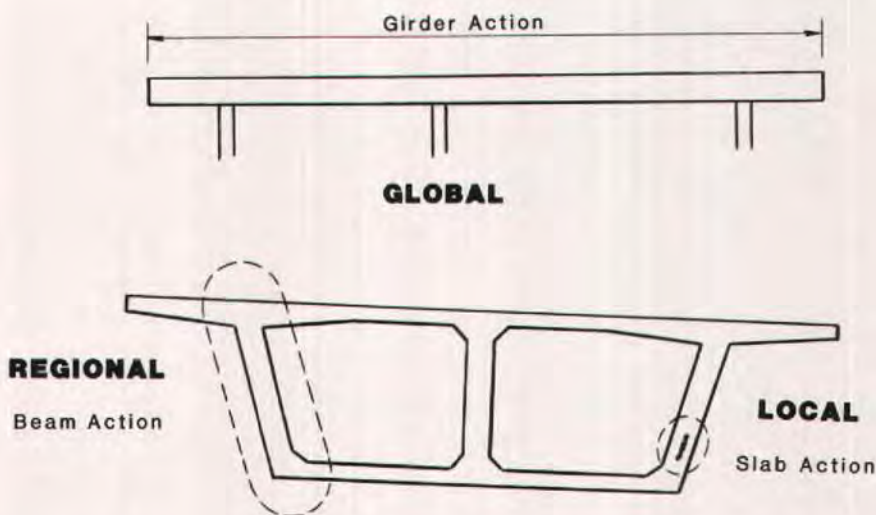
The analysis of the failure of these structures can be divided into three separate actions (Fig. 45) which need to be considered in design:

Fig. 45. Box girder actions due to horizontally curved tendons.

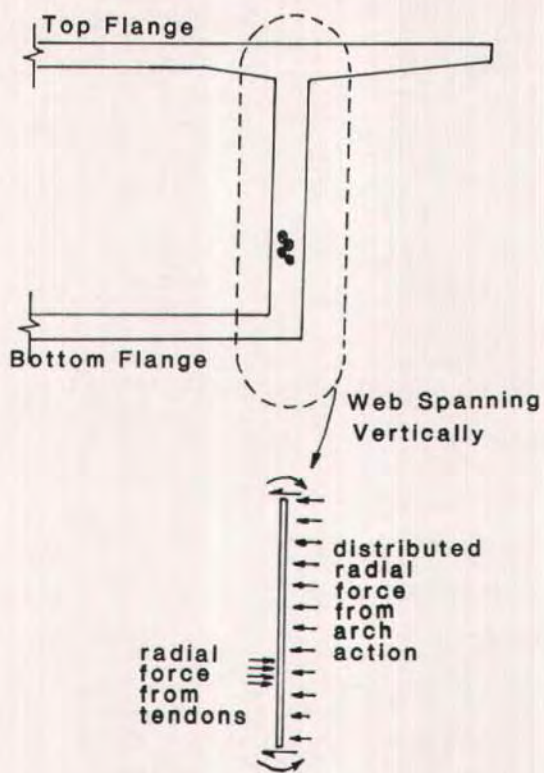
Regional action considers each web as a beam supported at the top and bottom flanges. This beam (Fig. 46) is acted upon by the radial force from the tendons. The radial tendon force produces shear and bending in the web, as it spans vertically. The bending moment and shear in the web are also influenced by the fact that the web concrete is under longitudinal compression from tendon prestress.

Fig. 46. Vertical span of web.

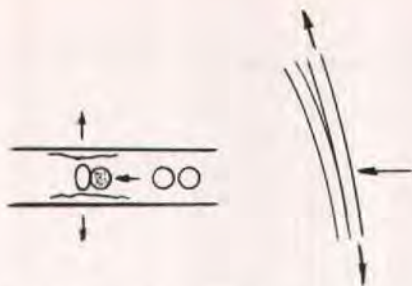
Fig. 58. Lateral duct crushing.

There are several other interacting causes that may have contributed to other laminar spalling. Although the design had the ducts spaced apart, in reality in many instances they touched, especially where there was a horizontal curvature of the ducts. In some instances where there was a horizontal curvature and there were closely adjoining ducts, stressing of the tendon on the outer side of the curve caused the duct to crush into the inner duct, distorting it vertically and causing spalling (Fig. 58).²⁴
