First Impressions of Earthquake Damage in San Francisco Area

James K. Iverson, PhD, P.E.

Principal
The Consulting Engineers Group, Inc.
Napa, California

Presents a preliminary report on the performance of structures during the October 17, 1989, San Francisco area earthquake. Primary emphasis is placed on the behavior of precast and prestressed concrete structures.

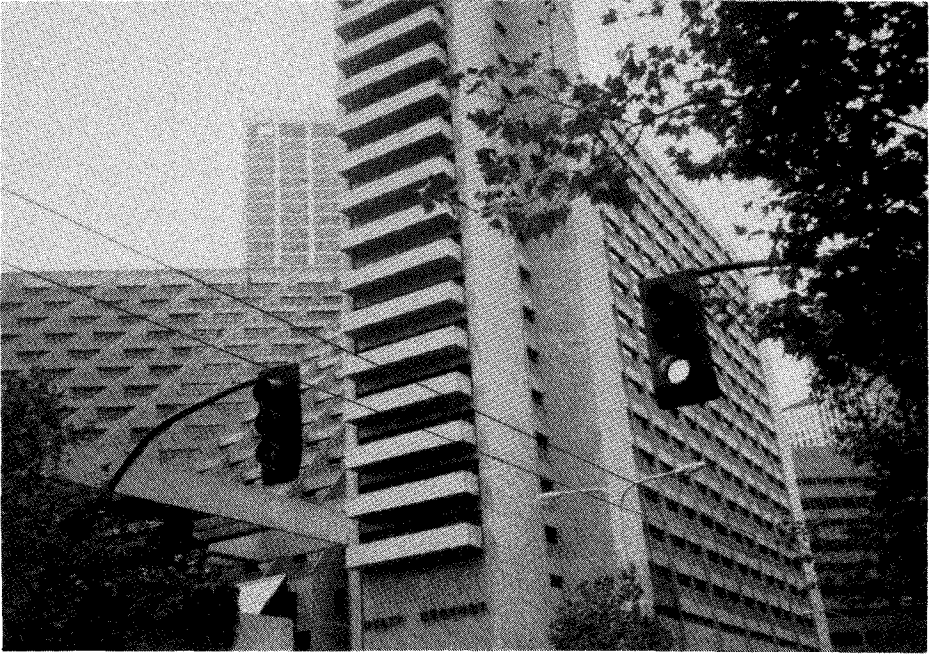
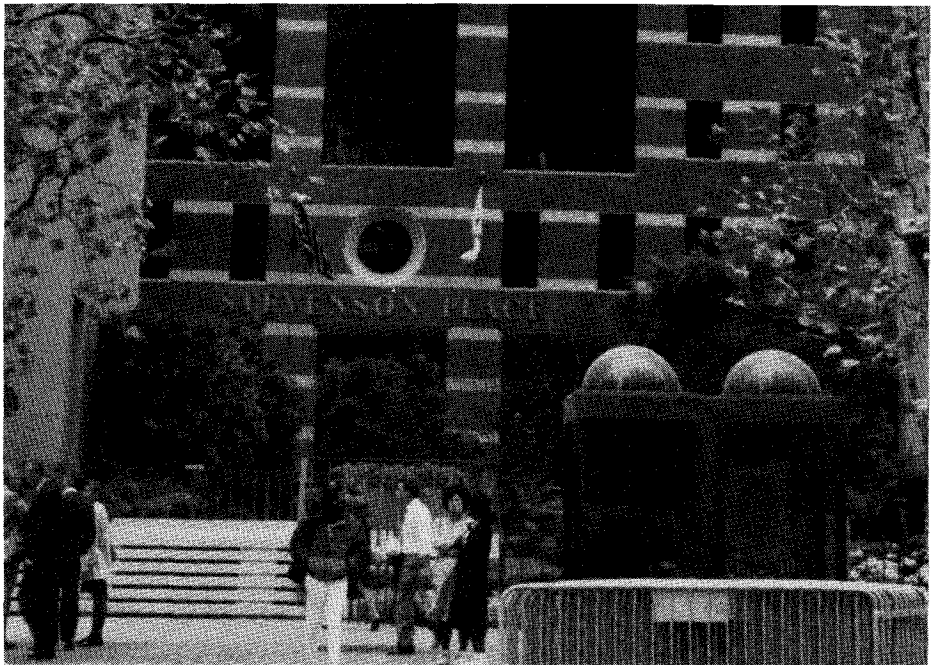
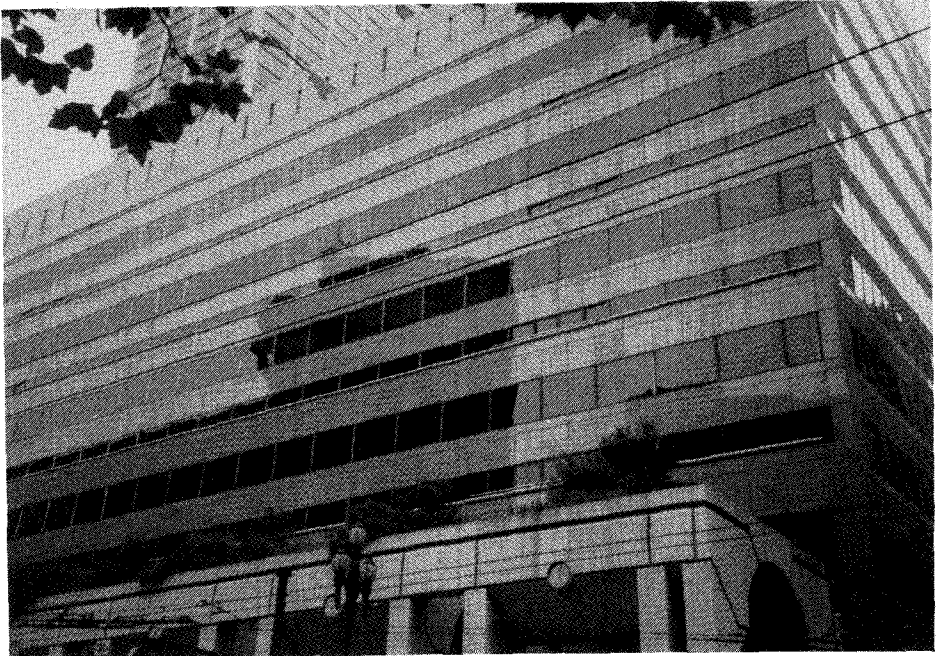
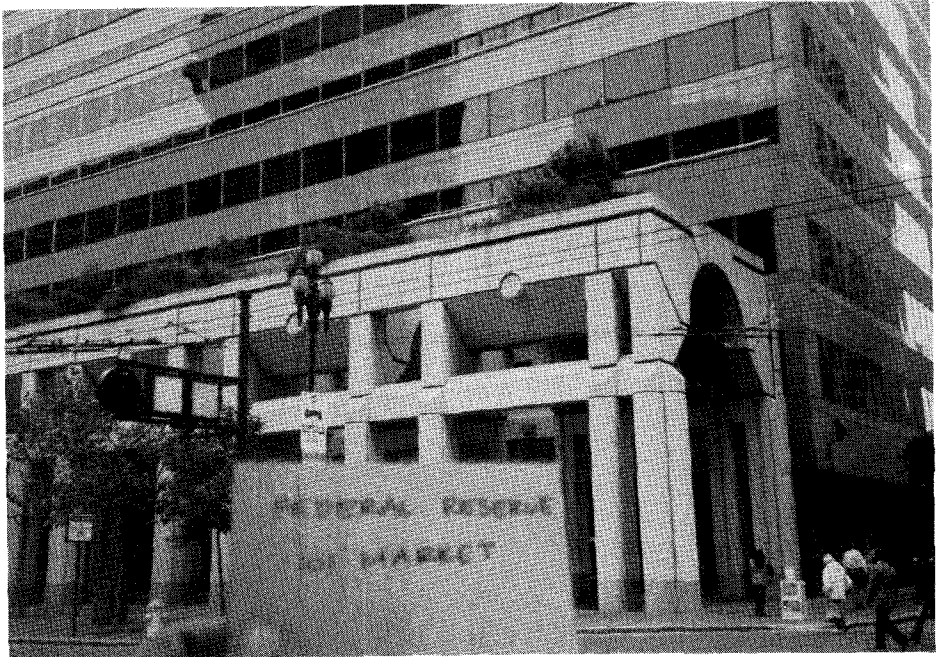
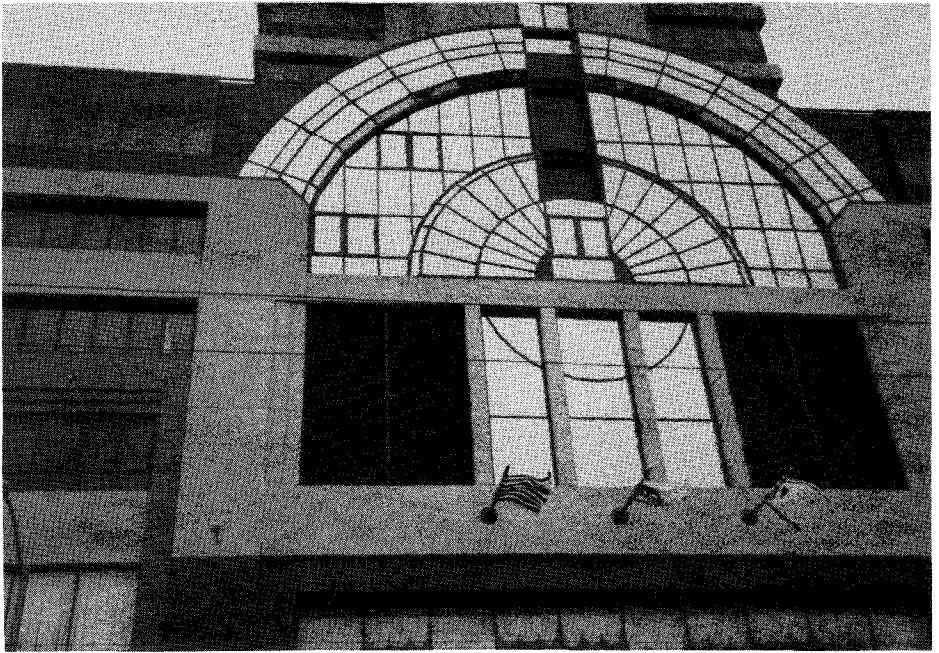
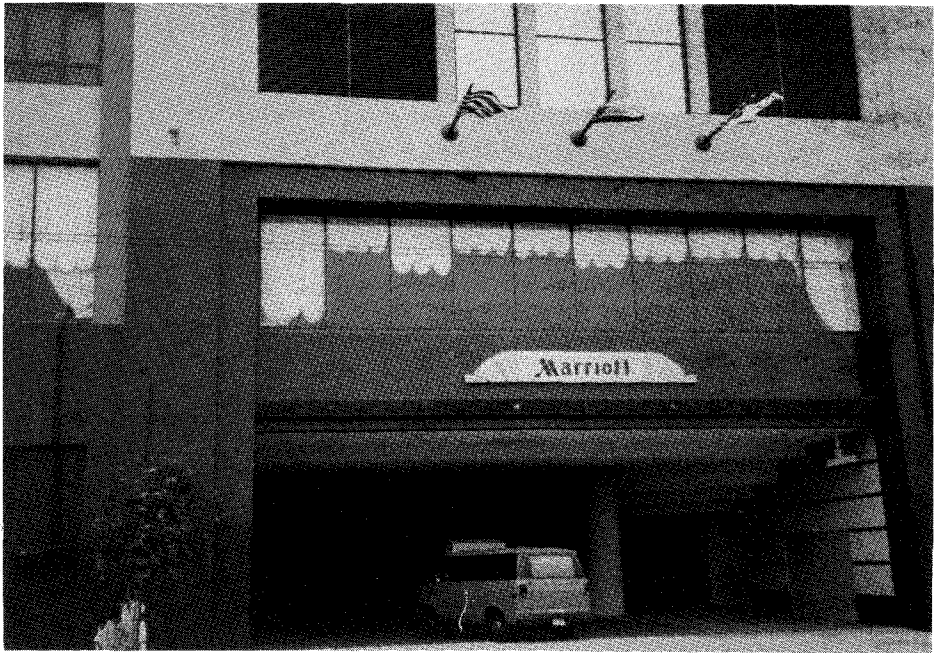
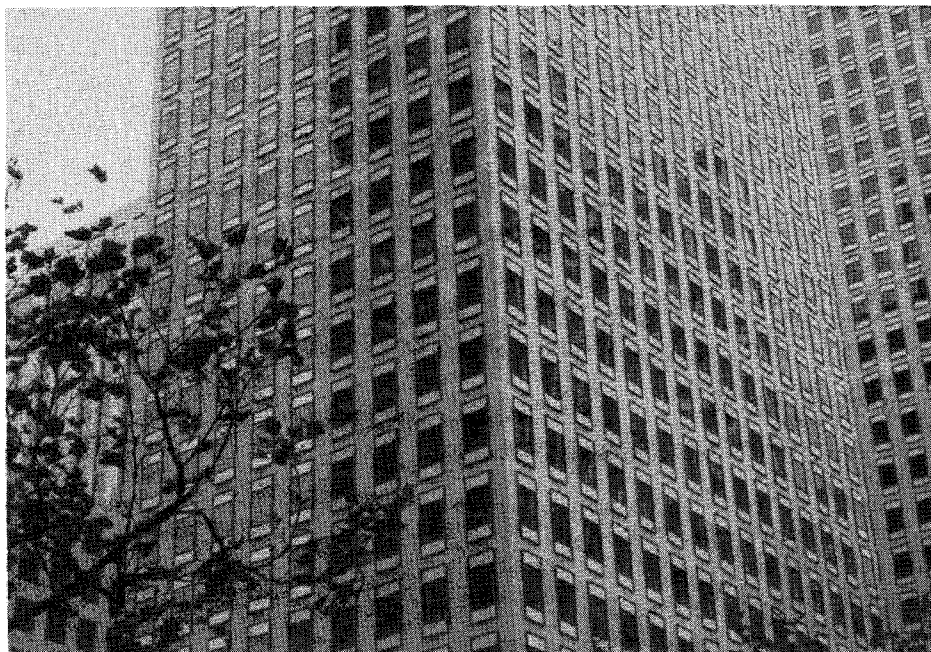
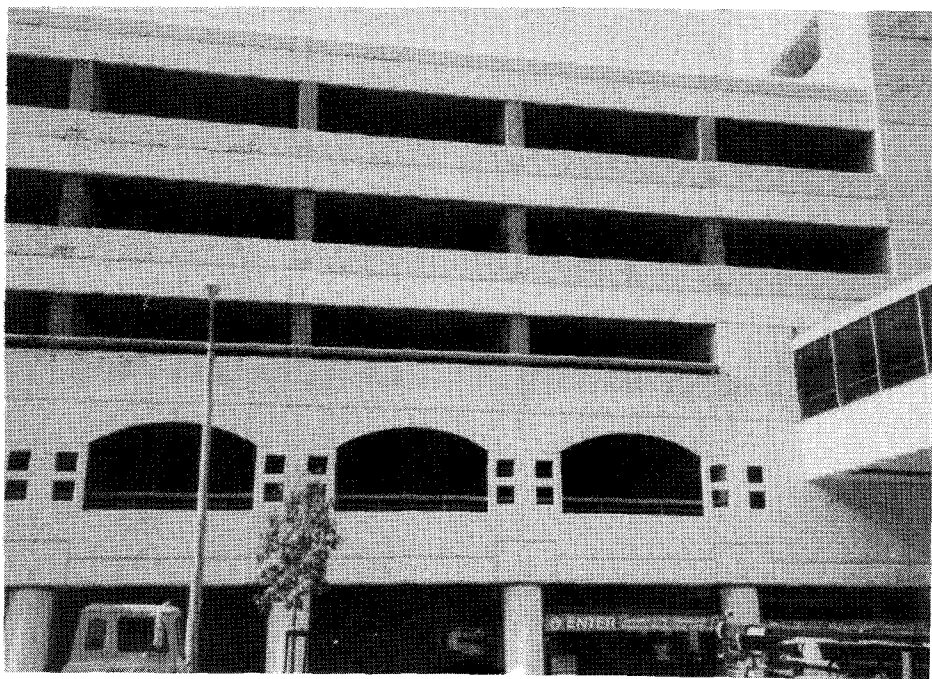
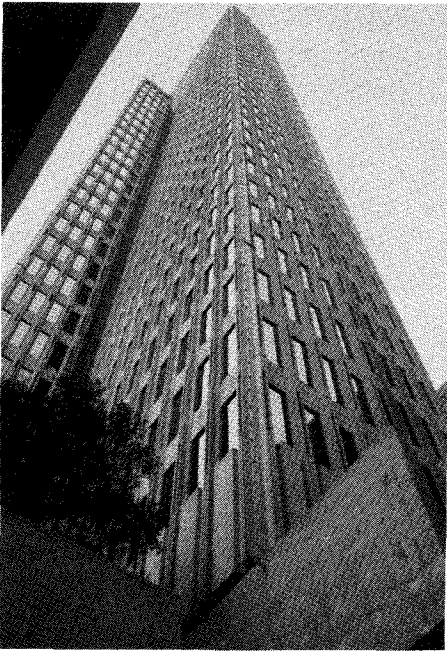
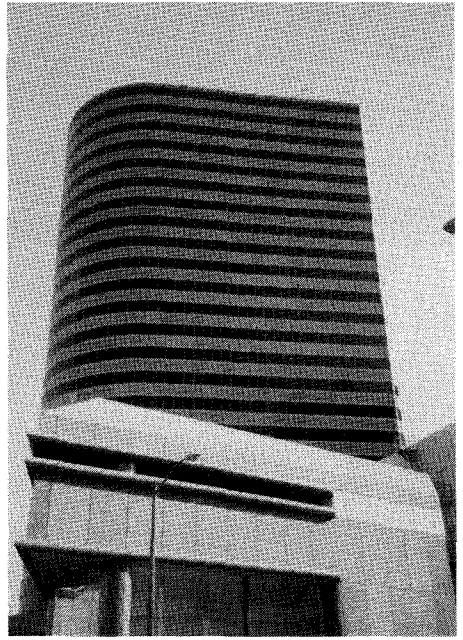
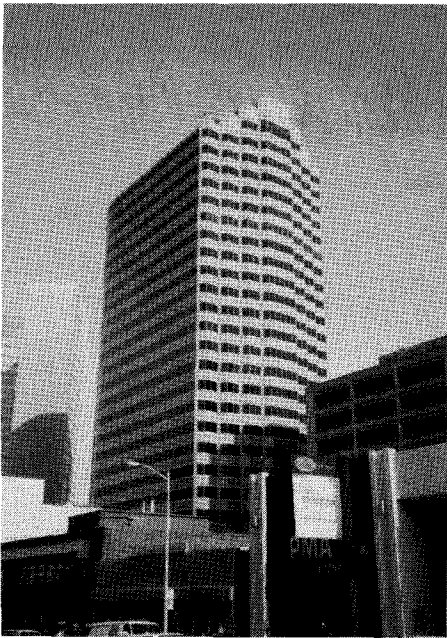
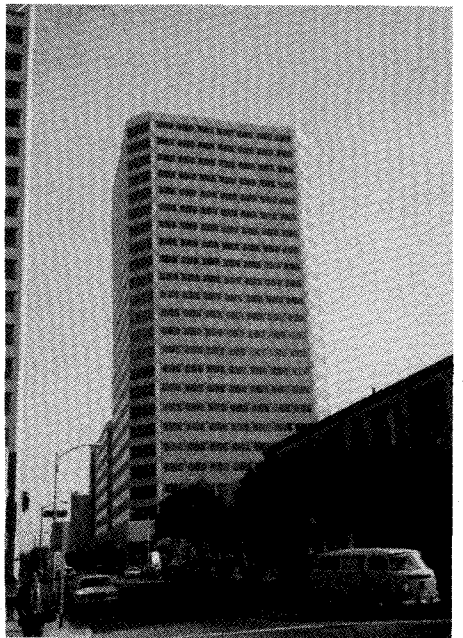
The results of the visual inspection of buildings were very good. In about thirty clad structures that were inspected, only two showed any signs of significant cladding cracking or movement. Various views of typical structures in both San Francisco and Oakland are shown in Figs. 6a through 6l.

Several of these structures are approximately forty stories tall. Their cladding performance was judged to be excellent. Many of these structures feature unusual geometry in both layout and panel configuration and numerous cutouts in the structure at higher stories. These conditions always present problems in connection detailing and layout and apparently were well handled in the affected area.

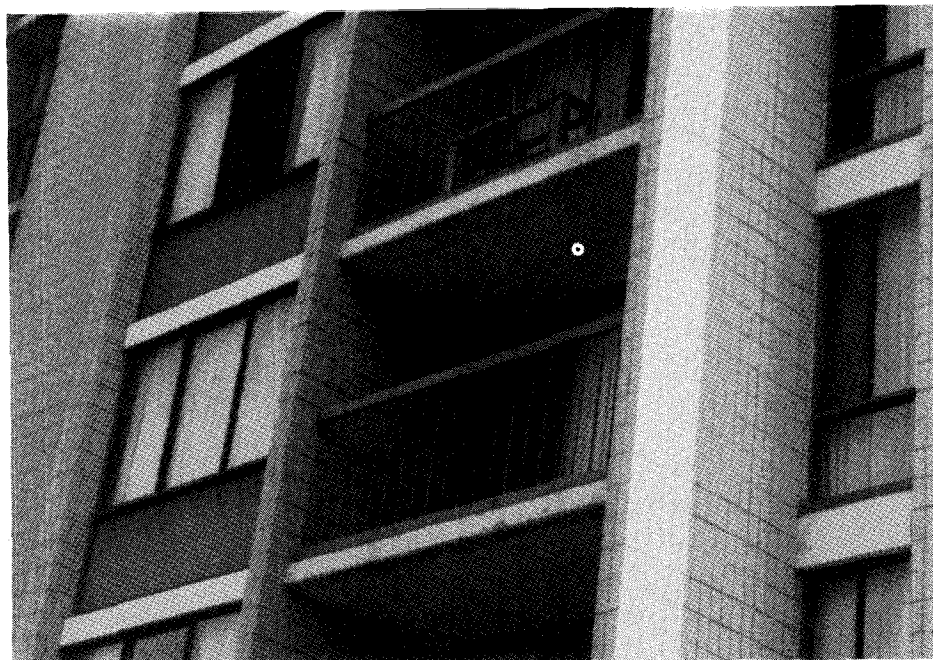
Fig. 16. Closeup of hollow-core balcony.

Within about a half mile (0.8 km) of the I-880 collapse, a housing development project utilizing reinforced concrete block and prestressed hollow-core slab construction was occupied and showed no signs of cracking. Fig. 15 shows two of the 12-story structures from this housing development and a closeup of the exterior is shown in Fig. 16.
