Building and Rebuilding of Philadelphia's Walnut Lane Memorial Bridge

PART 1: A History of Design, Construction, and Service Life

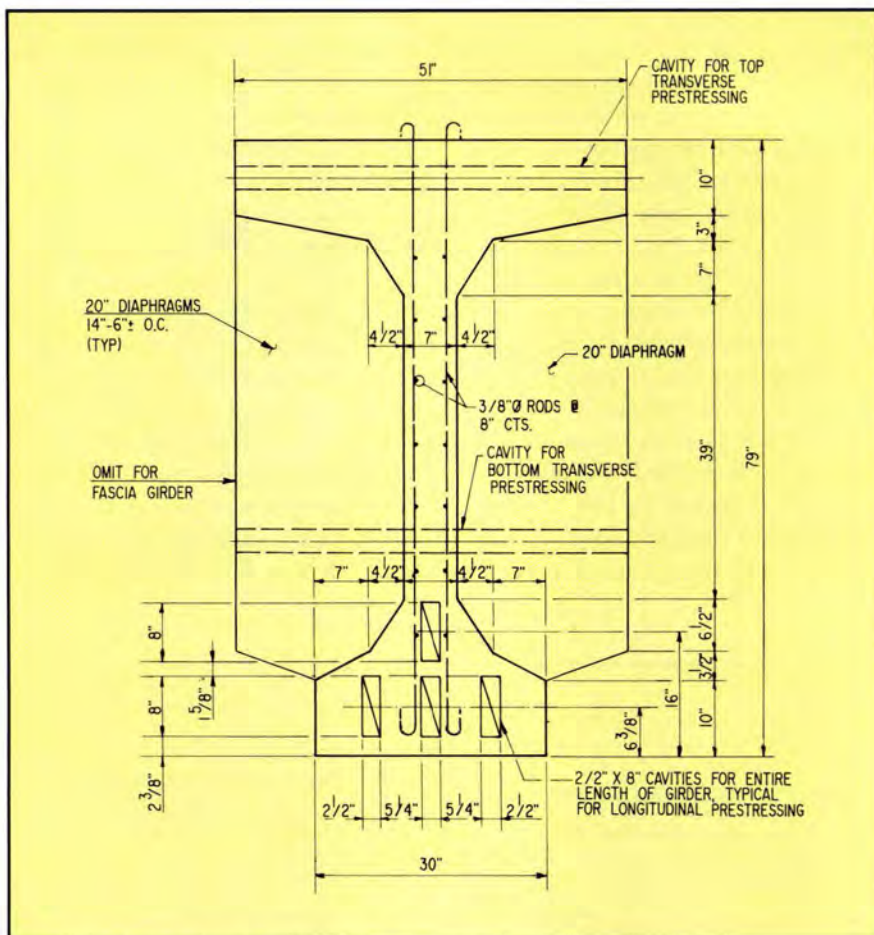
Fig. 5. Midspan cross section of typical main span girder.

Fig. 5. Longitudinally, the two outer chases in the bottom flange remained straight throughout the entire span while the chases in the web plane curved up parabolically as shown in Fig. 6.

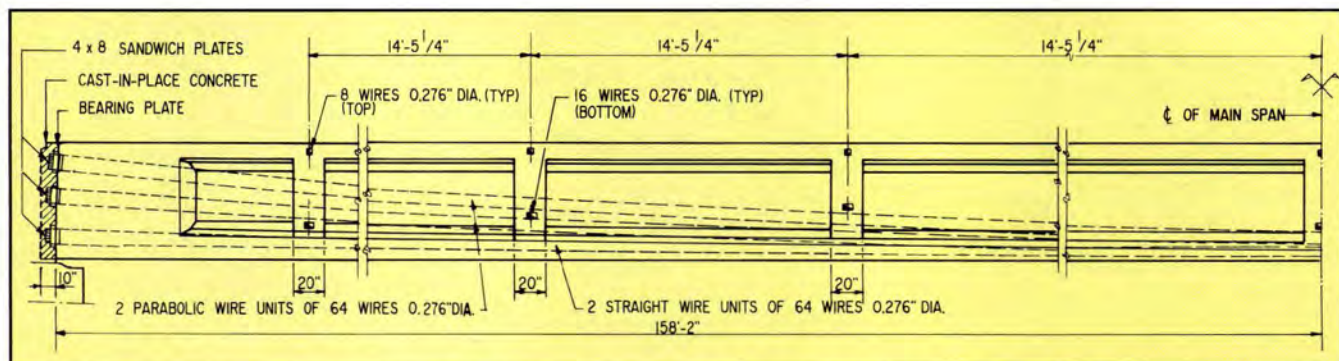
Fig. 6. Profile of longitudinal post-tensioning wire units in the main span girder of the bridge, and location of transverse prestressing wire units. Before the forms were removed, the longitudinal wires passing through the sandwich plates were prestressed and anchored with wedges.
