Performance of Precast/ Prestressed Concrete Building Structures During Northridge Earthquake

Observations are reported of the performance in the January 17, 1994, Northridge, California, earthquake of buildings in which precast/prestressed concrete components were utilized. Ground motions recorded during the earthquake are discussed in relation to fault movements, observed responses at building sites, and prevailing building code design requirements. The results of field observations of parking garages, cladding for buildings and foundations for residences are reviewed. For garages, the performance of structures utilizing primarily precast/prestressed concrete components is compared with that of garages utilizing other materials. It is concluded that, with the exception of buildings in the immediate vicinity of the epicenter, engineered structures, including those with precast/prestressed concrete components, generally performed well. Parking garages, particularly those with large plan areas, did not perform as well as other types of buildings. The greatest damage was in collector elements funneling lateral forces to the vertical elements of the lateral load resisting system and

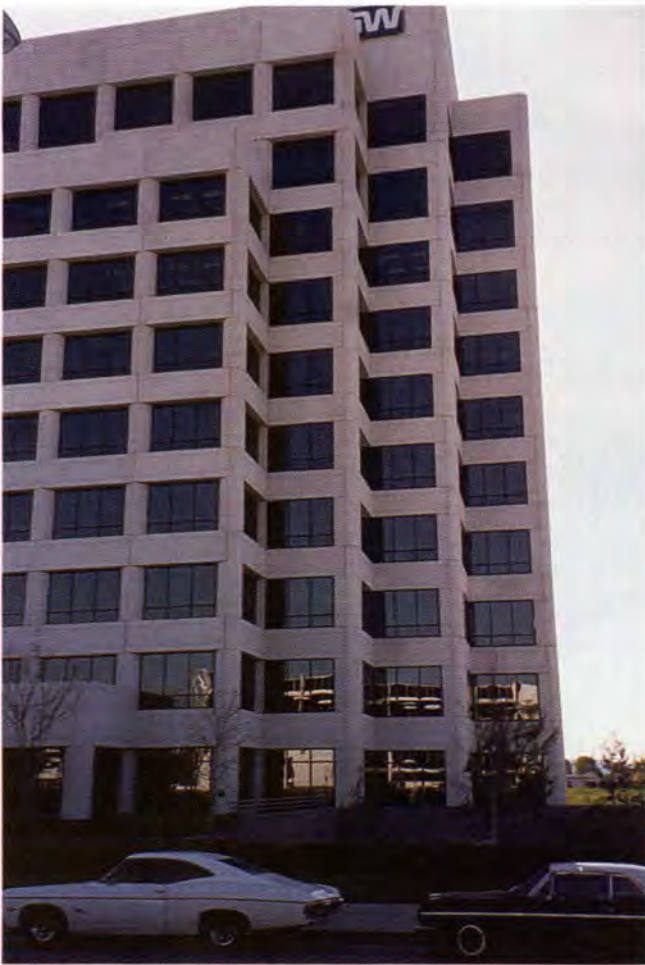
Fig. 31. Great Western Headquarters, Chatsworth.

Shown in Fig. 31 is the Great Western Headquarters in Chatsworth. That ten-story office building used precast cladding and was only about 1 mile (1.6 km) from the epicenter. No cladding damage was apparent. Shown in Fig. 32 is the Reliance Center in Glendale. That 15-story office center was clad with stone-faced, precast concrete panels and located about 18 miles (29 km) from the epicenter in an area where several garages were damaged. There was no damage to the cladding of the Center.

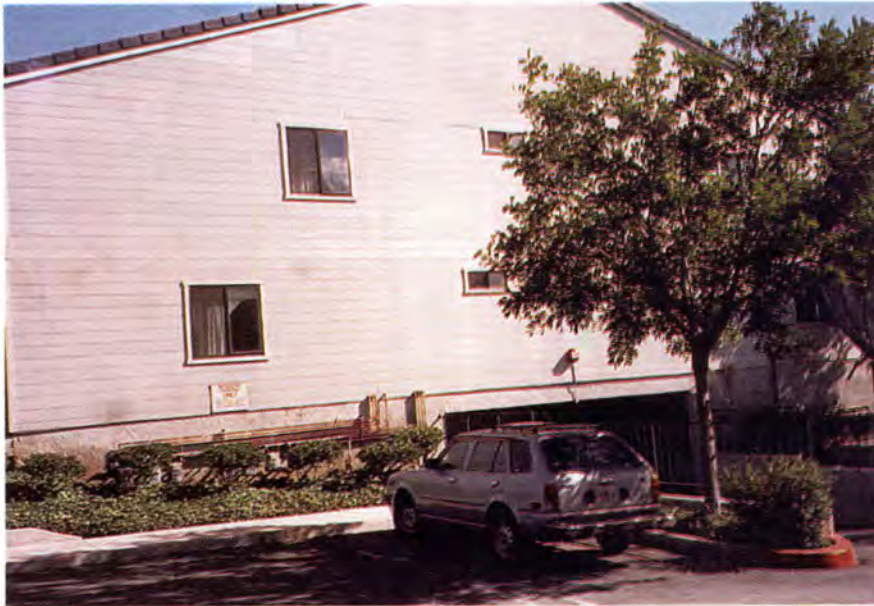
Fig. 34. Wood frame of Devonshire Apartments, Northridge.

Precast concrete components, frequently used for the first floor level and basement of condominiums and apartments throughout the Los Angeles area, performed uniformly well. These components allow secured parking below the living areas. Typical of that form of construction was the three-level wood frame Devonshire Apartment building located in Northridge about 3 miles (5 km) from the epicenter. The above grade portion of the building is shown in Fig. 34.

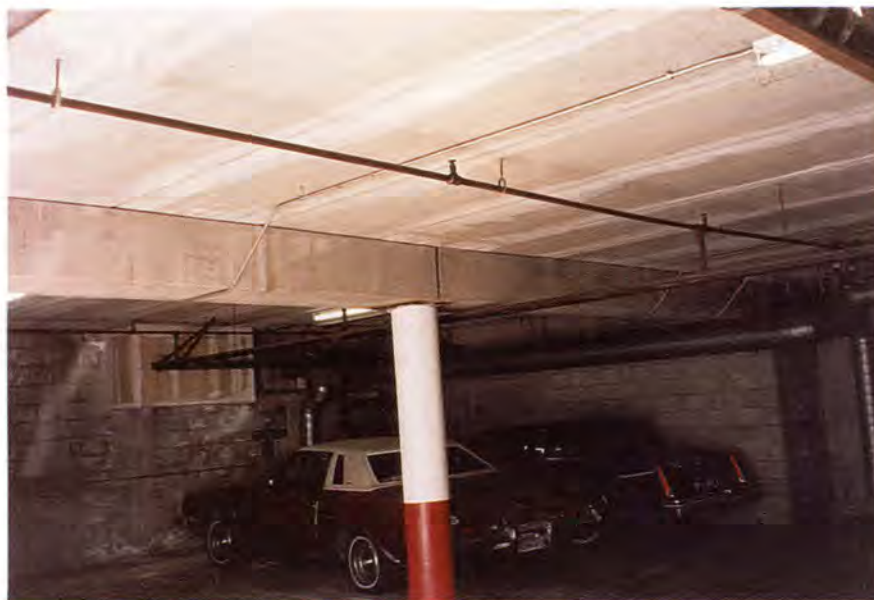
Fig. 35. First floor support system, Devonshire Apartments.

and hollow-core slabs, is shown in Fig. 35. No damage was observed in the precast concrete. However, repairs were being made to the above grade wooden portions of the building. This was one of seven buildings that were allowed to be occupied in a group of about 16 buildings. Many of the surrounding apartments were severely damaged and closed.
