SPECIAL REPORT

Lessons Learned from the Kobe Earthquake — A Japanese Perspective

Hiroshi Muguruma Ph.D.

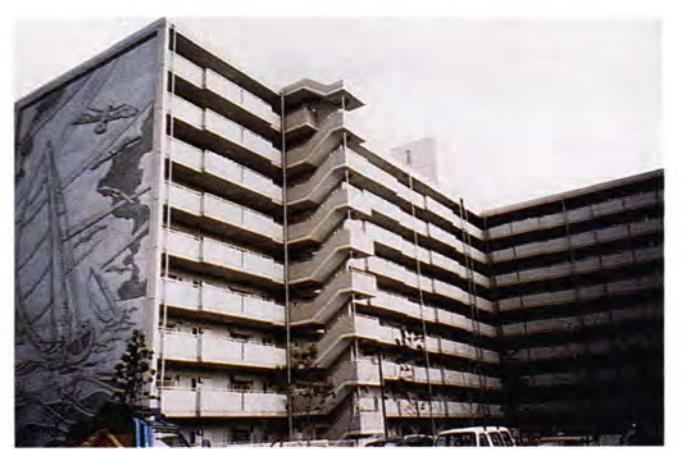
Several new buildings were designed such that a certain collapse mechanism, especially a beam sidesway mechanism, is intentionally formed. Fig. 25 shows a ten-story apartment building constructed in 1991. Fig. 26 shows the elevation of a structural frame and the plan. Plastic hinges at the ends of the beams in the second to seventh stories were found as intended in the design (see Fig. 27). The residual drift at the top of the building could not be observed. Because non-structural walls suffered damage, the building is scheduled for repair.

Fig. 25. An apartment building designed such that a beam sidesway mechanism was intentionally formed.

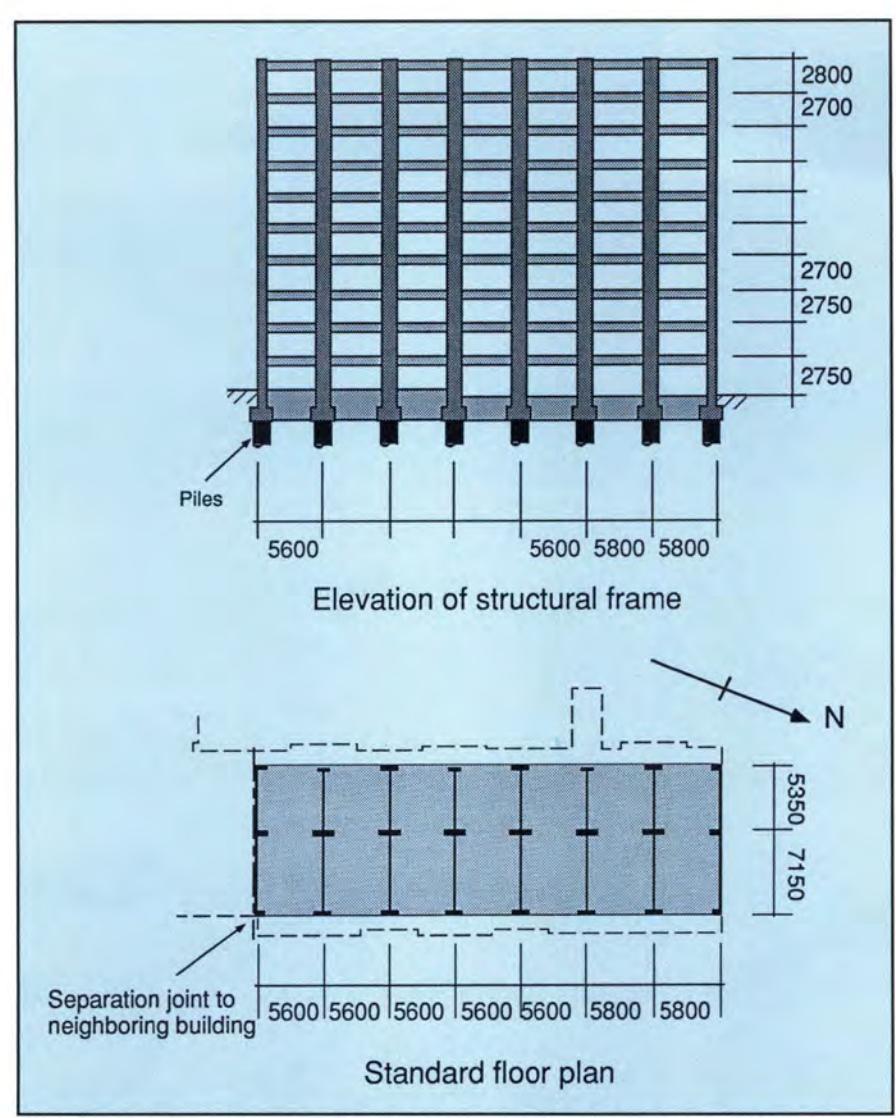
Fig. 26. Structural frame and plan of ten-story reinforced concrete apartment building pictured in Fig. 25.
