SPECIAL REPORT

Observations on the Performance of Structures in the Kobe Earthquake of January 17, 1995

S. K. Ghosh, Ph.D. Director Engineering Services, Codes and Standards Portland Cement Association Skokie, Illinois

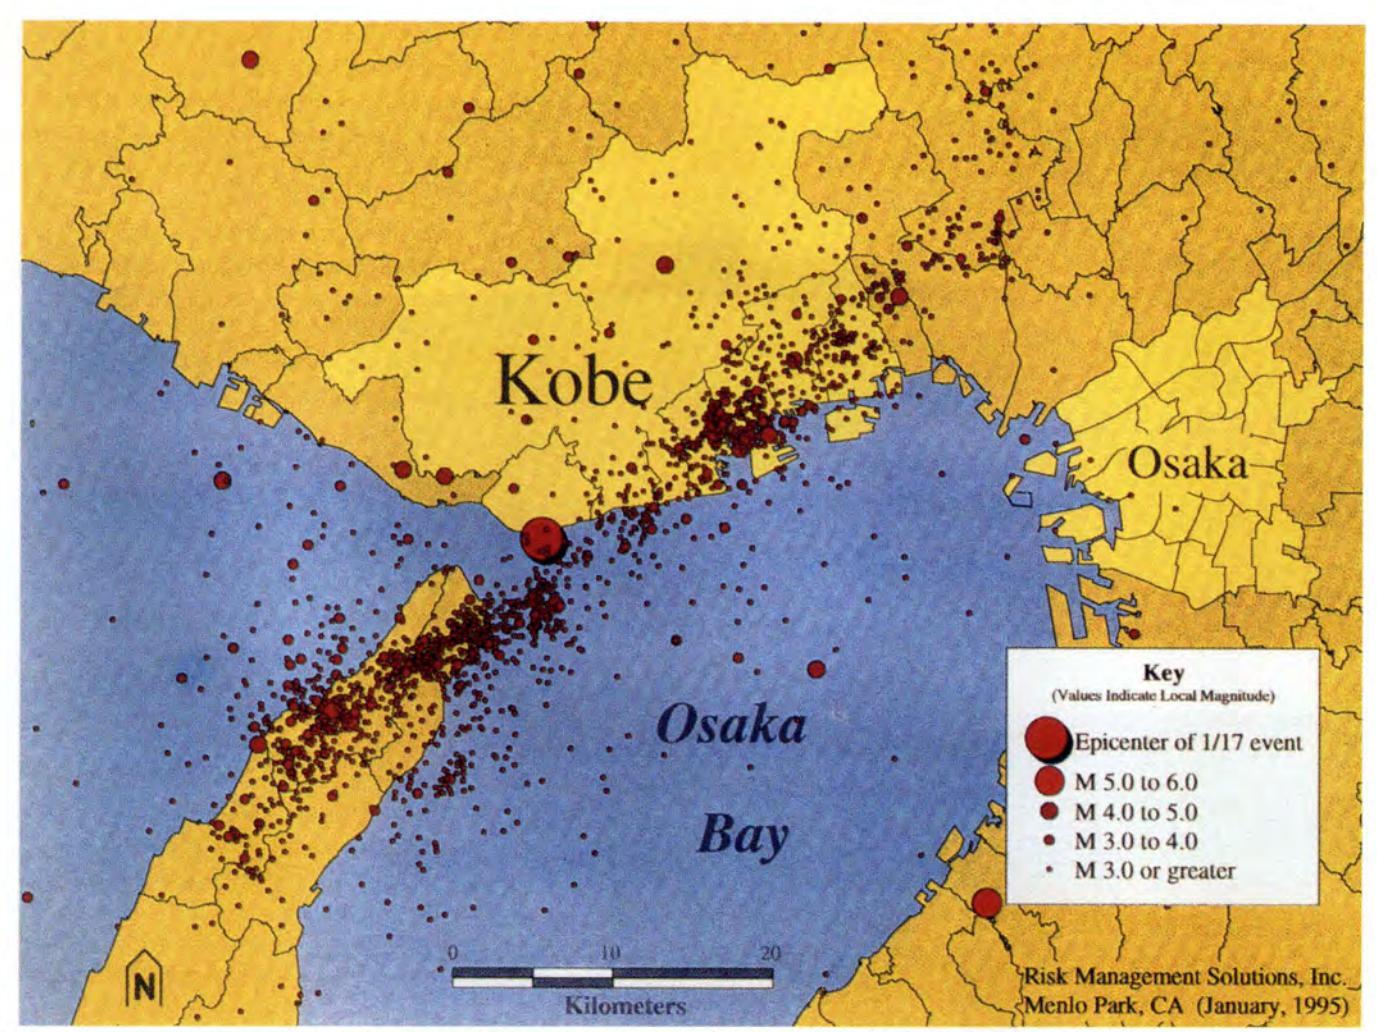
Fig. 1. Epicenter of foreshocks and aftershocks of the Great Hanshin (Kobe) Earthquake, January 16-23, 1995 (Ref. 3).

The epicenter of the earthquake was located at a depth of 6 miles (10 km) and at a distance of about 12 miles (20 km) southwest of downtown Kobe between the northeast tip of Awaji Island and the main island of Honshu.² Fig. 1 from Ref. 3 is a plot of epicenters of foreshocks and aftershocks recorded before and after the January 17 quake. This plot also represents an approximate trace of fault rupture in the January 17 event.

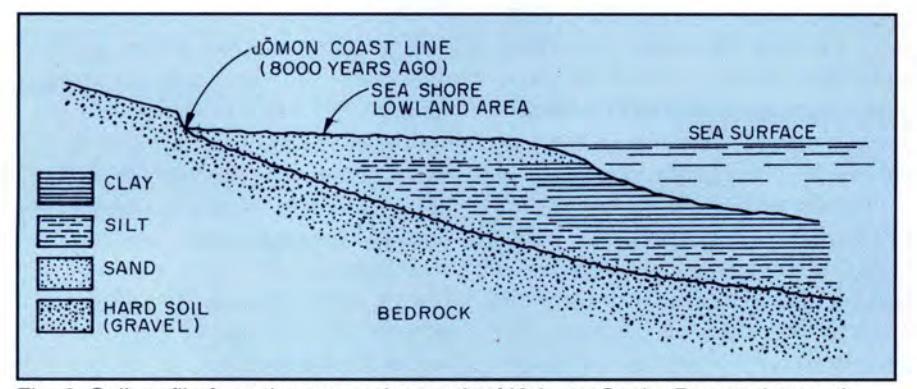
Fig. 2. Soil profile from the mountains north of Kobe to Osaka Bay on the south.

Fig. 2 shows a soil profile of the quake-affected area from the mountains to the north to the sea on the south. Higher ground accelerations were generally recorded on softer soils. However, as far as structural damage was concerned, near-fault effects appear to have been more important than soil characteristics. Also important were the age of the structure and its foundation type.

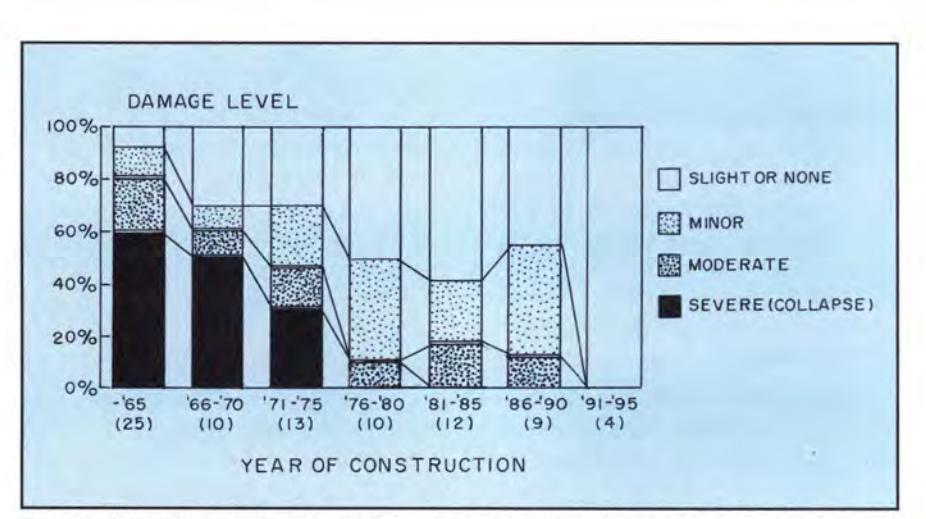
Fig. 17. Correlation between degree of building damage and year of construction (Ref. 5).

and steel reinforced concrete structures was understandable and predictable. Structural irregularities, combined with nonductile detailing of columns and beam-to-column joints, accounted for the vast majority of the cases of serious damage or collapse.
