Case Studies in Structural Repair of Pretensioned Concrete Products

Alan S. Hoback, Sc. D., P.E.

Alaa I. Hermiz

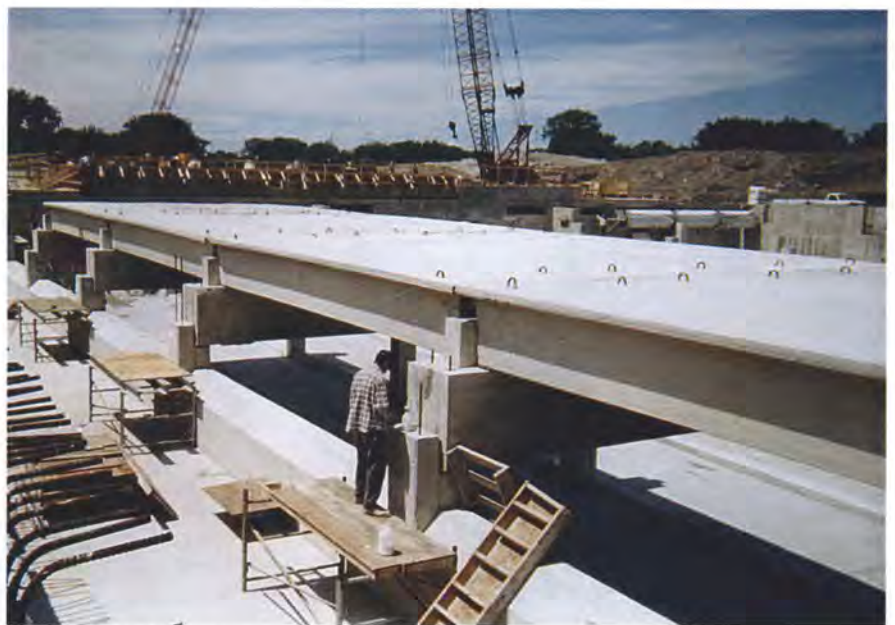
Fig. 2. Water Treatment Basin.

Inverted tee beams and double tees were used to construct a water treatment basin in the Detroit, Michigan area (see Fig. 2). A few weeks after erection, it was noticed that three of the inverted tee beams were cracked in the bearing area on one end of each beam as shown in Fig. 3. All the cracks were located solely on the east end bearing area of the beam. The cracks were found in different directions on each beam and where the bond between the prestressing strands and concrete had been released.

The reason these beams were cracked was that water froze in the sleeves provided for the connections with the columns. The problem did not arise on the other beams and on the other ends of the damaged beams because all the other sleeves were covered with duct tape. Fabricators and erectors should be aware that water freezing inside a tube or duct is a problem. Rainwater and curing water can be kept out of sleeves by capping the ducts with tight fitting plastic caps or by grouting the ducts.

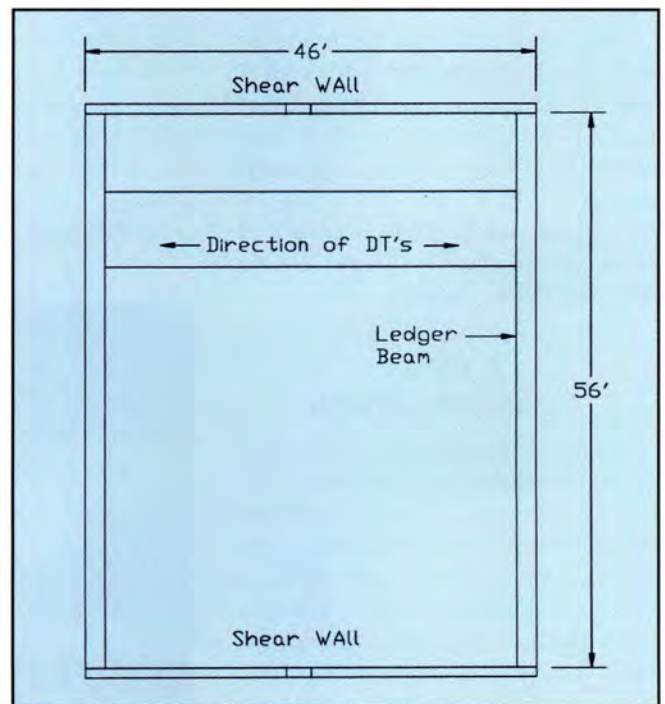
Fig. 9. Plan view of parking structure ramp.

The shear walls are shown in Fig. 8. The walls had 5 x 5 ft (1.52 x 1.52 m) cut-outs to reduce a driver's blind area. Brackets to carry ledger beams were inserted on top of each opening. A plan view of the ramp is shown in Fig. 9.

The repair options were either to enlarge the cantilever area or to add columns in the cut-outs. It was more economical to cast 1 ft (0.305 m) wide columns in the cut-outs. An example of this is shown in the bottom left cut-out of Fig. 8.
