Observations From the Bhuj Earthquake of January 26, 2001

S. K. Ghosh, Ph.D.

President
S. K. Ghosh Associates, Inc.
Northbrook, Illinois

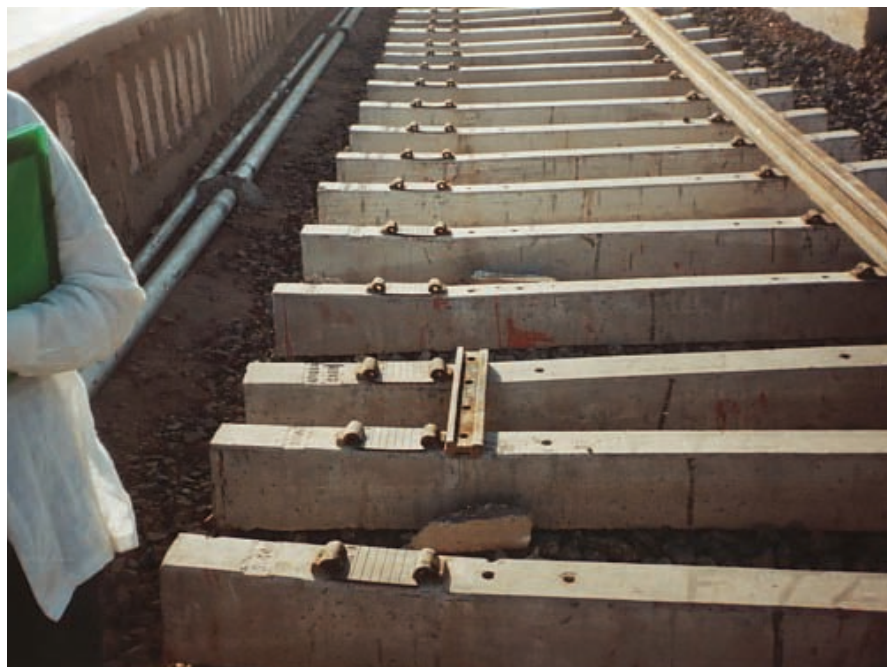
erational on February 3. Fig. 12 shows precast sleepers supporting the new broad-gauge railway track near Morbi.

Fig. 12. Precast railroad ties (sleepers).
