# Investigation of repair techniques for deteriorated end regions of prestressed concrete bridge girders

William B. Rich, Christopher S. Williams, and Robert J. Frosch

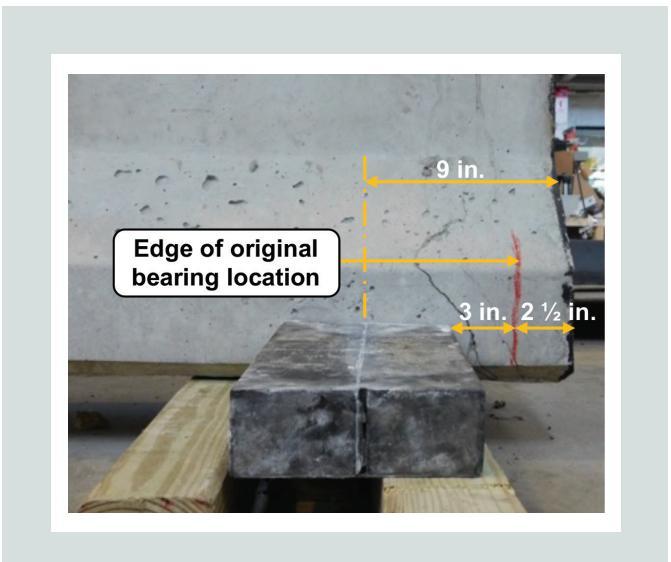
**Figure 8.** Shifting bearing pad for girder C. Note: 1 in. = 25.4 mm.

**Control specimen** The control specimen (girder C) was in good condition, with the only notable sign of destress being cracking in the bottom flange near the end of the girder. No repairs were made. The bearing pad was shifted 3 in. (76 mm) relative to its original location (**Fig. 8**) to avoid the cracks. The shear span remained at a length of 45 in. (1140 mm) (Fig. 3).

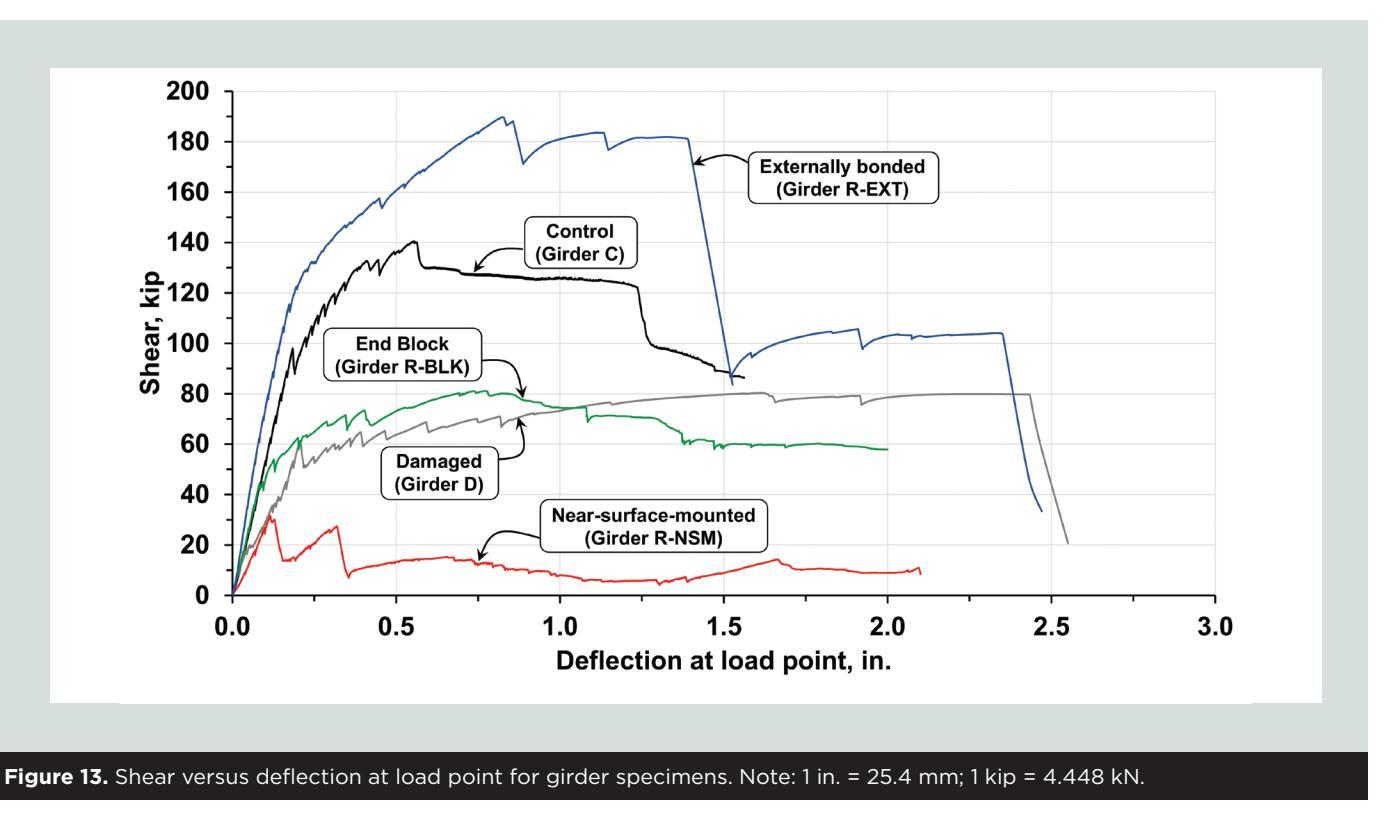
**Figure 13** plots the shear within the test region (that is, the 45 in. [1140 mm] shear span) versus the deflection at the load point for each of the specimens. The shear due to the self-weight of the girder is not reflected in the response curves or the values in Table 4, but it is estimated to be approximately 6.5 kip (29 kN) at the middle of the 45 in. (1140 mm) shear span considering the original cross section of the girders. Deflections caused by deformation of the bearing pads were small (for example, deflection at the load point due to bearing pad deformation was 0.039 in. [0.99 mm] for girder C at  $V_{test}$  and are therefore neglected.
