Lateral capacity and repair of corrosion-damaged pile bents, part 3: Carbon-fiber-reinforced polymer application and strength testing

Gray Mullins, Rajan Sen, Jethro Clarke, Tristen Mee, Amanda Lewis, and Malaak Araujo

- This is the final paper in a three-part series that explores the effects of corrosion damage on pile bents and demonstrates the effectiveness of carbon-fiber-reinforced polymer (CFRP) repair of severely corroded piles.
- This paper reports a study of the lateral load capacity of a one-third-scale pile bent bridge constructed with five piles that had exhibited greater than 96% cross-sectional steel strand loss and were repaired with CFRP material to restore bending resistance.
- Test results also demonstrated the suitability of numerical modeling to predict the strength gain from CFRP wrap repairs.

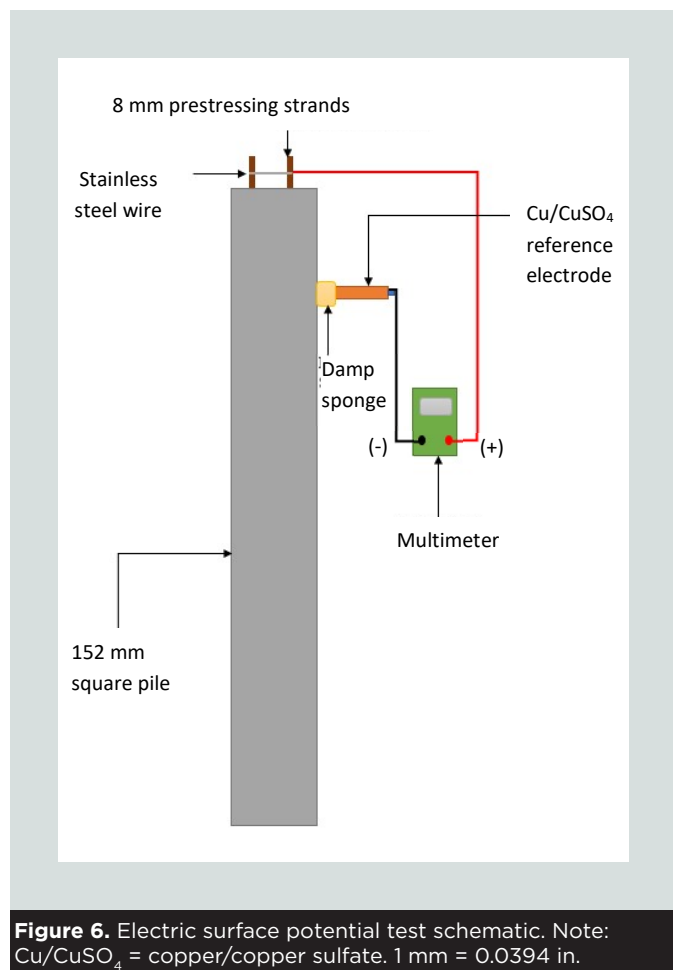
voltmeter connected to the reinforcing steel with the positive lead and the negative lead connected to a copper/copper sulfate (Cu/CuSO_4) reference electrode (**Fig. 6**). The reference electrode is touched onto a wetted concrete surface, and the electrical connection to the surface is ensured with a damp sponge. Measurements were conducted using the same 51 mm (2.0 in.) grid used for crack mapping (**Fig. 5**). Surface potential contours were then prepared along with average potential profiles for each side of the piles. Surface potential readings more negative than -350mV indicate a 90% probability of active corrosion, and surface potential readings above -200mV indicate no corrosion. Values between these thresholds indicate that the corrosion state in the measured area is uncertain.¹¹ In all piles and all faces, the contours were similar to those in **Fig. 7**, where surface potential values were far below -350 mV in the damage zone and were above -200 mV in the undamaged regions. At the bottom of all piles, surface potential values fell below -350 mV, but no cracks were observed. This finding was not surprising given that the piles had been in exposed conditions with moisture dripping down them since 2000 and that the strands were exposed as they extended below the bottoms of the piles. Figure 7 shows a typical surface potential contour plot, where dark-colored regions were corroding and light-colored regions were not. Figure 7 also shows a typical surface potential profile where the average of three surface potential measurements at each elevation for each face of the pile is plotted versus vertical po-

Figure 6. Electric surface potential test schematic. Note: Cu/CuSO_4 = copper/copper sulfate. 1 mm = 0.0394 in.

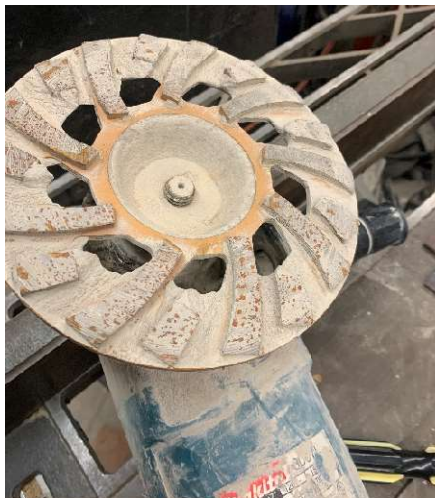
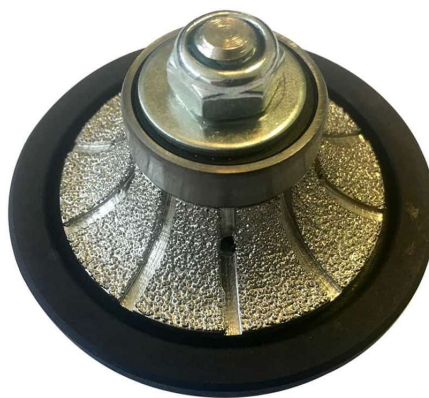
Figure 12. Grinder attachments.

To facilitate the CFRP wrap around the piles, surface roughness and discontinuities in the mortar caused by the form fitment were ground flat and the corners of the piles were rounded. Flat surfaces were ground with a 178 mm (7.0 in.) diameter diamond-impregnated grinding cup. The corners were rounded with a 9.5 mm ($\frac{3}{8}$ in.) radius demi-bullnose diamond grinder attachment (commonly used for finishing granite countertops). Both attachments (**Fig. 12**) were effective and faster than aluminum oxide alternatives. **Figure 13** shows the sharp corners and discontinuities in the mortar behind the fill port, as well as a pile after surface preparations. Corner radius preparations extended slightly beyond the anticipated CFRP repair regions but not into the 102 mm (4 in.) cap embedment region at the tops of the piles.

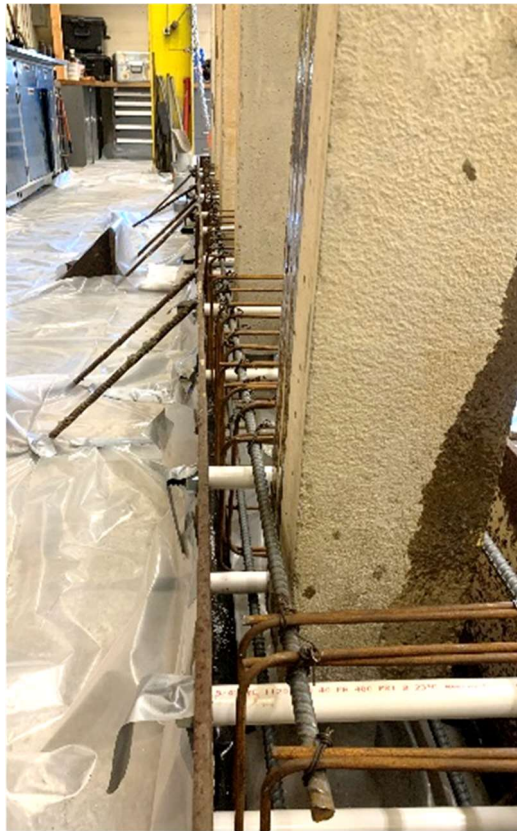
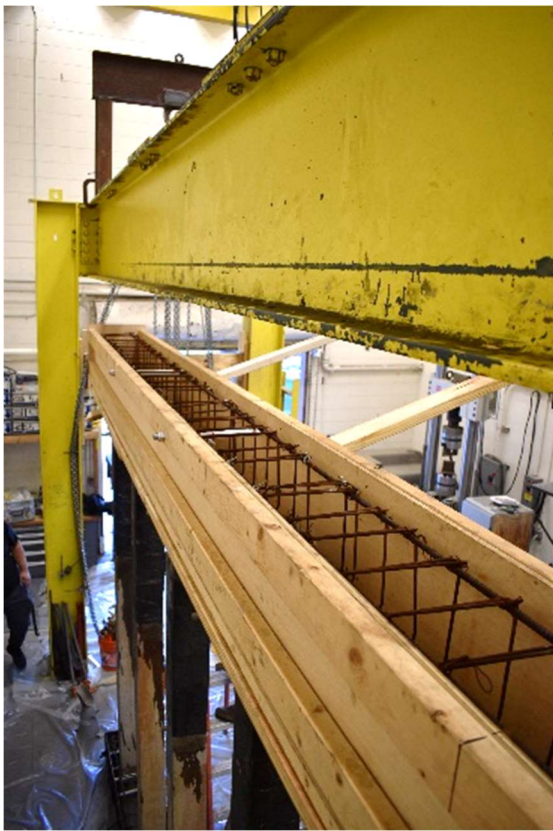
Figure 19. Forms for floor-level footing and pile cap prior to concreting.

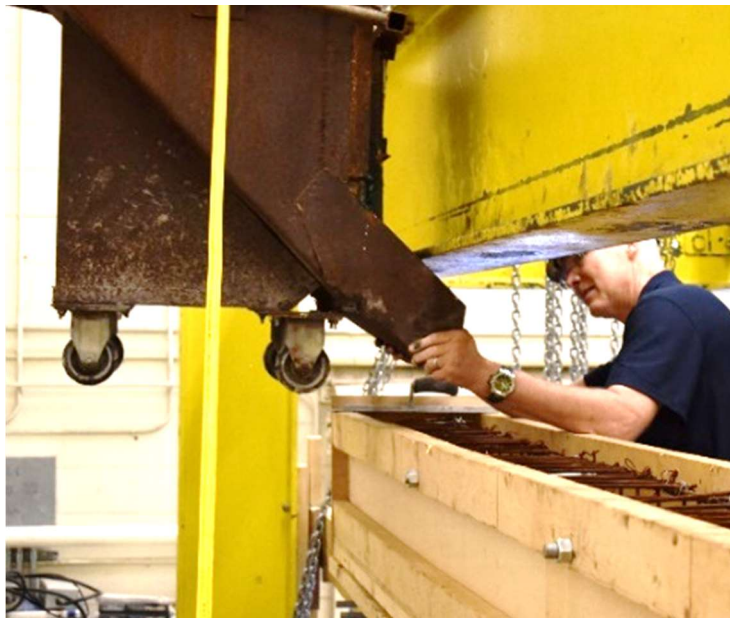
Concreting was performed with a 0.4 m³ (0.5 yd³) side discharge concrete bucket specially built in 2000 to place concrete under the laboratory reaction frame (**Fig. 20**). The 28-day compressive strength of the cap and footing concrete was 47.3 MPa (6860 psi). Forms were stripped when compressive strength achieved 44.9 MPa (6510 psi).

Figure 20. Side discharge concrete bucket suspended above the pile cap.

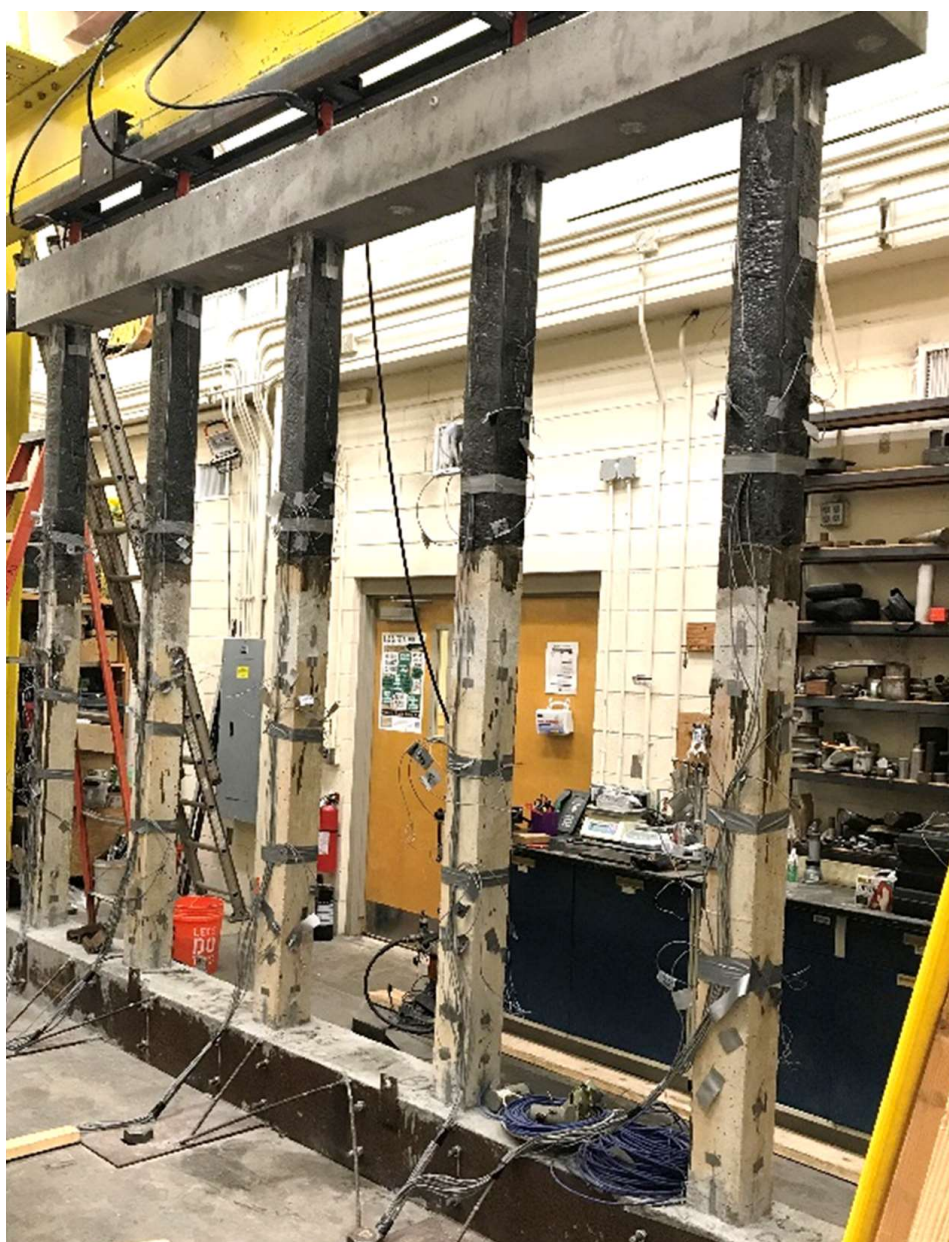
Lateral loading was displacement controlled at 7.6 mm/min (0.30 in./min) applied at the center of the pile cap using a hydraulic actuator. Vertically aligned hydraulic actuators were positioned above each of the five piles to represent service load from girders. Vertical loads were maintained at 44.4 kN (10 kip) per pile and were free to translate with the pile cap during the lateral loading event using high-capacity rollers pushing up against the overhead reaction frame flanges. A shear force cell was placed between each of the hydraulic actuators and the pile cap. All strain gauges, displacement transducers, shear cells, and load cells were monitored and recorded at 1 Hz. **Figure 21** shows the fully instrumented pile bent prior to loading.

Figure 21. Fully instrumented pile bent.

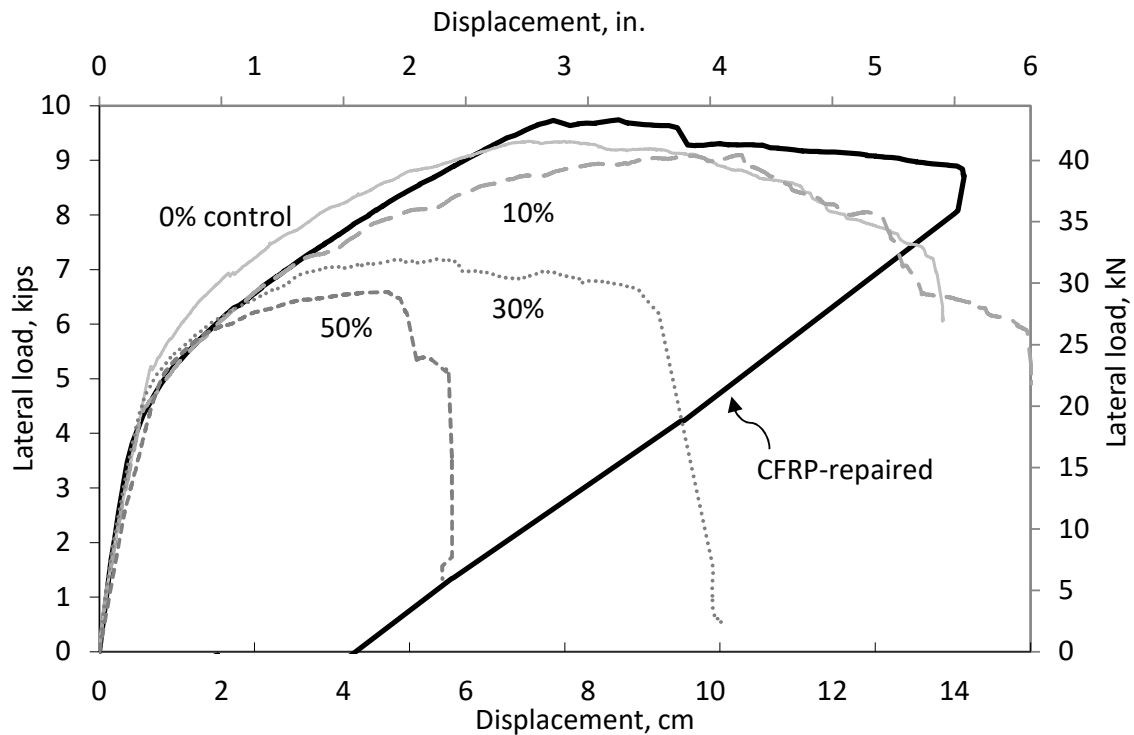
With the load fully removed, the pile bent elastically recovered 118 mm (4.65 in.) of lateral movement, which was more than the lateral movement recovered in any of the pile bents in the original study,¹ including the undamaged control with 0% steel loss. **Figure 23** shows the response to loading for the CFRP-repaired pile bent as well as the responses for the pile bents from the original study. The peak lateral load of the repaired pile bent was 43 kN (9.7 kip), which is slightly greater than the peak lateral load of the undamaged control (41.5 kN [9.33 kip]). The peak lateral loads in the repaired pile bent and the control occurred at similar displacements, 74 and 70 mm (2.9 and 2.8 in.), respectively. The linear-load

Figure 23. Comparison of measured displacement in response to lateral loading for the repaired pile bent and the unrepaired pile bents. Note: CFRP = carbon-fiber-reinforced polymer.

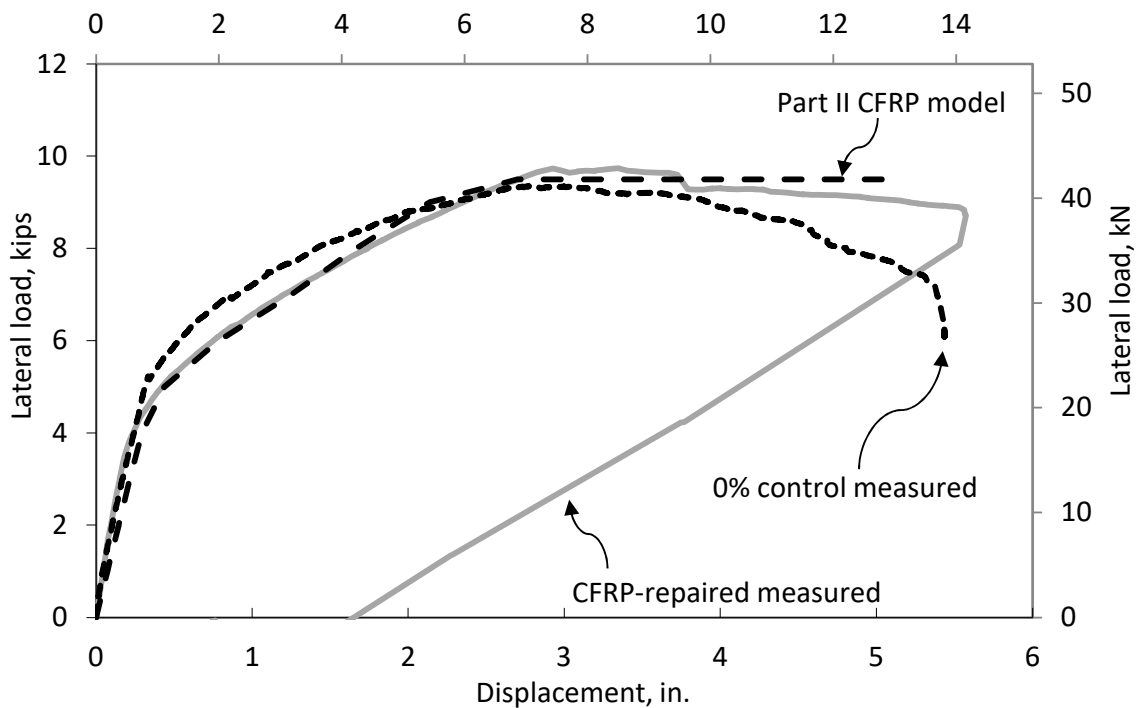
Investigators also compared the repaired pile bent response to the model-predicted pile bent response from part 2 of the research program.² **Figure 24** shows close agreement between the measured and modeled lateral load responses up to 73 mm (2.9 in.). At this load, the model piles start to reach the bending moment limit of the unrepaired pile, which exists at an infinitesimally small region between the cap and the top of the CFRP repair. Without this limit, the model assumes that the CFRP pile sections extended into the cap. Model response was terminated when three of the five piles reached the moment limit.

Figure 24. Measured versus model-predicted displacement of the repaired pile in response to lateral loading. Note: CFRP = carbon-fiber-reinforced polymer.

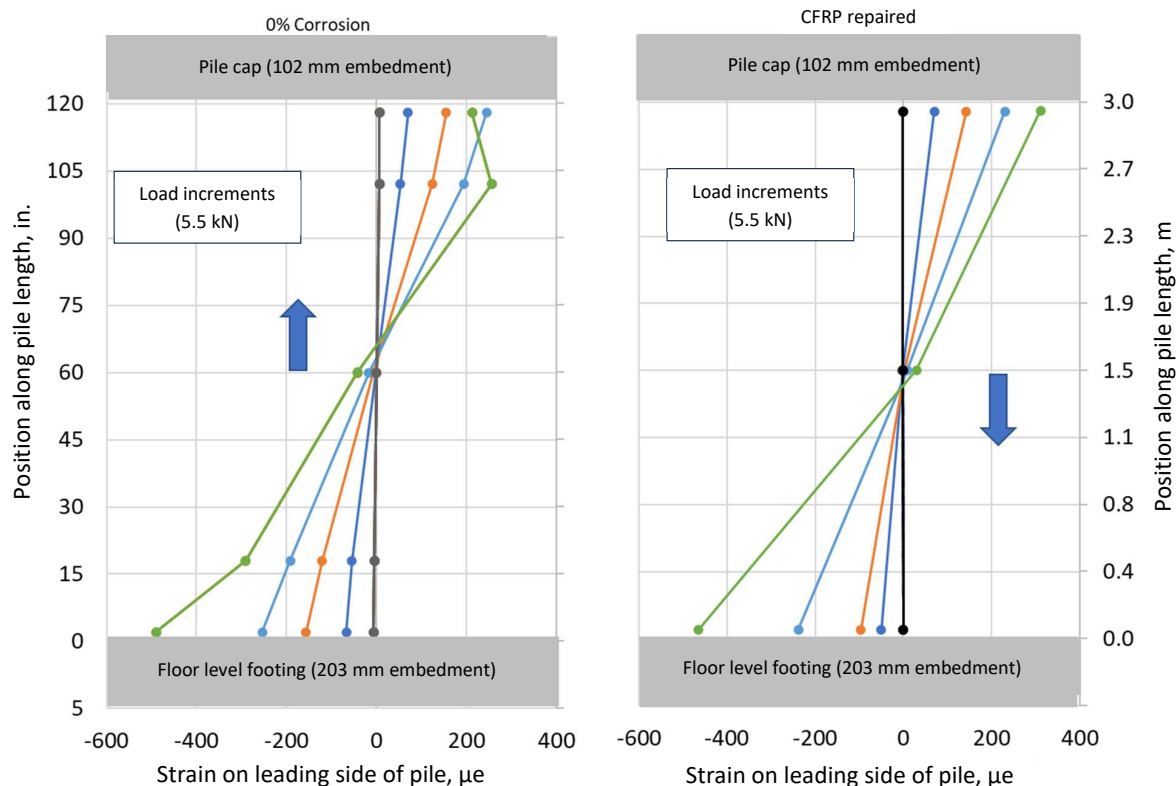
Figure 25 shows the strain distribution in the pile bent with no corrosion loss and in the CFRP-repaired pile bent where the upward and downward movement of the inflection point was noted as lateral load increased in increments of 5.56 kN (1.25 kip). In the last load increment shown, no pile cracking

Figure 25. Strain distribution on leading face of pile 1. Note: CFRP = carbon-fiber-reinforced polymer. 1 mm = 0.0394 in.; 1 kN = 0.225 kip.
