## **MONITORING PRECAST DECK PANELS FOR LOAD AND ENVIRONMENTAL EFFECTS**

As part of Strategic Initiative #9, Building Bridges Smarter, Faster Cheaper, the Ohio Department of Transportation has a pilot project which uses precast, prestressed concrete deck panels. The bridge is a single 170 foot span, steel plate girder bridge. The 41 foot by 10 foot 3 inch wide deck panels are post-tensioned in the transverse direction (which is perpendicular to the bridge girders) in the plant and are then longitudinally post-tensioned together after being erected. After post-tensioning, shear studs are welded to the top of the beams at pockets cast in the panels. The panels are secured to the beams by grouting these pockets. Vibrating wire strain gages were placed in the grouted shear keys between some of the panels. These gages were monitored during the lateral post-tensioning process (October 2004). Data shows that the expected level of stress was obtained in all the joints. The gages have been monitored for environmental effects since construction and the results show effects of creep, shrinkage and temperature. In March 2005, a load test was performed. The joints in the bridge were sound and

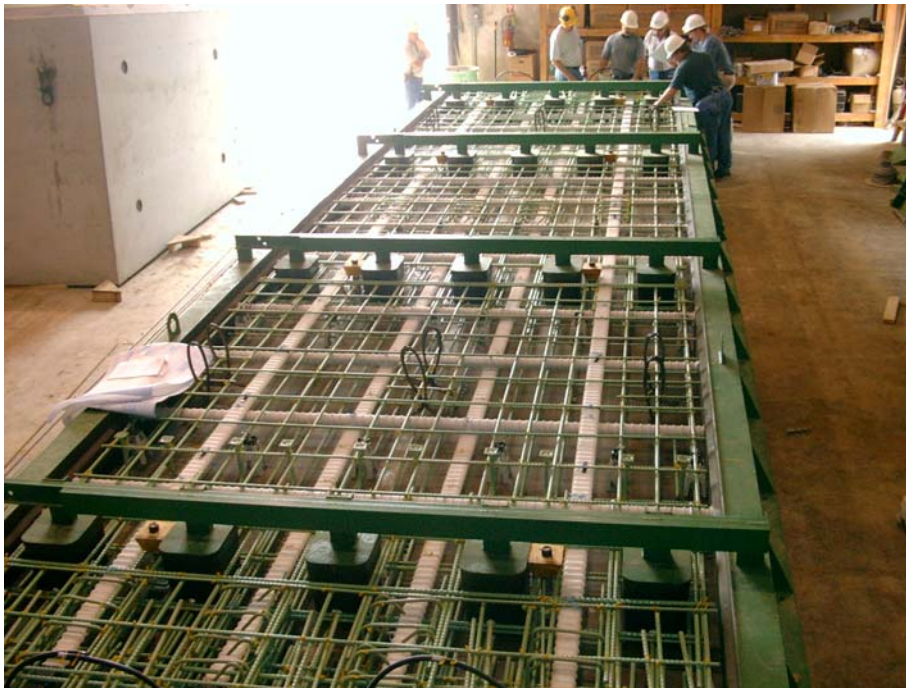
Figure 4 Typical Panel Before Casting

Details of the concrete deck panels are shown in Figures 3 and 4. The deck panels have four post-tensioning ducts that run longitudinal to the panel (transverse to the bridge). These ducts contain four 0.6 inch diameter uncoated seven wire strands which were tensioned and grouted before the panels left the fabricator's yard (Figure 5). The concrete was to be at least 5500 psi at this time. The maximum jacking force per tendon was specified 45k/strand or 180 kips total for the 4 strand tendon. For two tendons in one panel, a friction test was performed by placing a load cell at the deadhead (unjacked end). The friction loss was found to be approximately 6-9%. Seating loss, as measured by the change in elongation during the seating process, was 2-4%.

To tie the panels to the steel plate girders there are 5 shear stud pockets with 9 studs per pocket per panel (Figures 3, 4 and 6).

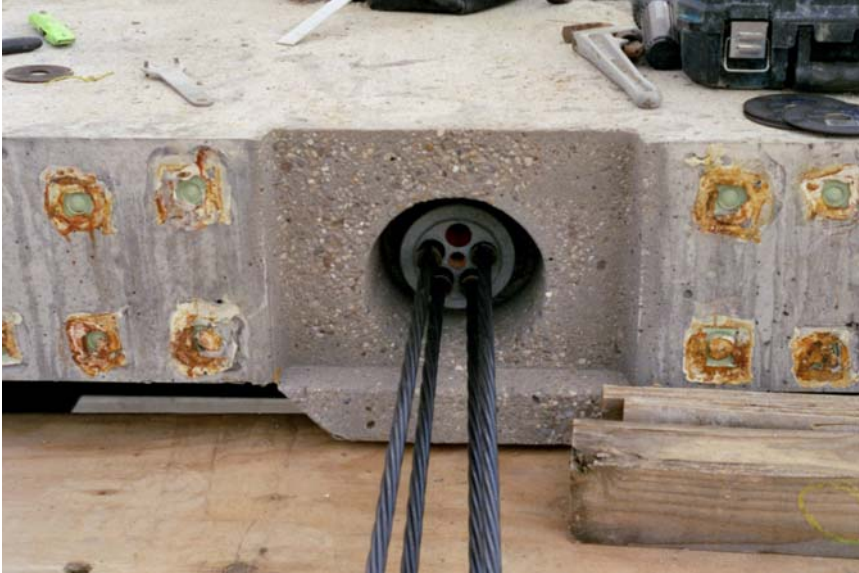
**Figure 5 Typical Longitudinal Post-Tensioning Duct**

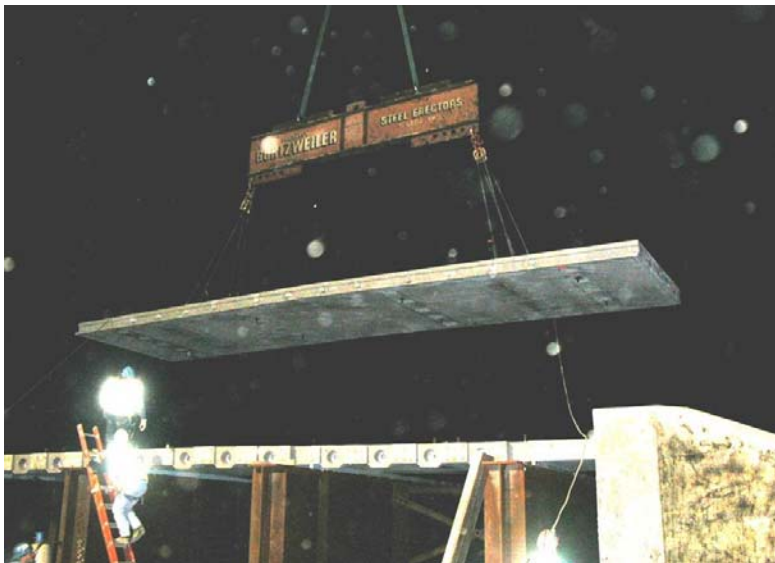
**Figure 7 Placing the Precast Panels on the Steel Plate Girders**

After the MSE abutment walls and wing walls were constructed, the 78 inch deep steel plate girders were shipped and set into place. The girders were placed at night while I-75 was closed intermittently using the abandoned piers as a launch point. This eliminated one splice which in turn decreased erection time. Once the girders and cross frames were in place, the precast concrete deck panels were placed on the girders (Figure 7).

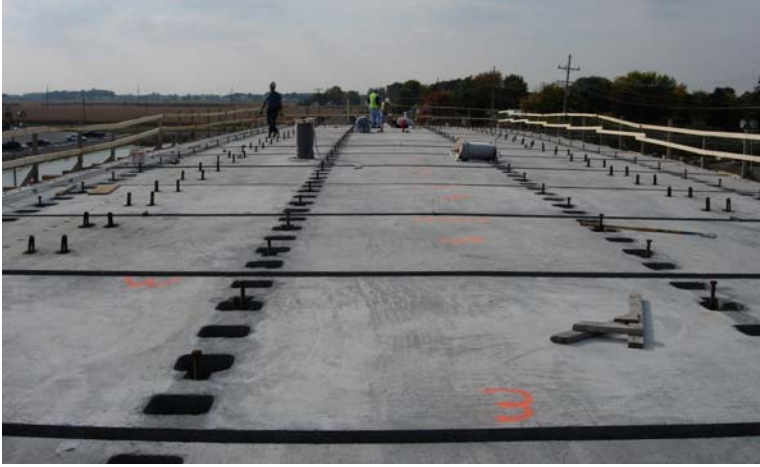
**Figure 8 Top of Bridge After the Panel Placement Before Grouting the Joints**

As with the girders, I-75 was closed intermittently to place the panels. This operation took two nights to complete. Styrofoam shims were placed on top of the girders. Leveling bolts were used to achieve the required profile grade, although the deck was to be ground to final grade. Figure 8 shows the bridge after the completion of the panel placement.

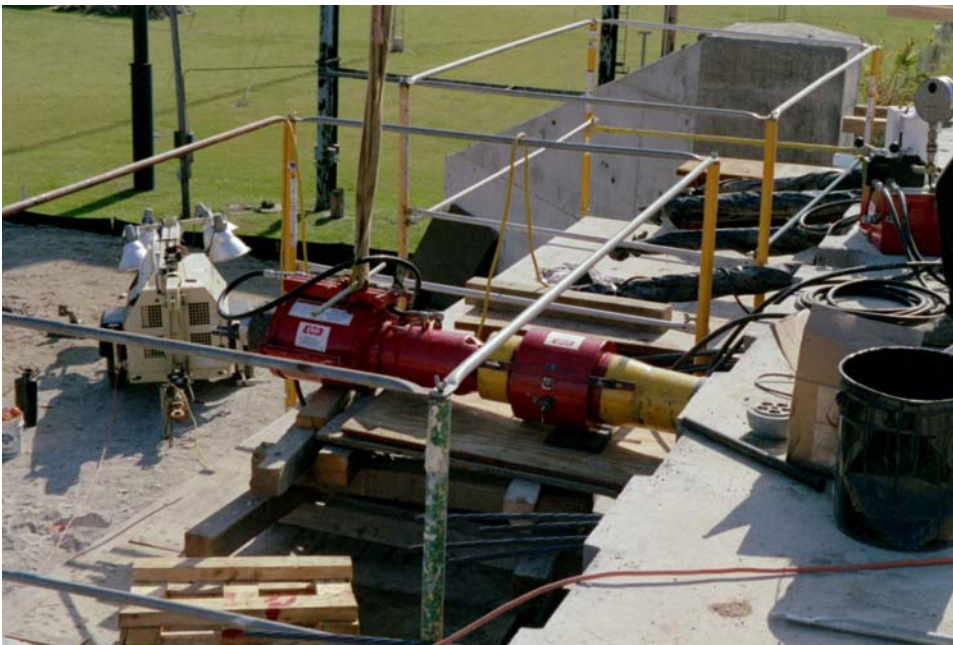
**Figure 9 Post Tensioning at the Forward Abutment**

Before the grout was poured in the joints the post-tensioning ducts between panels needed to be connected. This was also the time that the vibrating wire strain gauges were placed in the joints, (see Experimental Program). It took two days to grout all of the joints due to rainy weather conditions. Once the joints were grouted, the post tensioning strands were installed into the longitudinal ducts (Figure 9).

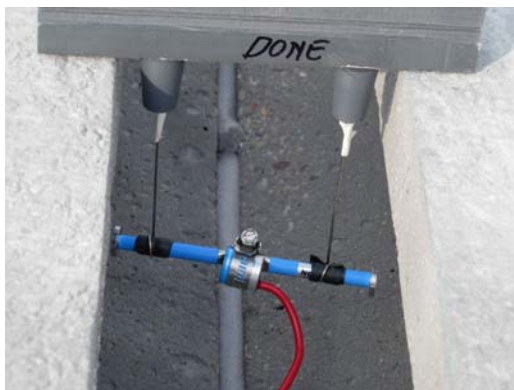
Figure 10 Vibrating Wire Gauge Placed in the Joint

Vibrating wire strain gauges were placed in the joints between the precast deck panels (Figure 10 and 11) prior to grouting the joints. Once the grout was set the plastic holder pieces were removed and the remaining wire cut. The holes were then plugged with grout.

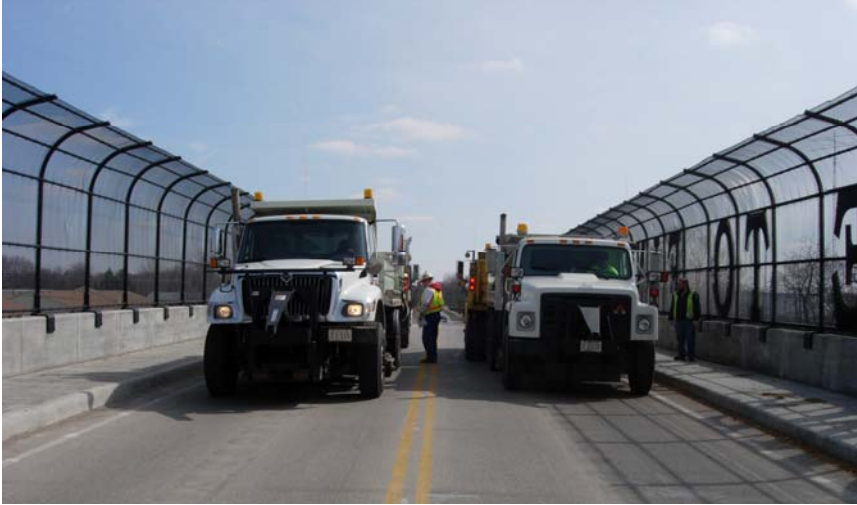
Figure 17 Truck Configuration During Load Test

Approximately 5 months after the structure was post-tensioned a load test was performed. Four loaded trucks were placed on the bridge over the joints to determine the response and check for composite action. The trucks were not heavy enough to obtain a large response. The case of the four trucks placed over the center joint, two side by side then the pair back to back, yielded the greatest response (Figure 17).
