# **Fabrication and Shipment Cracks in Prestressed Hollow-Core Slabs and Double Tees**

## **PCI Committee on Quality Control Performance Criteria**

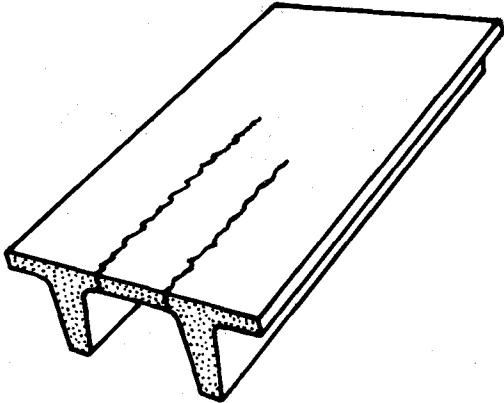
## 8. Flange Cracks Each Side of Stem

Description — Longitudinal cracks that occur on each side of a stem and usually originate at the end of the member.
