# Design and Construction of the Houston Ship Channel Bridge

Describes the major design and construction highlights of the \$60 million Houston Ship Channel Bridge, a prestressed concrete segmental structure having a record length 1500 ft (457 m) main span. The approach spans use Texas DOT standardized prestressed I-beams.

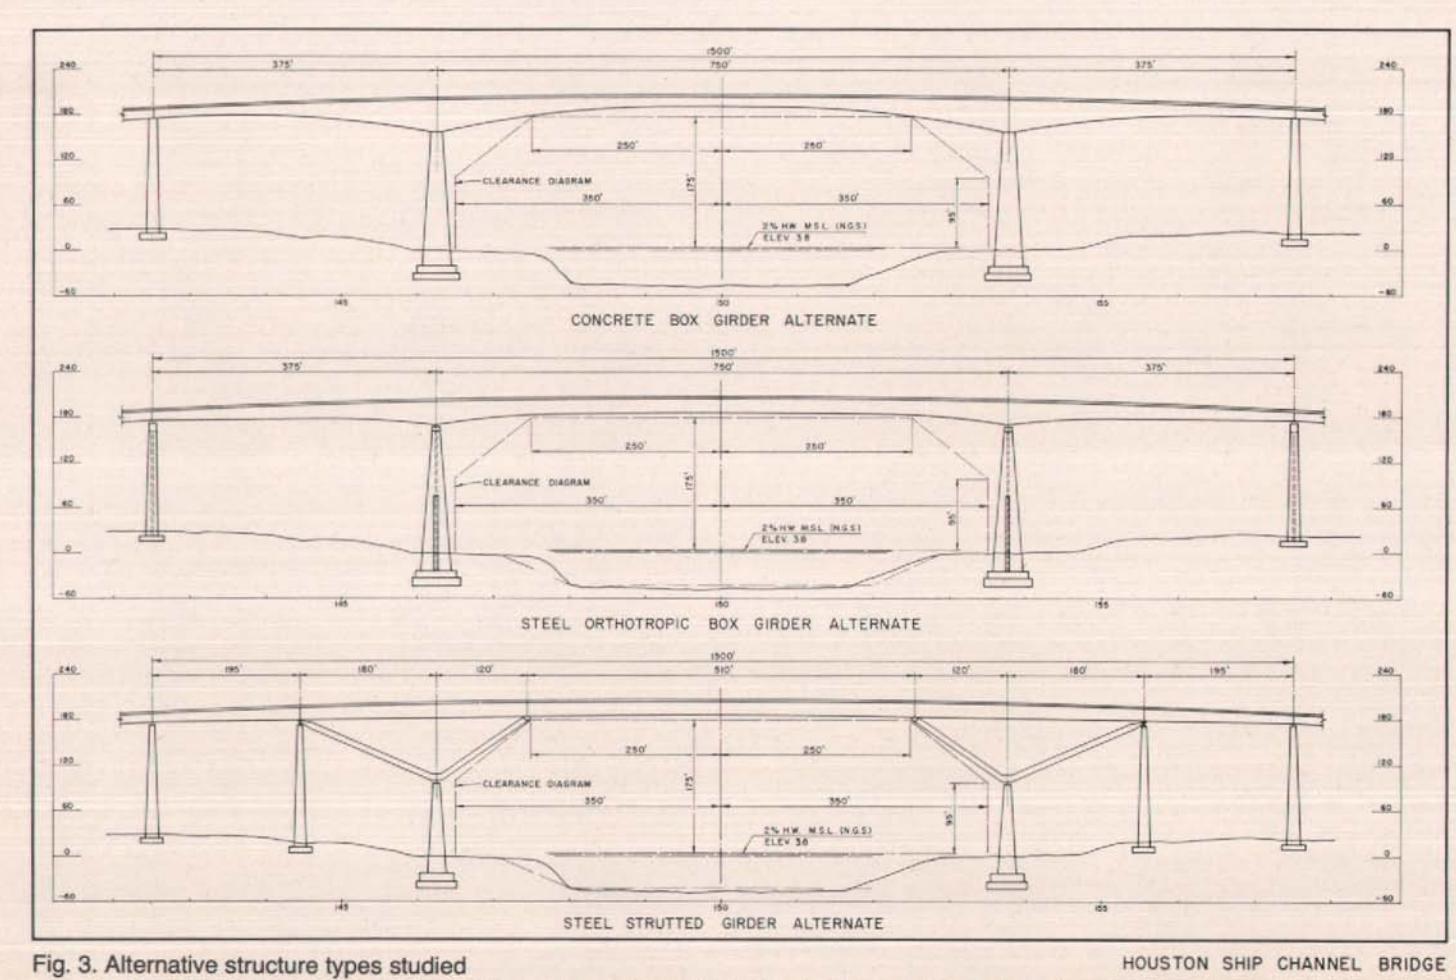
(a) Segmental concrete prestressed box girder, steel orthotropic deck box girder and steel strutted box girder.

The various structure types (see Fig. 3) were:

- 1. Steel orthotropic deck box girder
- 2. Steel strutted box girder
- 3. Steel tied arch
- 4. Steel half-through arch
- 5. Steel cantilever through truss
- 6. Steel cable-stayed girder
- 7. Concrete cable-stayed girder
- 8. Segmental concrete prestressed girder

The concrete box girder, steel strutted girder and steel tied arch types were the three most competitive alternate designs. These three designs were compared in terms of interference with navigation during construction, longterm maintenance and construction scheduling.

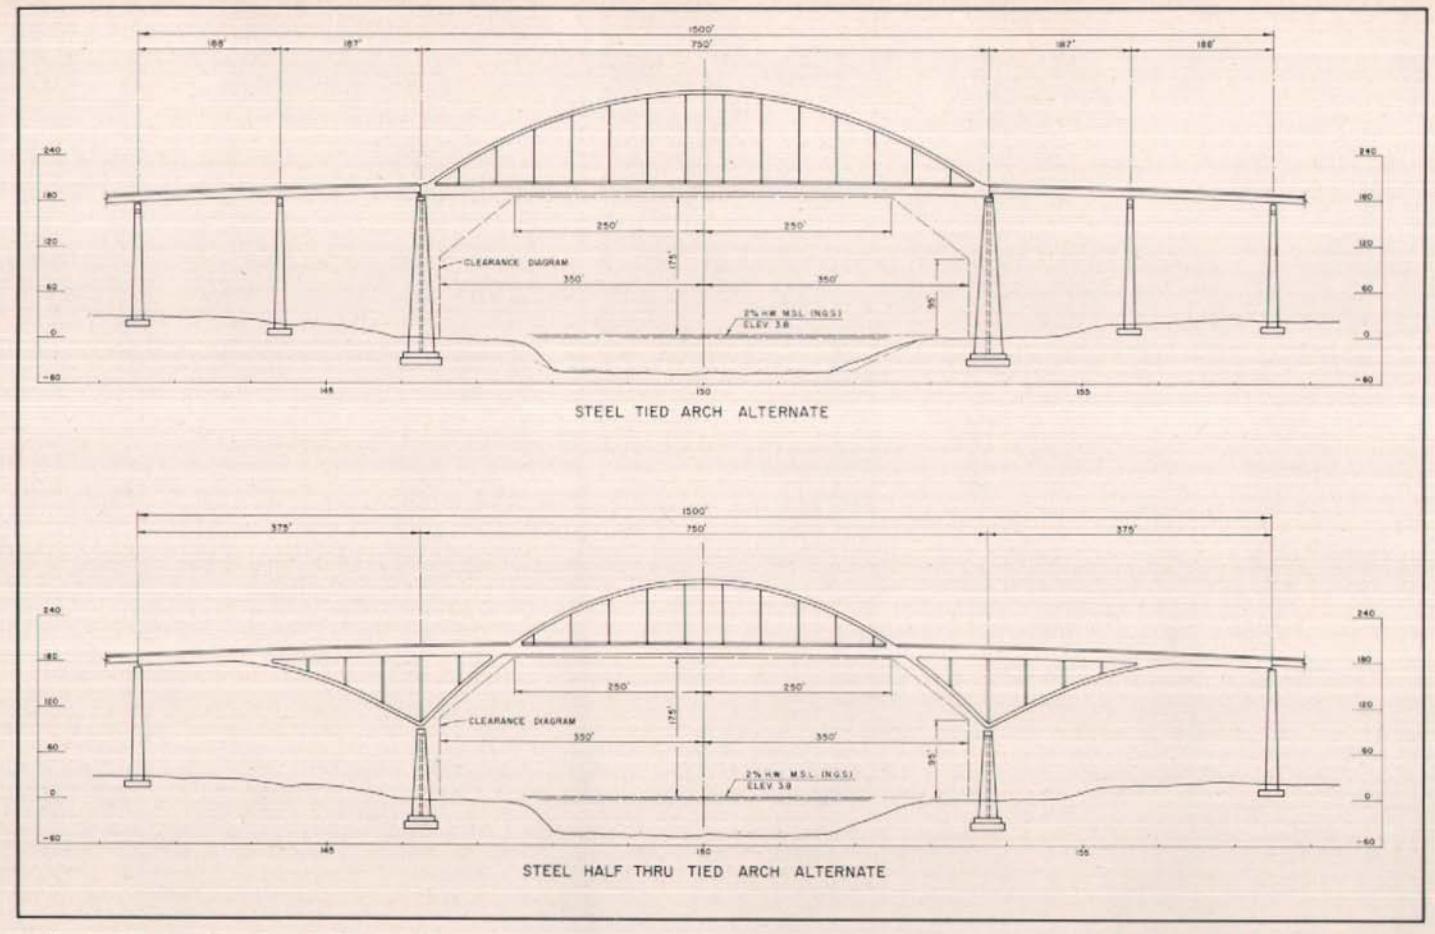
(b) Steel tied arch and steel half-through arch.

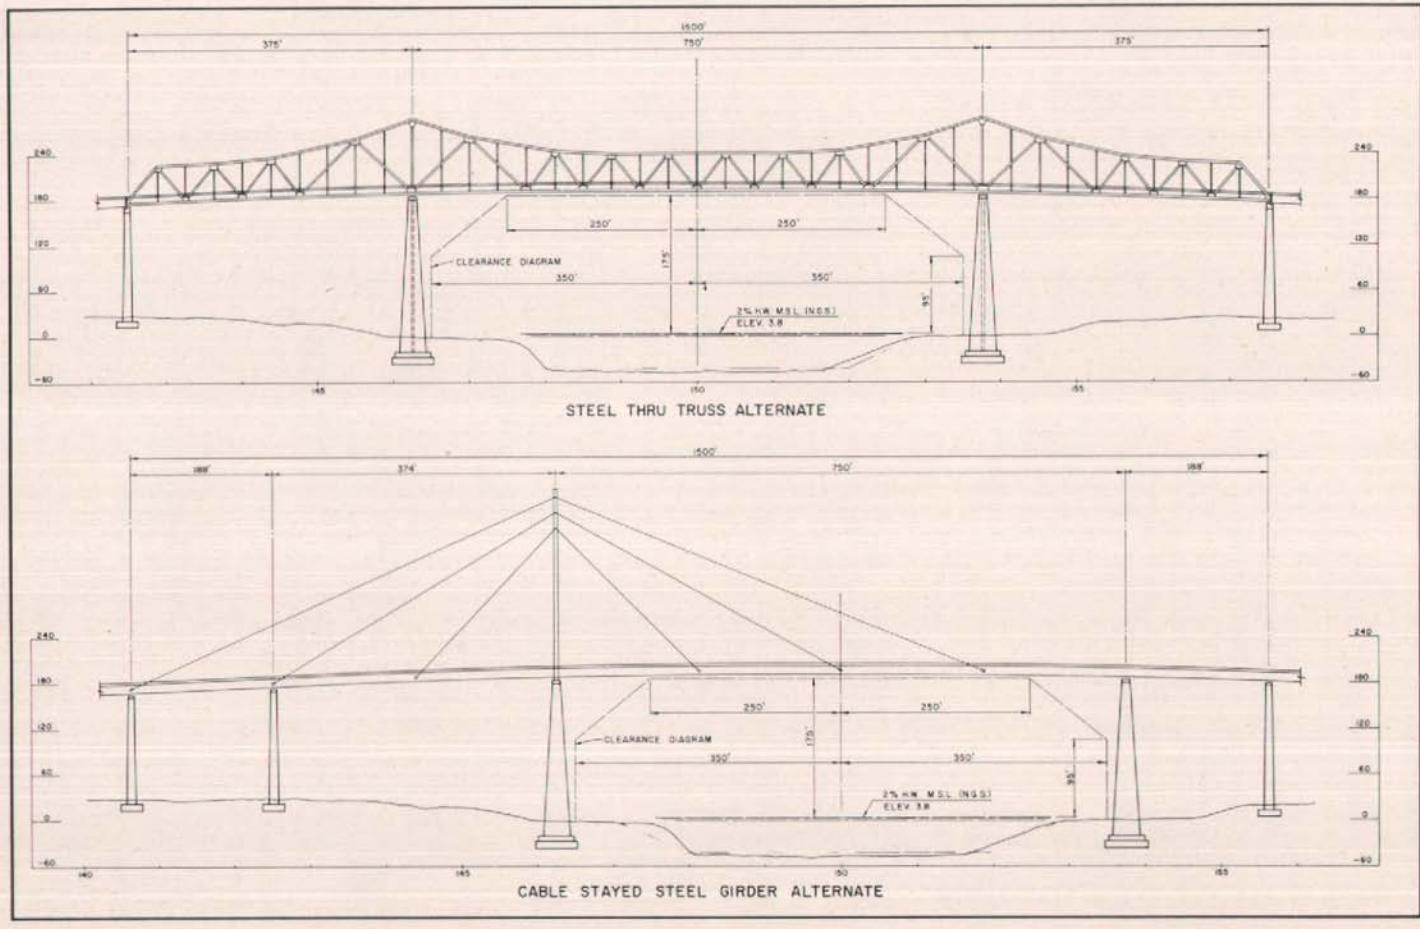
(c) Steel cantilever through truss, concrete and steel cable-stayed girder.

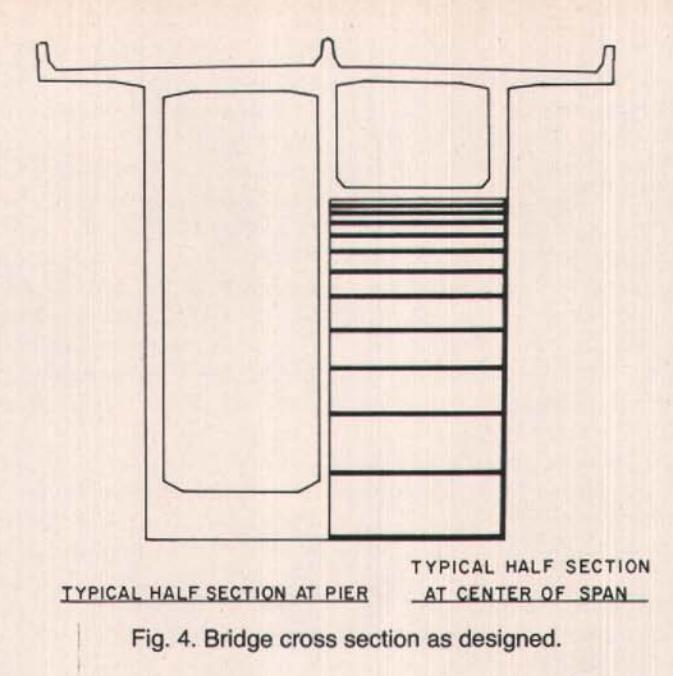
The plans prepared for bid provided a cross section with two 27-ft (8.23 m) roadways, a 2 ft 3 in. (0.68 m) New Jersey type median barrier and 1 ft 6 in. (0.46 m) wide parapets. The median barrier was designed to be removable in the future for conversion to one-way traffic. The main span is 750 ft (228.6 m), the side spans 375 ft (114.3 m). The bridge was designed for an HS-20 traffic loading and, although maximum operating speeds were projected to continue to be 55 miles per hr (88.5 km/hr) the design criterion was based on a higher design speed of 60 miles per hr (96.6 km/hr). The Houston design cross section consisted of a two-cell box with a slab overhang of 10 ft 71/2 in. (3.24 m) and three 14-in. (0.36 m) wide webs spaced at 19 ft (5.79 m). A two-web alternate was studied but the balance of slab versus web tipped slightly toward three webs. The box was 12 ft (3.66 m) deep at midspan with a haunch at the piers 42 ft 1/8 in. (13.1 m) deep. The top slab varied from 8 to 18 in. (0.20 to 0.46 m); the bottom slab from 10 in. to 3 ft 9 in. (0.25 to 1.14 m) at the pier (Fig. 4).

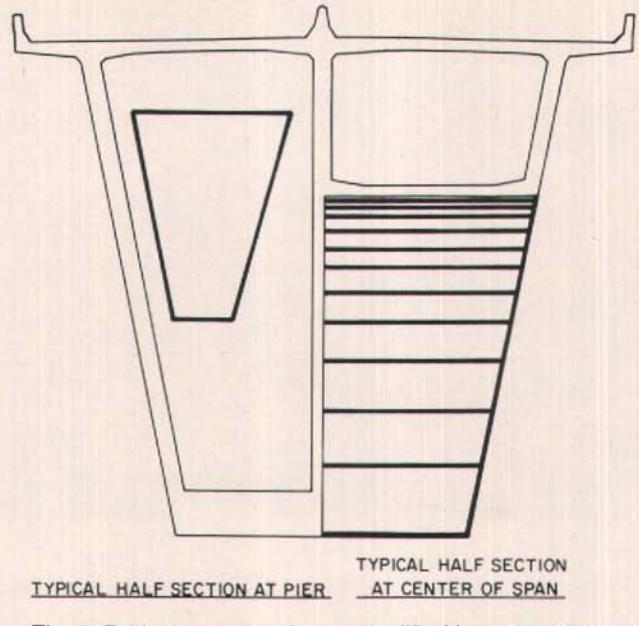
Fig. 5. Bridge cross section as modified by contractor.

The contractor changed the box shape in cross section to sloping webs. Some material savings resulted but the forming and steel fabrication and concrete placement became more complex. The variable depth required by the haunch made adjustment of the traveling forms more difficult and increased the cycle time somewhat (see Fig. 5).

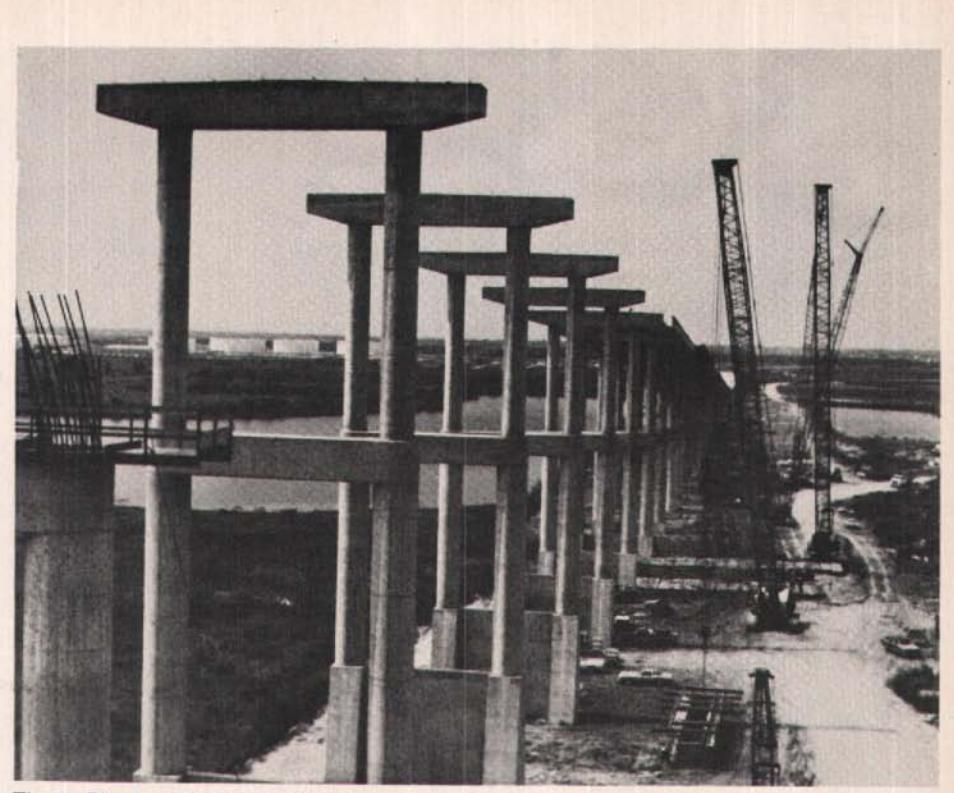
Fig. 7. Piers on land approaches.

Once the pier reached a height in excess of 60 ft (18.3 m), the entire upper portion remained the same. Similarly, when the height exceeded 120 ft (36.6 m) the entire upper portion remained the same. This allowed the contractor's maximum economy in reusing the forms which was reflected in their bids.

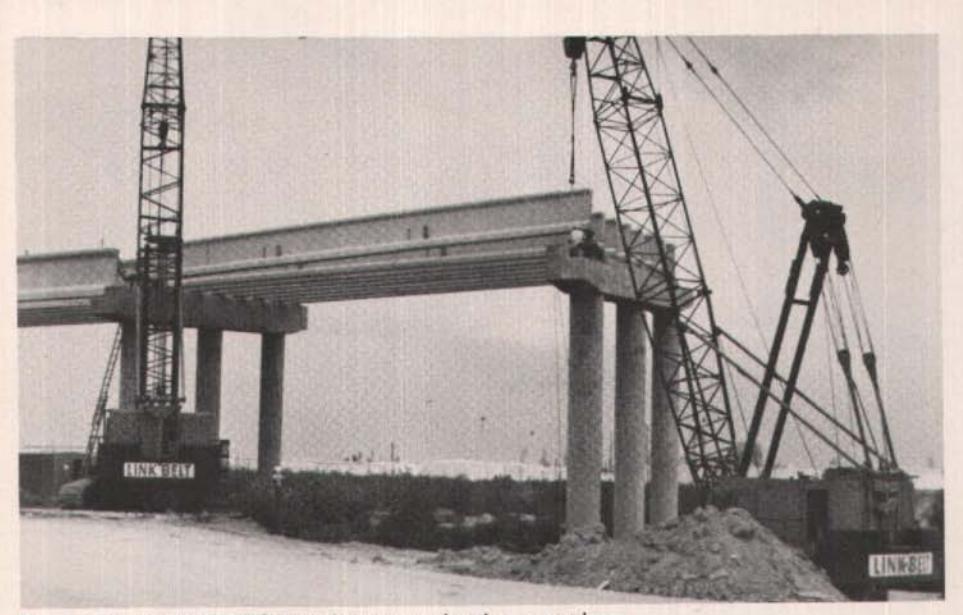
Fig. 8. Placing AASHTO type beams on land approaches.

Superstructure construction started with beam erection. On this project 54-in. (1.37 m) AASHTO type beams for the 120-ft (36.6 m) spans were set on elastomeric bearing pads. Each contractor had his own method of setting beams. Most contractors utilized two cranes in setting beams, as shown in Fig. 8. One contractor developed a delta frame consisting of tubular steel for the delta and flat plates for stiffeners. This approximately 25-ft (7.6 m) lifting frame permitted him to lift most of the beams with a single crane. Steel diaphragms were used to provide stiffness and lateral support during construction.

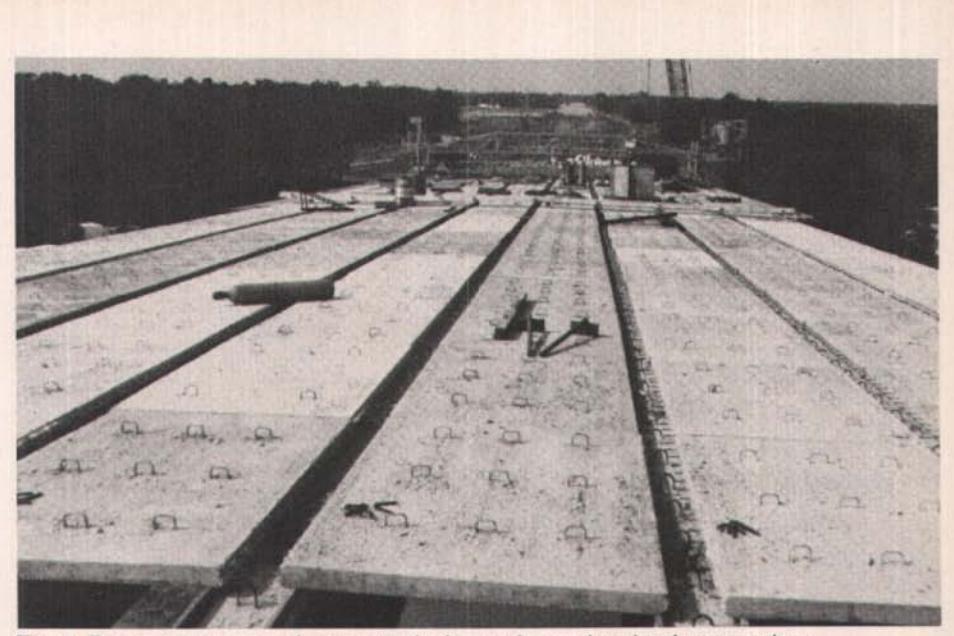
Fig. 9. Precast prestressed concrete deck panels used on land approaches.

Similarly, some contractors elected to use precast prestressed concrete deck panels in lieu of conventionally placing the deck (see Fig. 9). These 4-in. (102 mm) panels were prefabricated on site and put into place with a 3<sup>1</sup>/<sub>2</sub>-in. (89 mm) cast-in-place deck placed on top of them. This composite deck panel eliminated the wood formwork. Finally, after the decks were placed, the median and parapets were placed. The parapet was a conventional "Jersey Barrier" type. It was, however, 1 ft (0.3 m) higher than the conventional barrier and heavily reinforced. On some contracts this barrier was cast in place in conventional forms, on others it was slipformed. The median was either precast, poured in place in forms or slipformed, depending on the contractor.

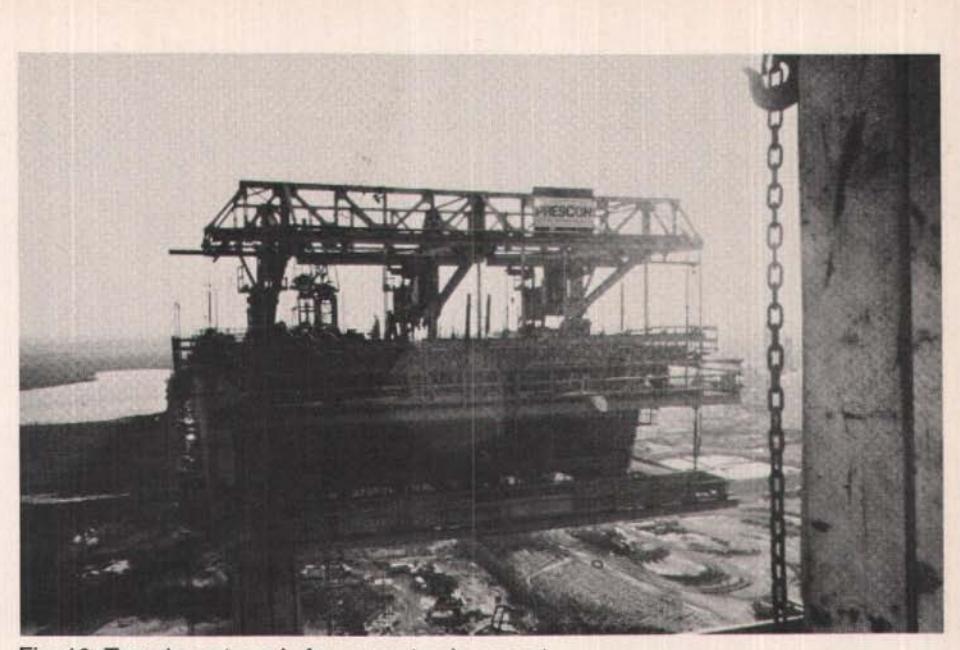
Fig. 10. Traveler set ready for concrete placement.

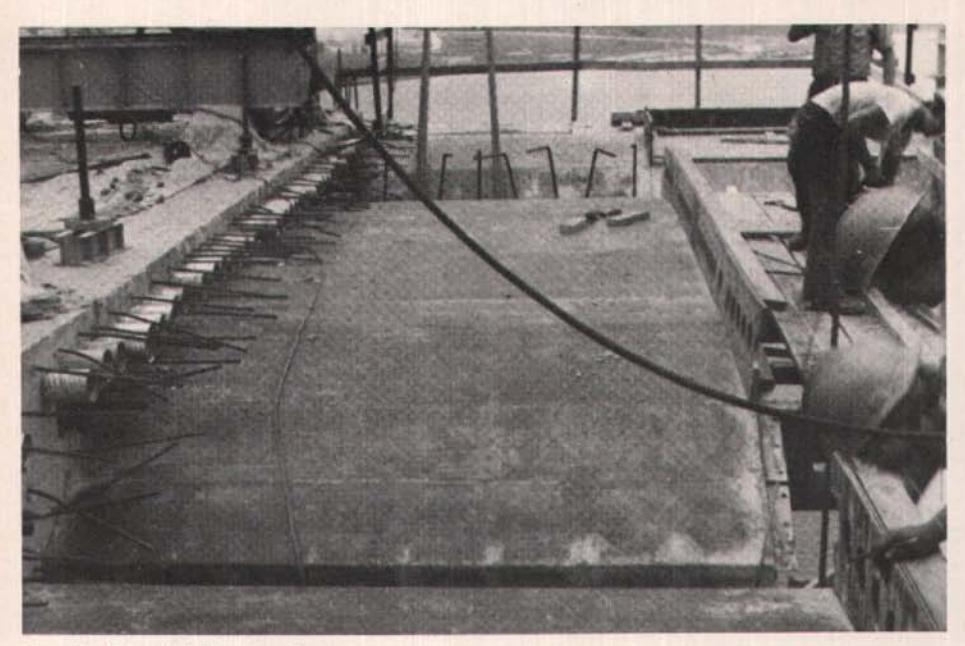
Fig. 11. Top slab formwork.

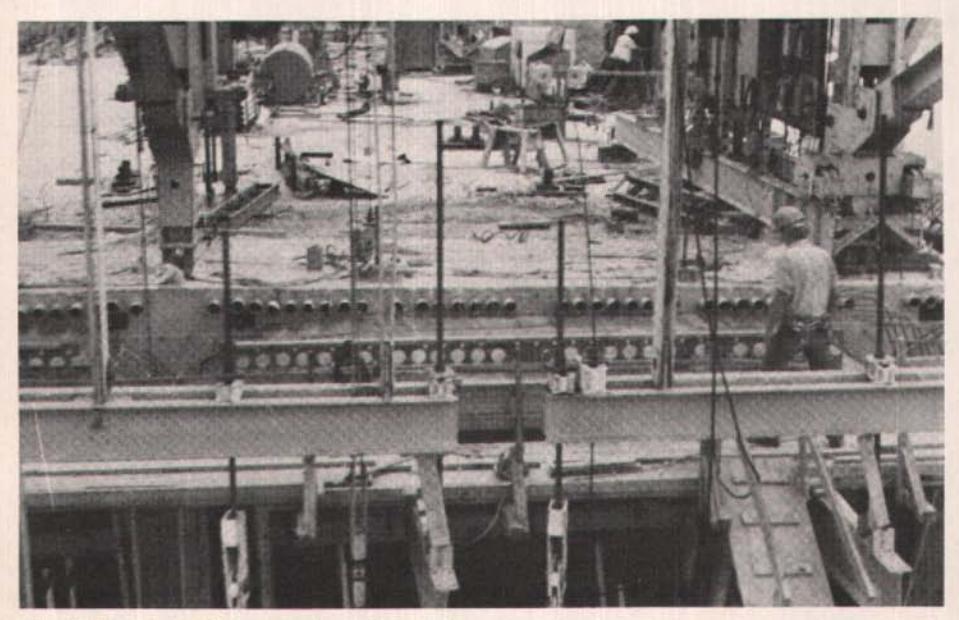
Fig. 12. Bulkhead for extension of top slab.

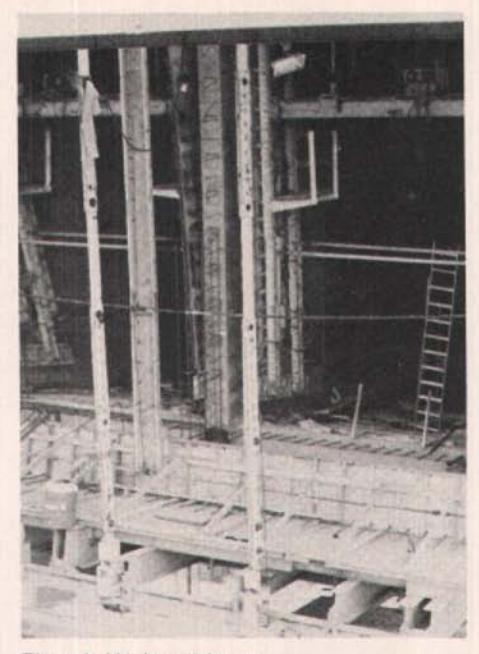
Fig. 13. Webwall forms.

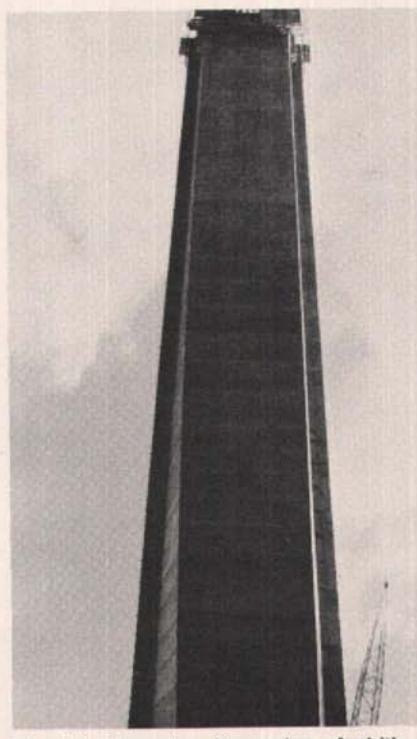
Fig. 14. Changing dimension of width of bottom slab (looking up).

bottom slab required changes in the transverse dimension of the soffit form every time the traveler was moved (see Fig. 14).

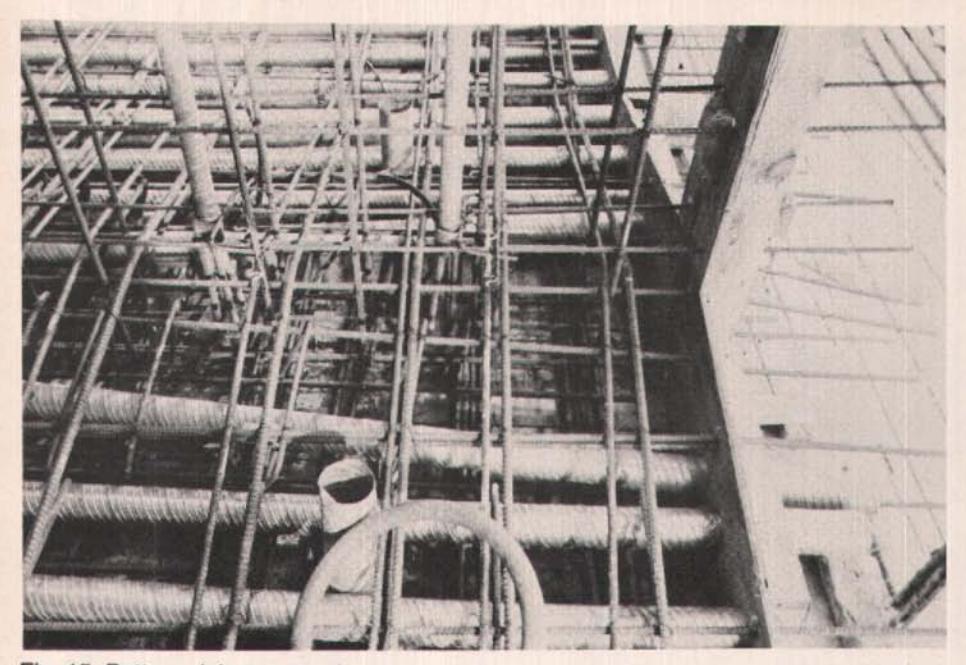
Fig. 15. Bottom slab construction.

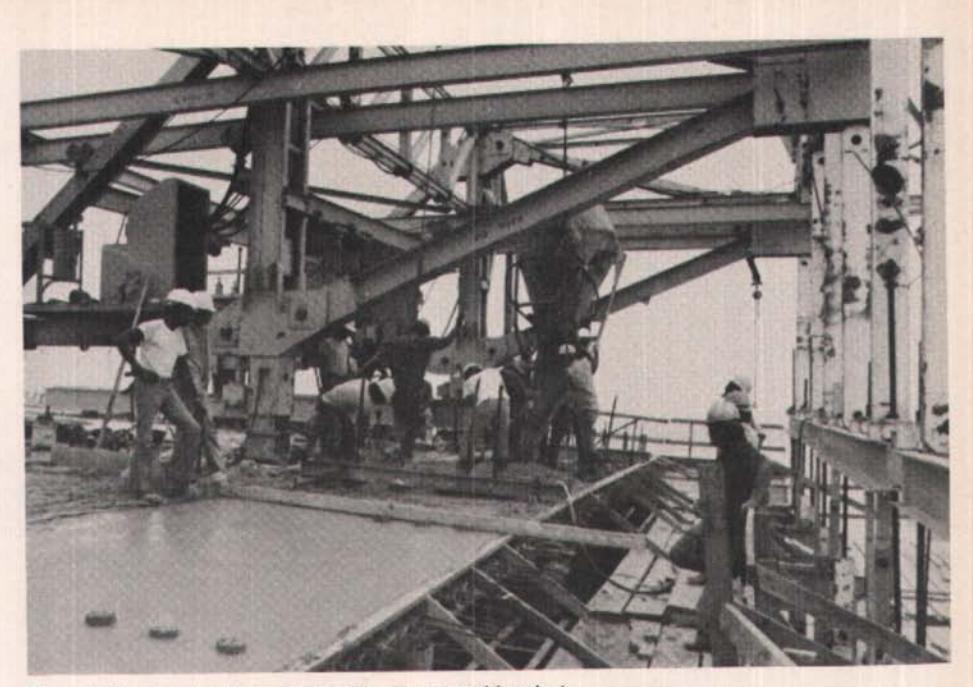
Fig. 16. Concrete placement with crane and bucket.

The tower crane for the project was capable of directly serving only 20 of the 58 segments to be placed (see Fig. 16). Beyond the reach of the tower crane the contractor devised a system of lifting the 2 cu yd (1.53 m<sup>3</sup>) bucket to the top of the pier, unloading approximately 7 cu ft (0.2 m<sup>3</sup>) to a motorized buggie, running the buggie to a ramp and dumping it into a conveyor which took the concrete into the forms. This was later modified to a forklift operation which eliminated the ramp and motorized buggie (see Fig. 17). This modification reduced the concrete placing time from 12 hours to 7 hours and greatly enhanced the quality of the concrete poured.

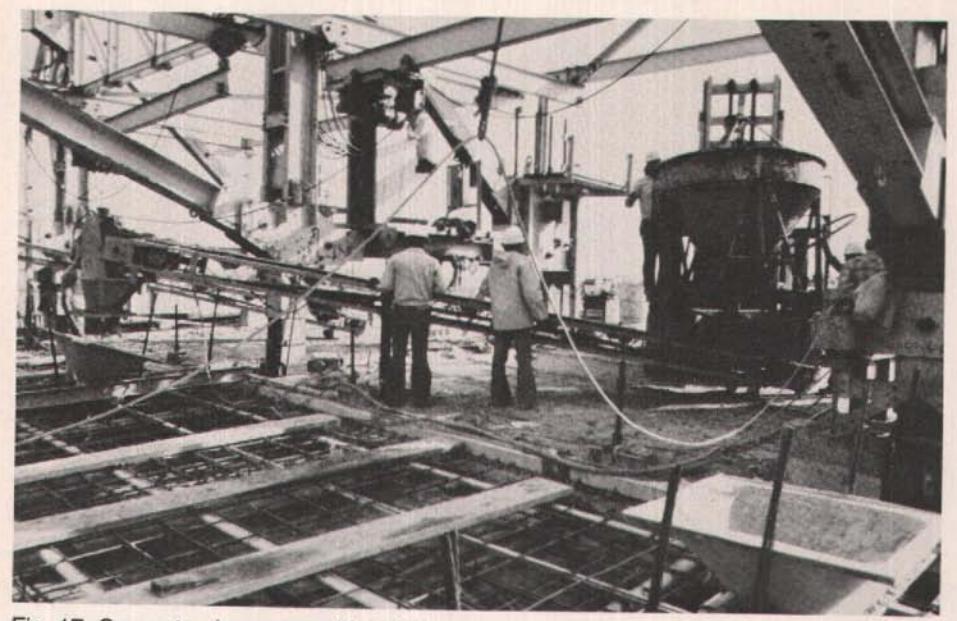
Fig. 17. Concrete placement with forklift and conveyor.

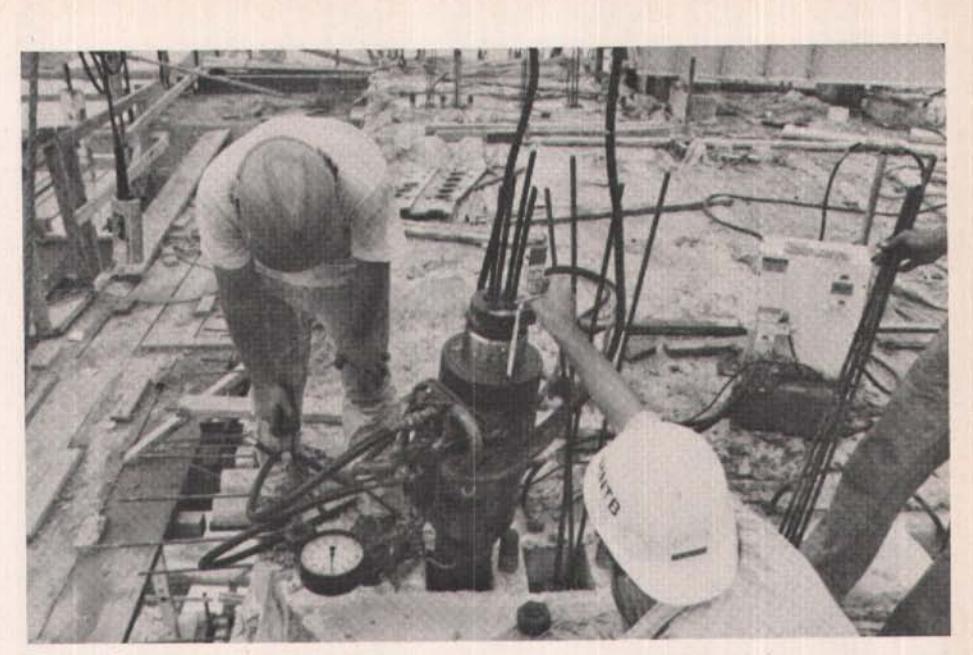
Fig. 18. Stressing of vertical tendons.

handled with extreme caution. The stressing of the 270 ksi (1860 MPa) low relaxation strands was controlled on this project by achieving the desired elongation of the strand within the limits of force allowed in the specifications as measured by the jacking pressures. In order to minimize differential stress on the structure, simultaneous stressing was required in the longitudinal tendons when stressing the large tendons. This required two-way communication between the contractor's personnel and the inspection team. Because of the amount of friction losses. dead-end stressing was a necessity. Stressing was a complex operation that required close monitoring by the engineer and a thorough knowledge of the forces and reactions involved in every phase of the stressing operation (see Fig. 18).

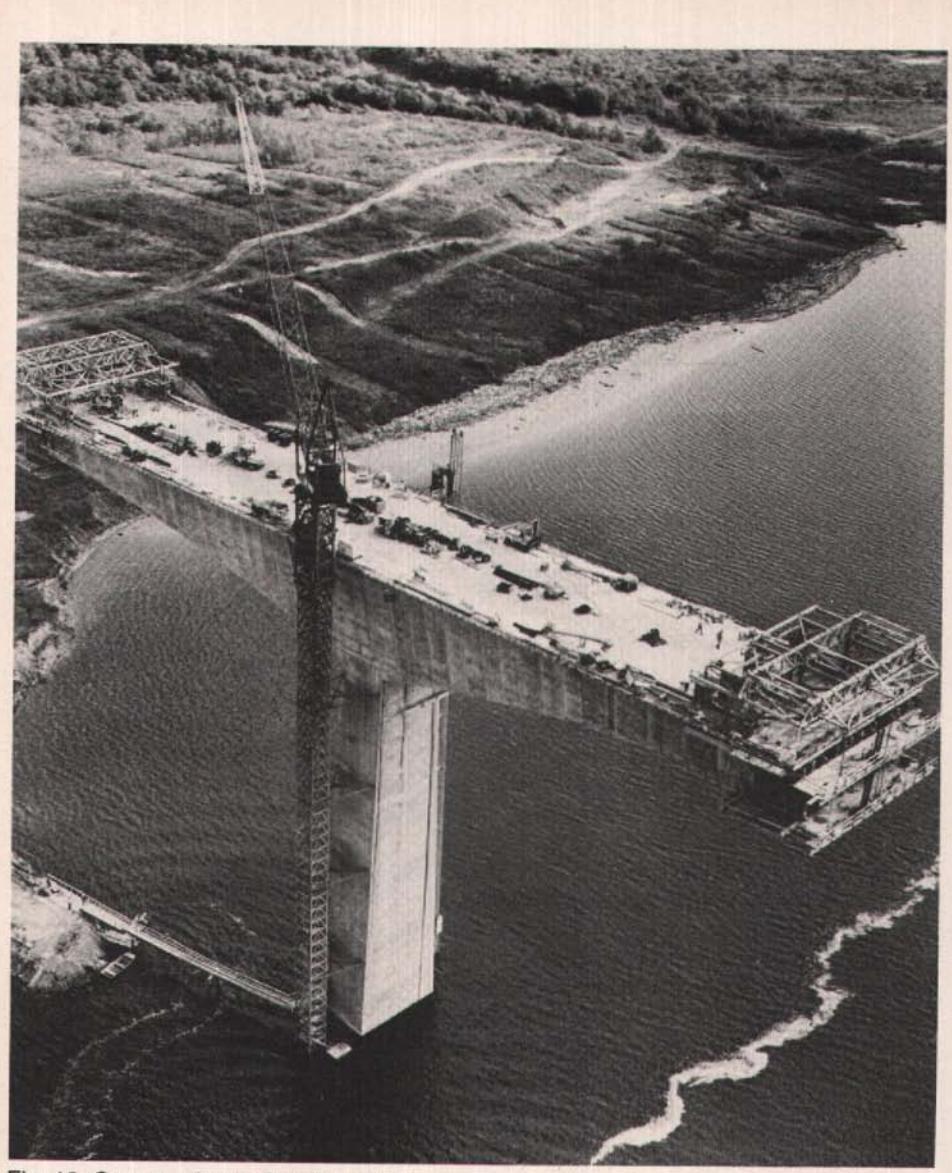
Fig. 19. Construction in October, 1981.

The Houston Ship Channel Bridge project is a 1500 ft (457.5 m) long segmentally constructed concrete bridge (see Figs. 19 to 23). Segmental bridge construction is a relatively new industry in the United States. This prestressed concrete structure is the longest of its type in North America. Being at the edge of the state of the art it was anticipated that some problems would develop during the construction of the project that would require on-site expertise as well as close cooperation and communication between the designers and field engineers. The major construction features discussed were:

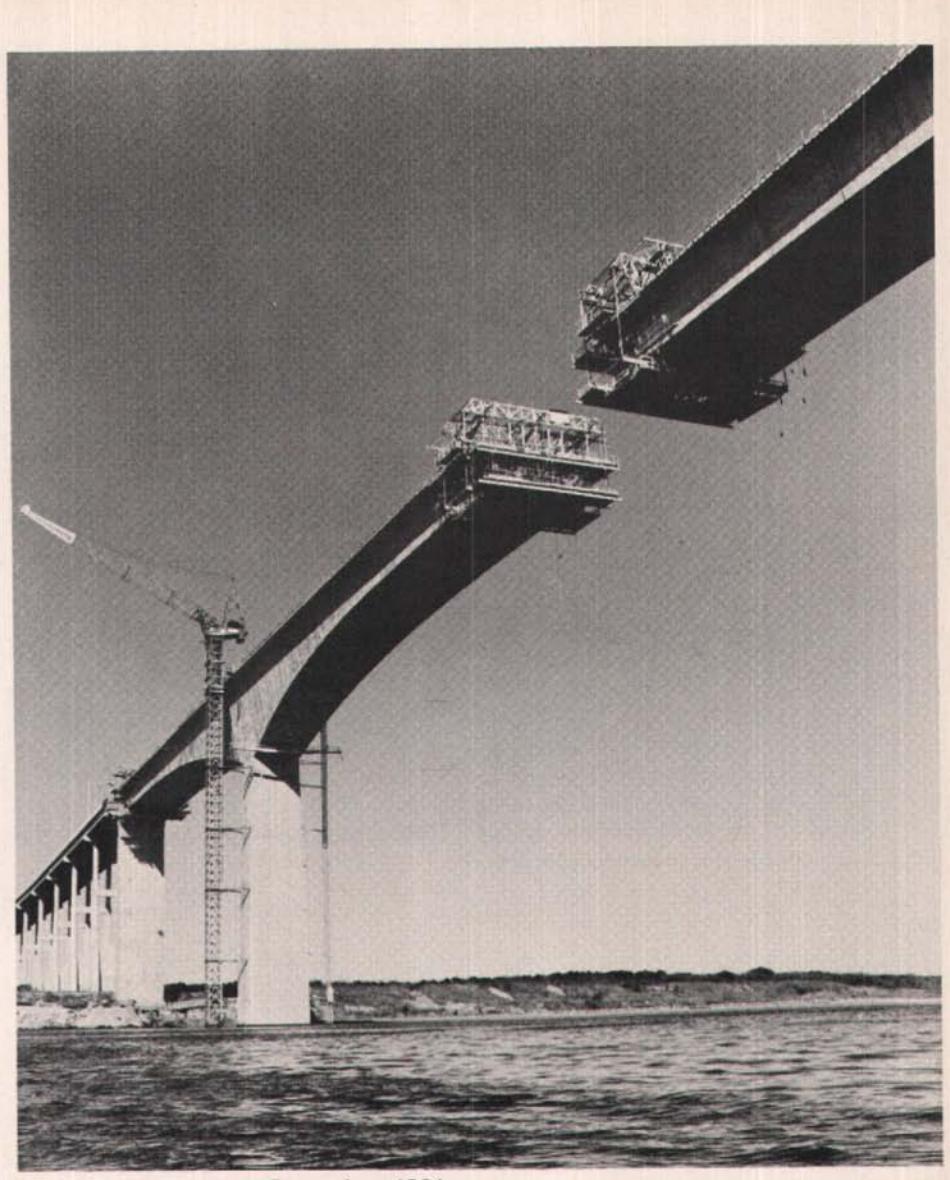
Fig. 20. Construction in December, 1981.
