# The Florida Suncoast Dome

Describes the conceptual and structural design, production and erection of a \$100 million multipurpose stadium in St. Petersburg, Florida. This all precast prestressed concrete structure utilizes more than 7000 precast components weighing over 50,000 tons (45350 t). A large variety of precast products were used including columns, beams, raker beams, double tees, hollow-core slabs, ramp elements and stadium seats. The first part of the article discusses the structural and construction aspects of the ring beam framing while the second part discusses the concourse and seating area framing.

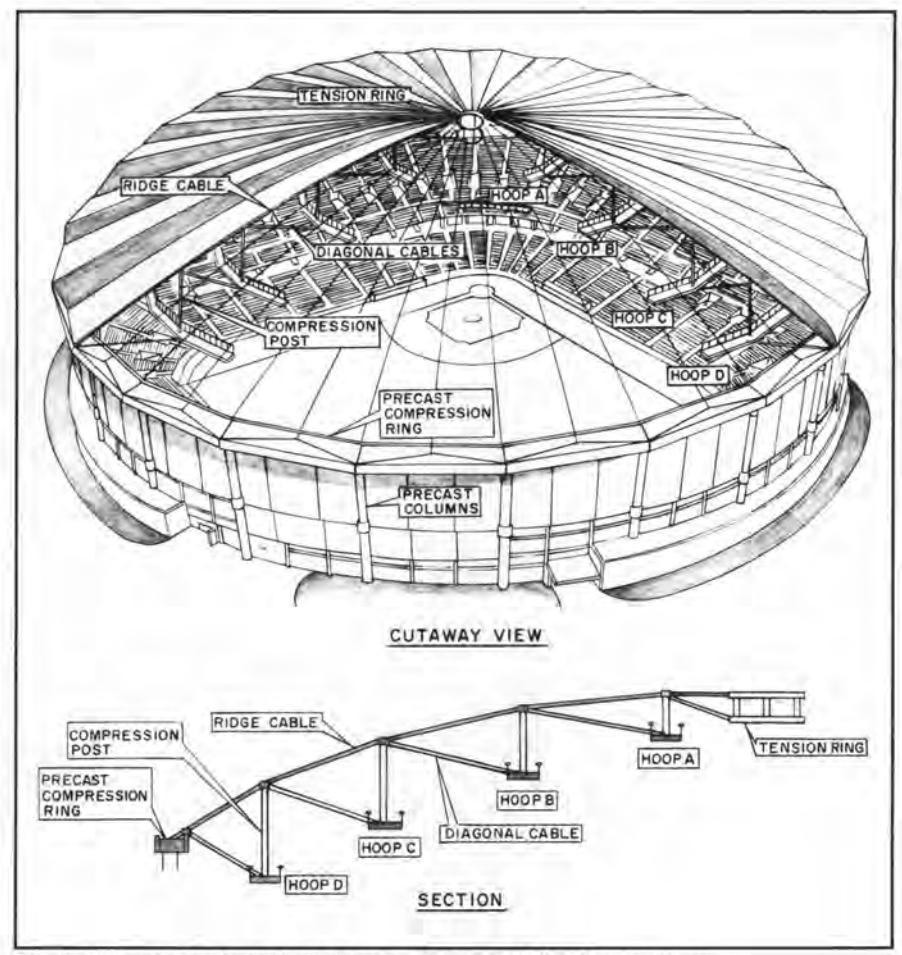
Fig. 1. Schematic of stadium showing basic roof framing system.

The diameter of the stadium is 688 ft (210 m) with a height of 225 ft (69 m). It covers an area of  $8\frac{1}{2}$  acres (3.44 ha). The facility has a seating capacity for 43,000 spectators plus 60 private suites (see Fig. 1).

The compression is created in the exterior outer ring by virtue of the radial post-tensioning forces, which create tremendous inward pressures on the ring (Fig. 1). The circumferential compression design force was 13,000 kips (57824 kN). A dome similar to this was completed in Seoul, Korea, for the 1988 Olympic Games, but is much smaller; it has only a 13,000 seating capacity and a 393 ft (120 m) diameter.

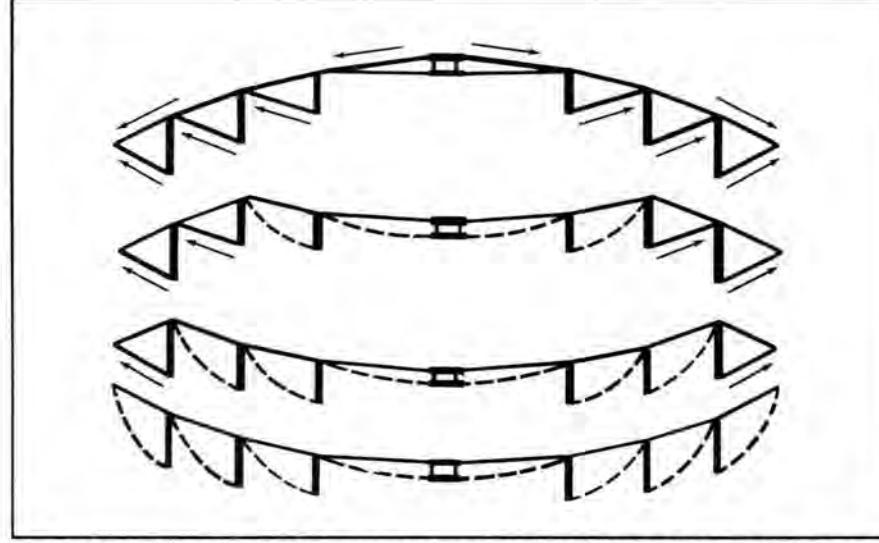
Fig. 2. Stressing sequence of post-tensioned roof cables to pull dome into place.

Fig. 2 shows how the diagonals of successive rings are tensioned forcing the vertical compression posts upward and achieving the curved roof configuration. In this process the roof cables are strung to a temporary tension ring; then the hoop elements are assembled on the ground and raised in position. The posts are erected in their proper locations and then stressing begins.

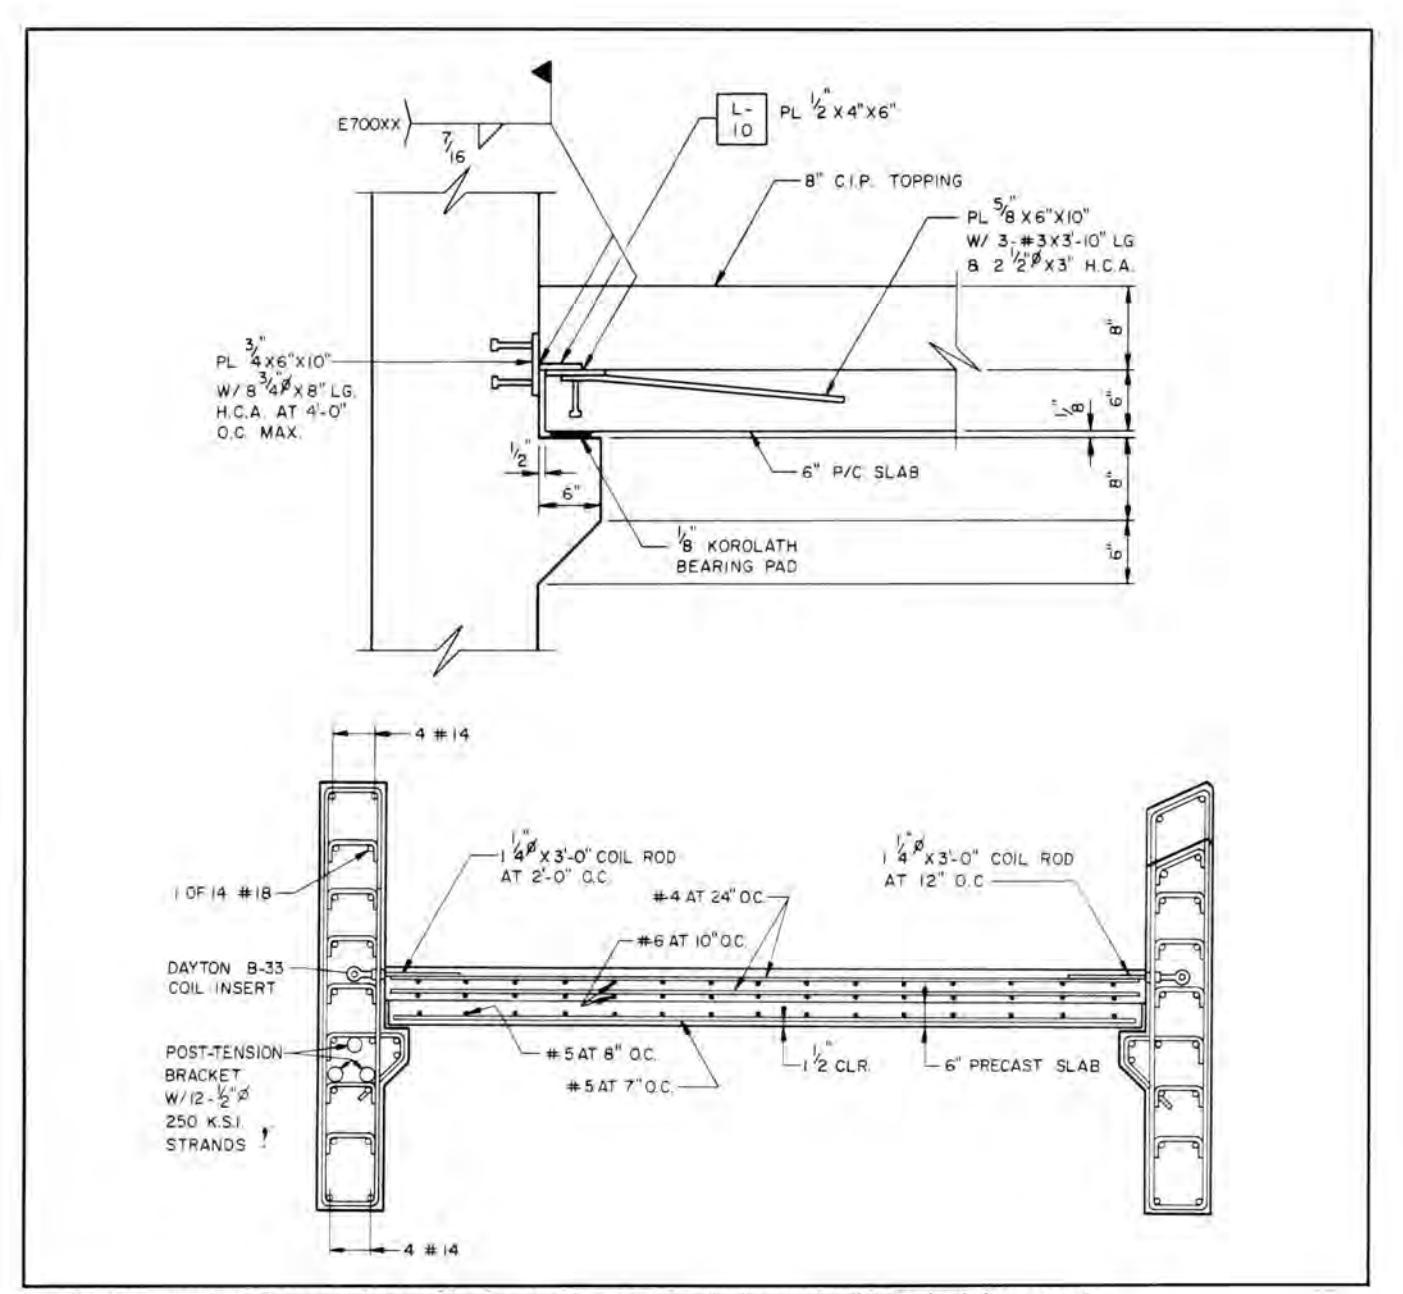
Fig. 3. Cross section of assembled ring beam showing post-tensioning and mild steel reinforcement.

The maximum column vertical design load was 1500 kips (6672 kN). The typical manufactured length was 56 ft (17 m), with the top column length varying based upon the 15 degree slope of the roof. The columns were typically made in four lengths with a maximum total length of 170 ft (52 m). Full moment splices were achieved at the column joints with the use of NMB splice sleeves. **B.** Ring Beam Frame — Four components make up the typical ring beam. One element is the main support connection element called a knuckle assembly which connects and supports the precast concrete ring beams on top of the precast columns. The remaining elements are all precast concrete and are arranged to create the giant 18 ft (5.49 m) deep beam (Fig. 3).

Fig. 3 shows a cross section of the main ring beam and identifies the deep flange beams, precast concrete slabs and composite concrete tying the 18 ft (5.49 m) wide flange ring beam together. The ring beam was designed for dead and live flexural loads with a 3000 ft-kip (4070 kN•m) bending moment plus a 13,000 kip (57800 kN) axial load. The main ring beam reinforcements were three 12 strand posttensioned tendons plus mild steel shear and torsion reinforcing bars. Fig. 4 shows a completed beam in storage.

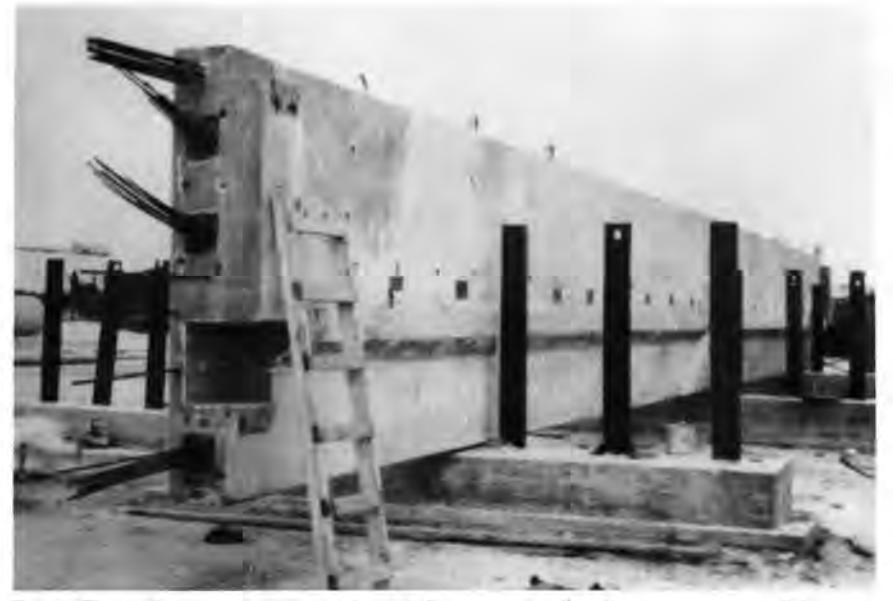
Fig. 4. Typical precast post-tensioned flange beam for ring beam assembly.

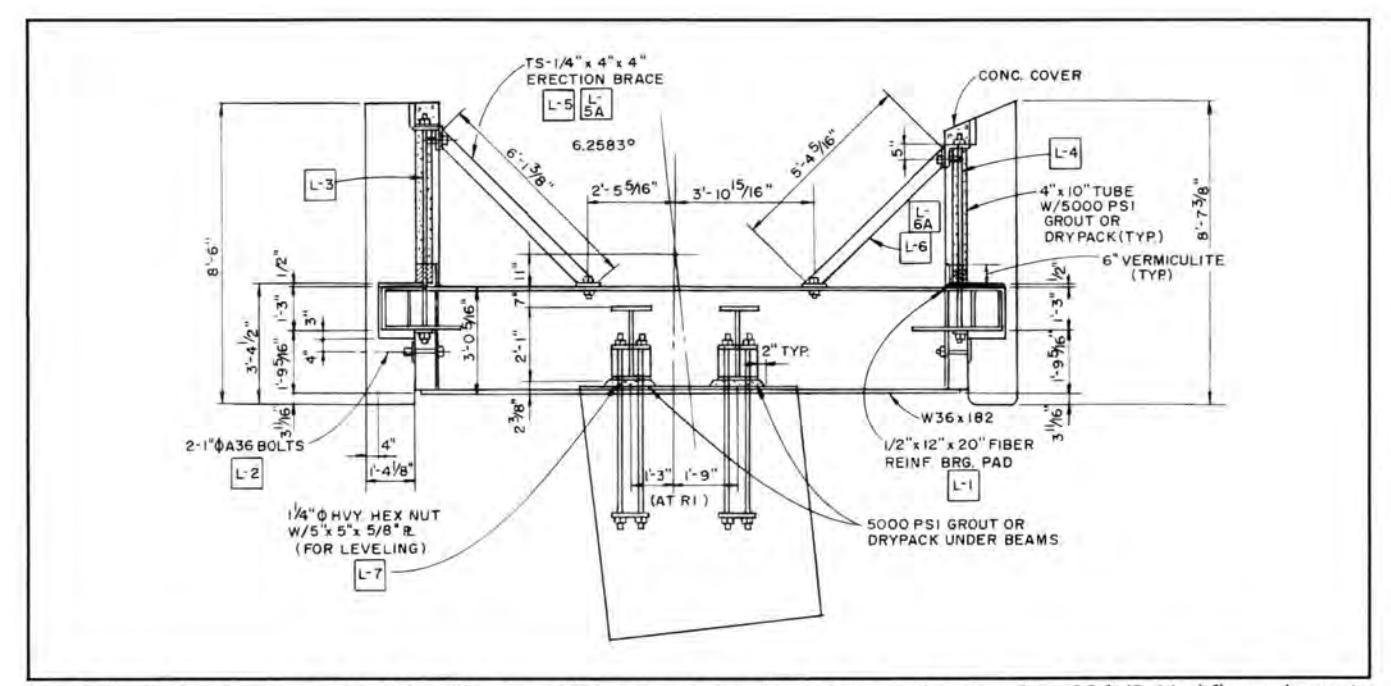
Fig. 5. Detail of connection of steel knuckle assembly to precast concrete column and connection of 8 ft (2.44m) flange beam to steel knuckle.

strength to carry the 8 ft (2.44 m) of field placed concrete. Details of the knuckle assembly are shown in Fig. 5.

Fig. 5 is a section through the column showing sloping knuckle assembly flange beams and special braces that were used to prevent the 8 ft 6 in. (2.59 m) high flange beams from being blown over. A vertical bolted connection was used to connect the precast concrete flange beams to the steel knuckle assembly.

Fig. 5 also shows the support of the precast concrete beams on the knuckle assembly and the cast-inplace composite slab needed to support the remainder of the knuckle concrete.

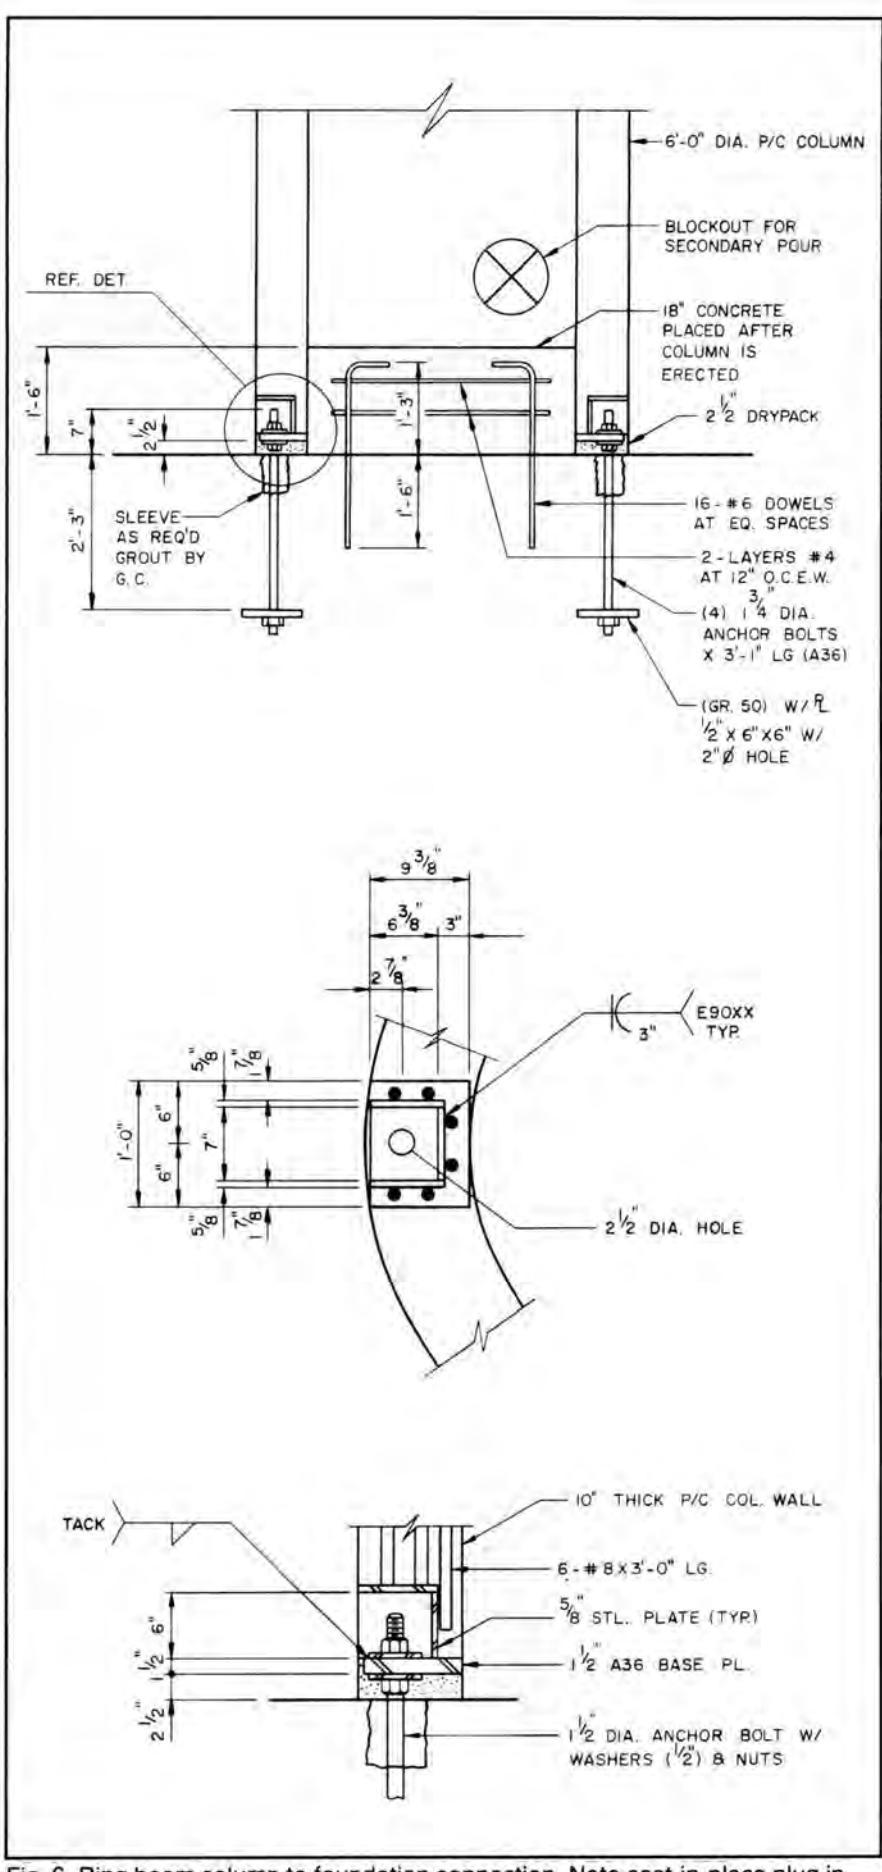
Fig. 6. Ring beam column to foundation connection. Note cast-in-place plug in circular void.

Fig. 6 shows a detail of the column base connection with the four anchor bolts and the cast-in-place plug employed for added fixity.

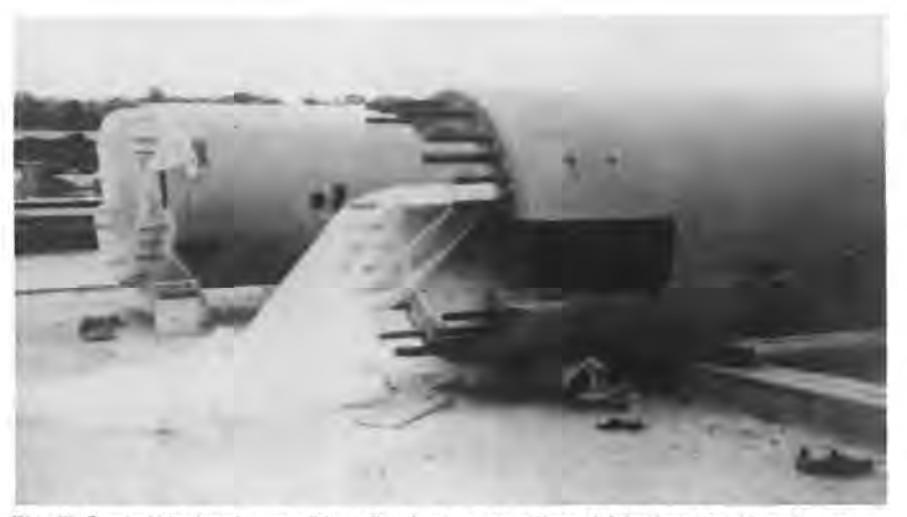
Fig. 7. Completed column with splice bars extending. A blockout is also shown to accommodate steel framing.

Fig. 7 shows a typical column in storage where a slot has been provided in the top of the column. This slot allows the steel framing K brace to fit into the column as the column is erected. Prior to installing the steel lateral load framing, the K brace is carefully aligned at the proper angle and attitude and then anchored in place with castin-place concrete. A computer program was used to determine the required angle and diagonal brace length required for the sloping elliptical roof configuration.

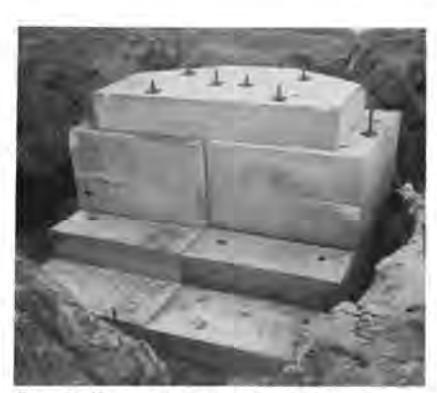
Fig. 8. Precast concrete deadmen connected with post-tensioned bars. This is used to support roof until roof cables are installed and steel bracing is in place.

The steel pipe braces were supported from the ground using unique precast concrete deadmen. The deadmen measured  $17 \times 17$  ft (5.18 x 5.18 m) and were made up of nine precast concrete elements which were bolted together using Dywidag post-tensioned rods (Fig. 8).

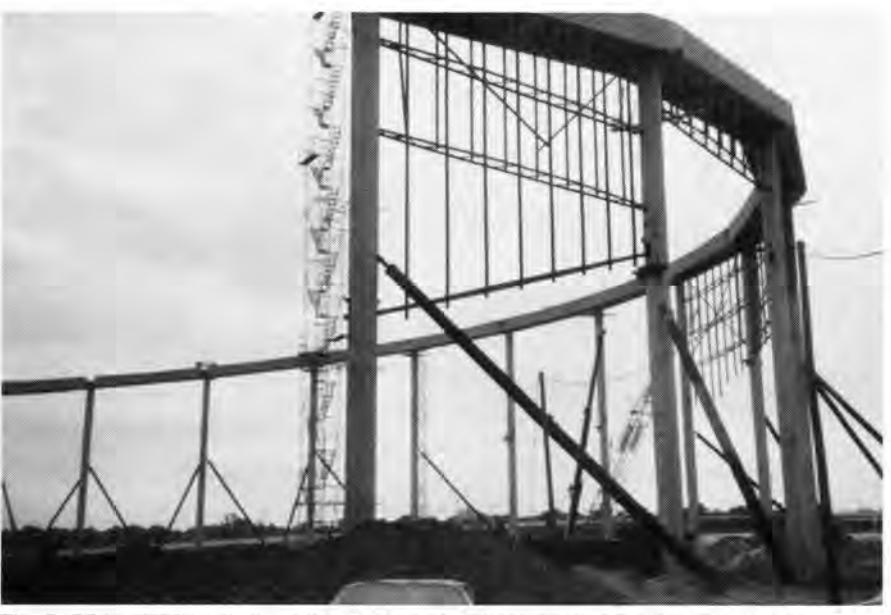
Fig. 9. 30 in. (762 mm) diameter pipe bracing in place to stabilize ring beam framing.

Fig. 9 shows the braces as they

were installed to brace the columns. The ends of the 30 in. (762 mm) pipe braces were articulated to account for the differing elevations of the soil surrounding the stadium and therefore the different angles between the precast con-

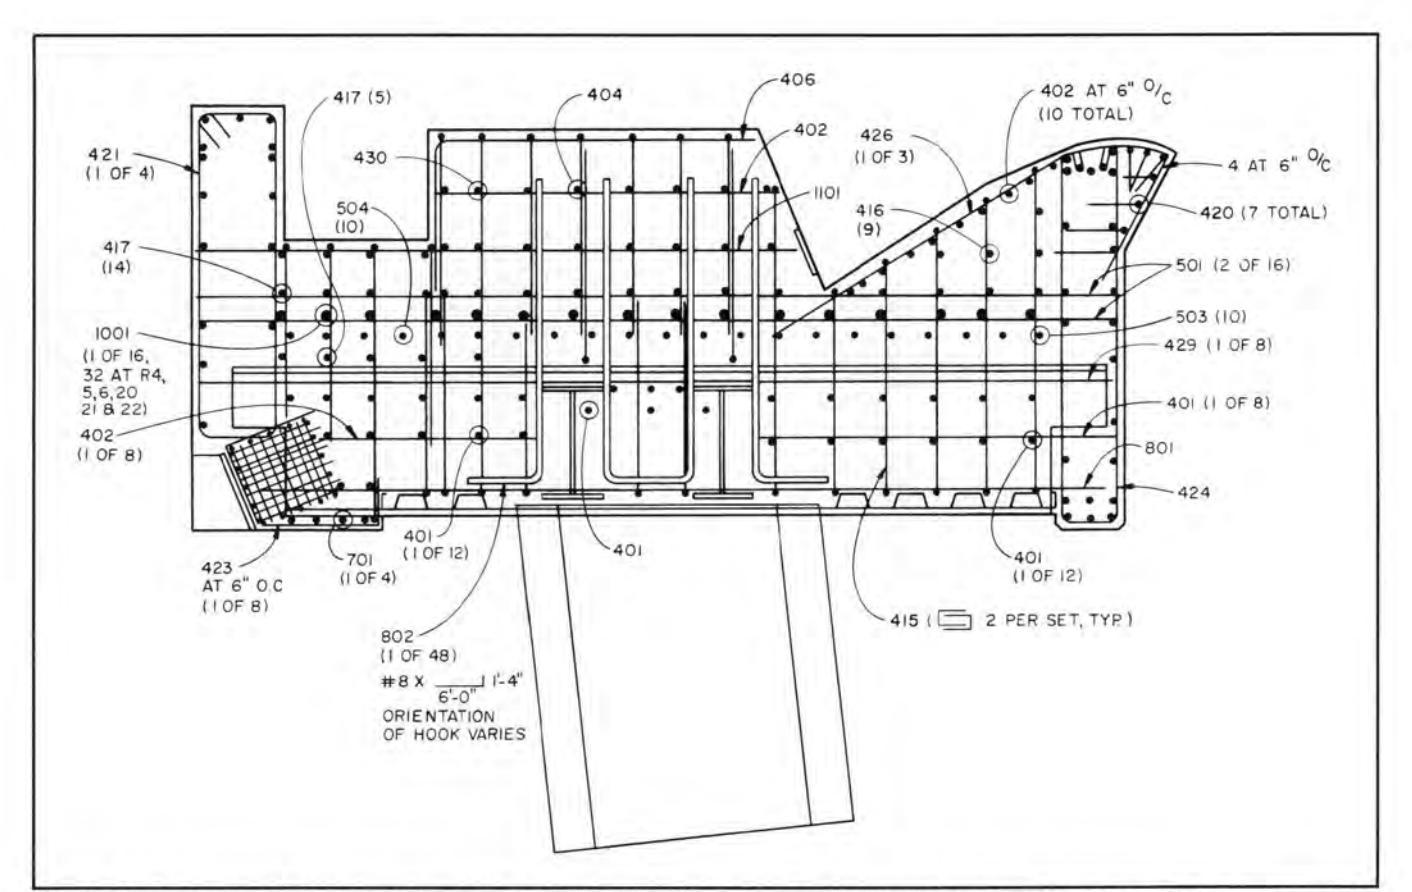
Fig. 10. Cross section through cast-in-place portion of knuckle assembly. Note bursting steel reinforcement in lower part for main cable anchorage (see Fig. 11).

Fig. 10 shows a section through a knuckle assembly showing the required reinforcing steel. Fig. 11 is a

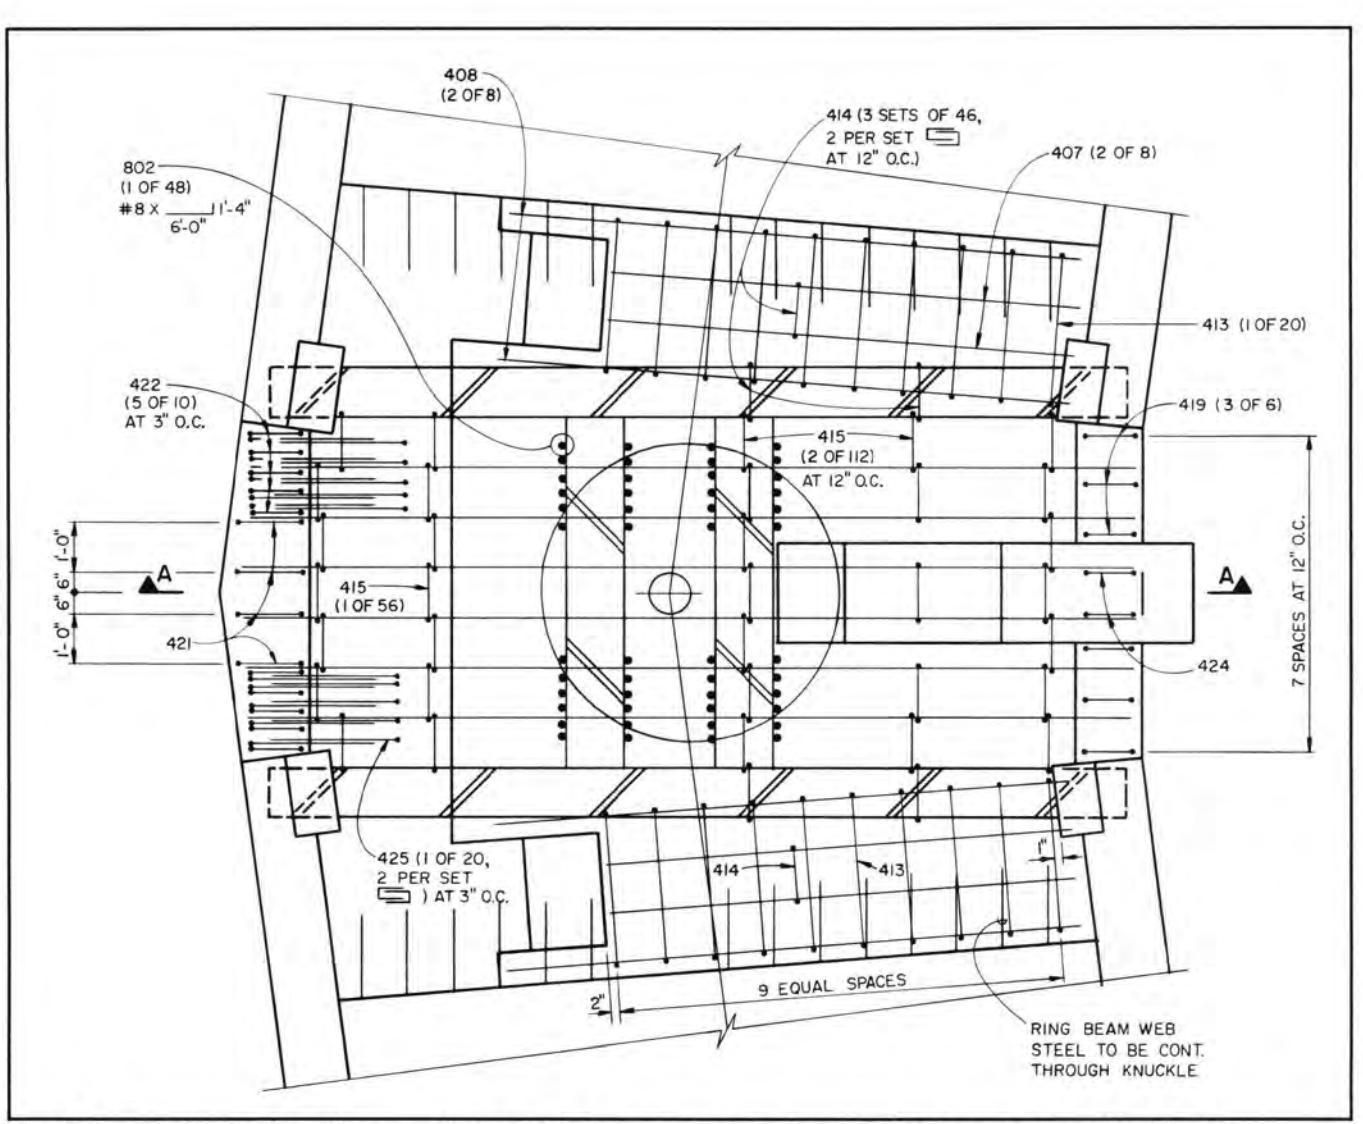
Fig. 11. Plan of complete knuckle assembly. Location of supporting precast concrete column is shown (see Fig. 10).

plan view of the knuckle assembly reinforcement showing the bursting steel at the roof cable anchorage locations. A cast-in-place concrete saddle retains the roof cables and roof cable profile and anchorages. Note that the leading edge is curved so as to avoid stress concentrations on the concrete edge as the cable roof system is raised from the floor of the stadium into its final elevated position.

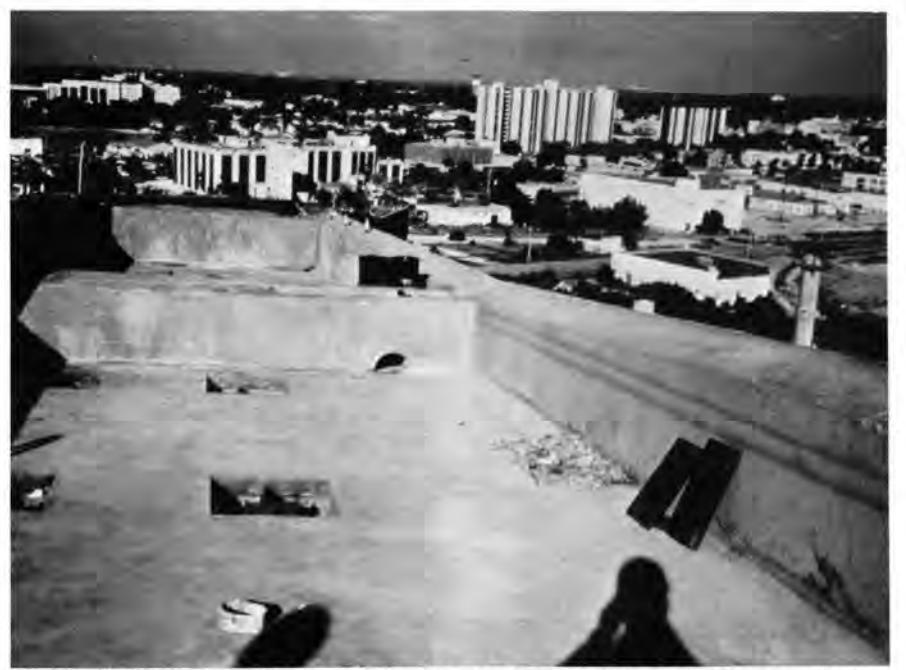
Fig. 12. Completed ring beam and knuckle assembly; at this height panoramic view of city and coast can be appreciated; note 15 degree beam slope.

Fig. 12 shows the top of the ring beam with completed cast-in-place intermediate and knuckle assemblies. Note that a drainage hole was provided through the assemblies to allow for water to drain from the high side of the roof to the low side. The 15 degree slope is very apparent in Fig. 12.

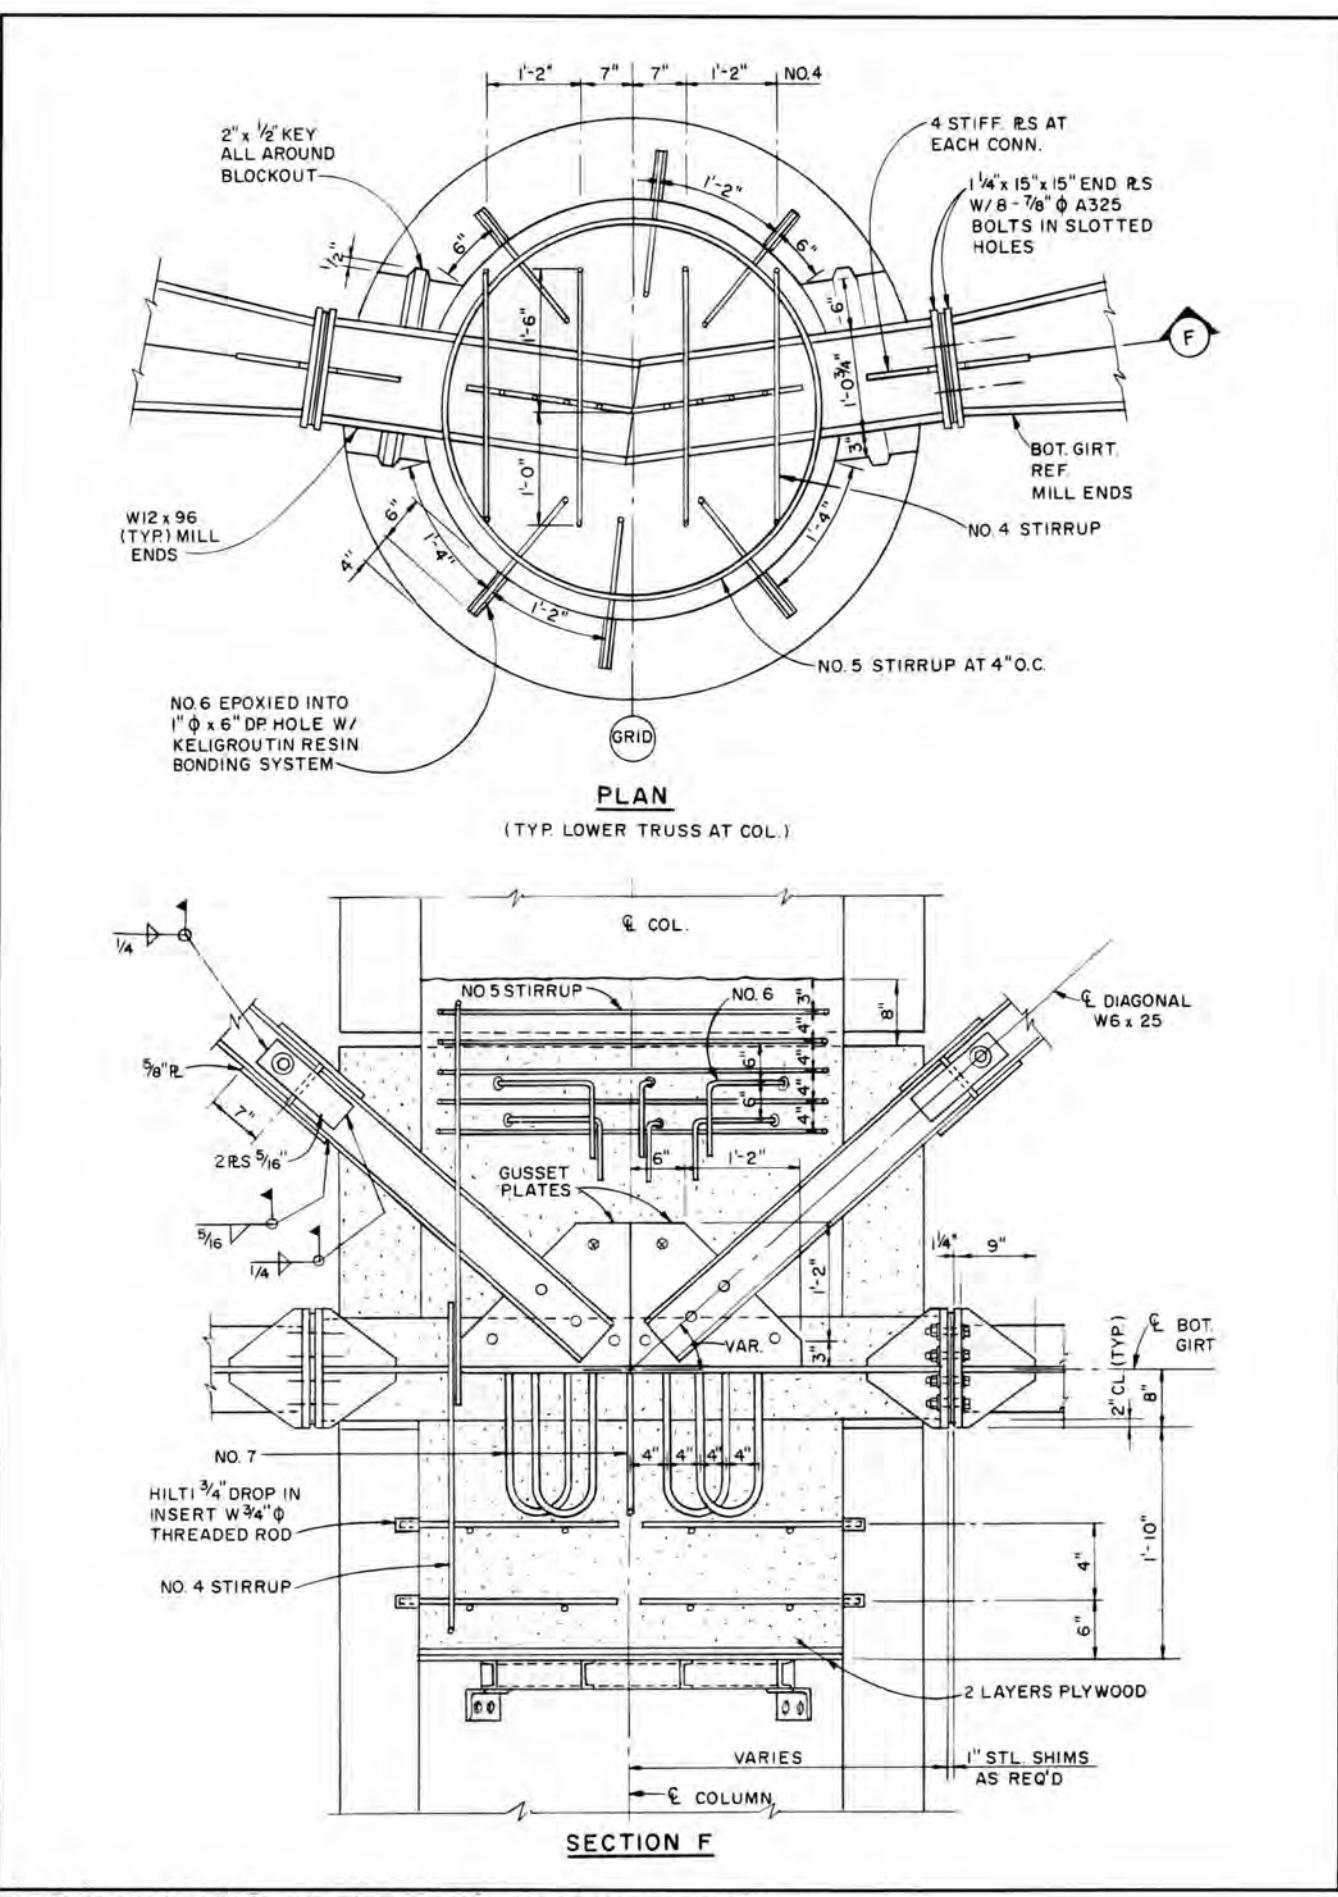
Fig. 13. Detail of steel lateral bracing connection to precast concrete column.

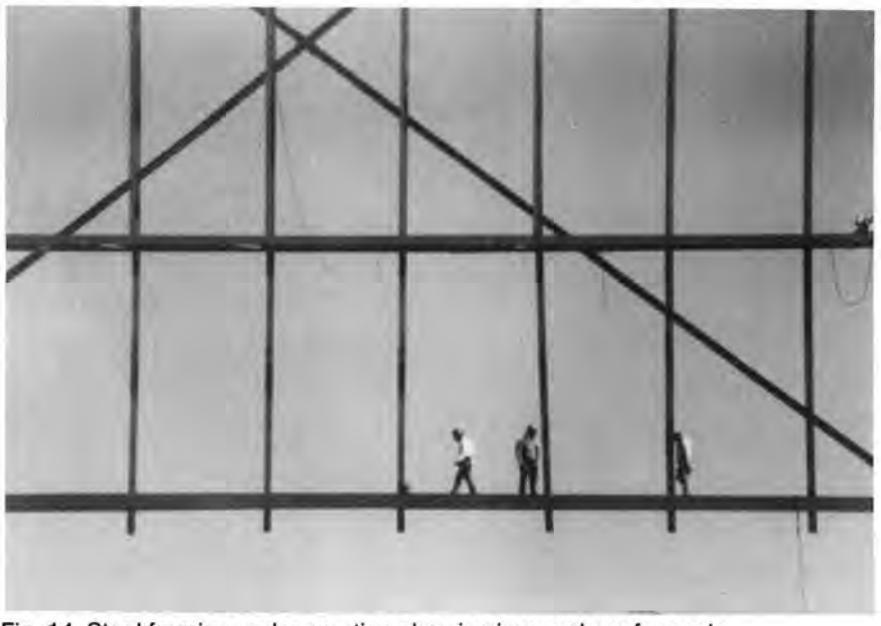
Fig. 14. Steel framing under erection showing ironworkers for scale.

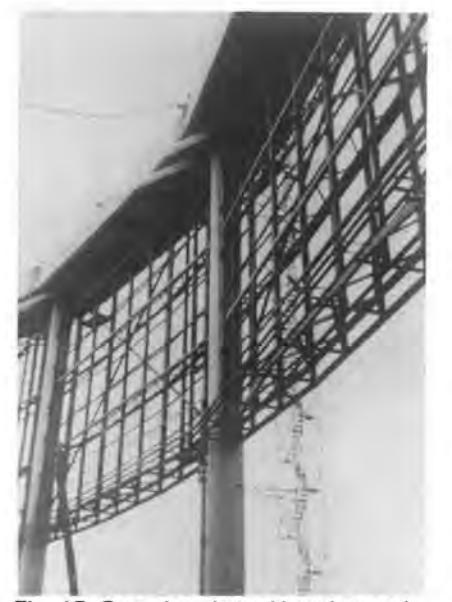
Fig. 15. Completed steel bracing and metal siding supports.

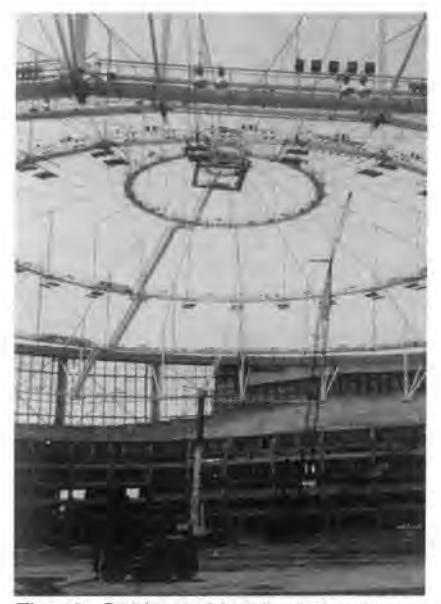
Fig. 16. Cable roof in place; hoops are stressed around tension ring.

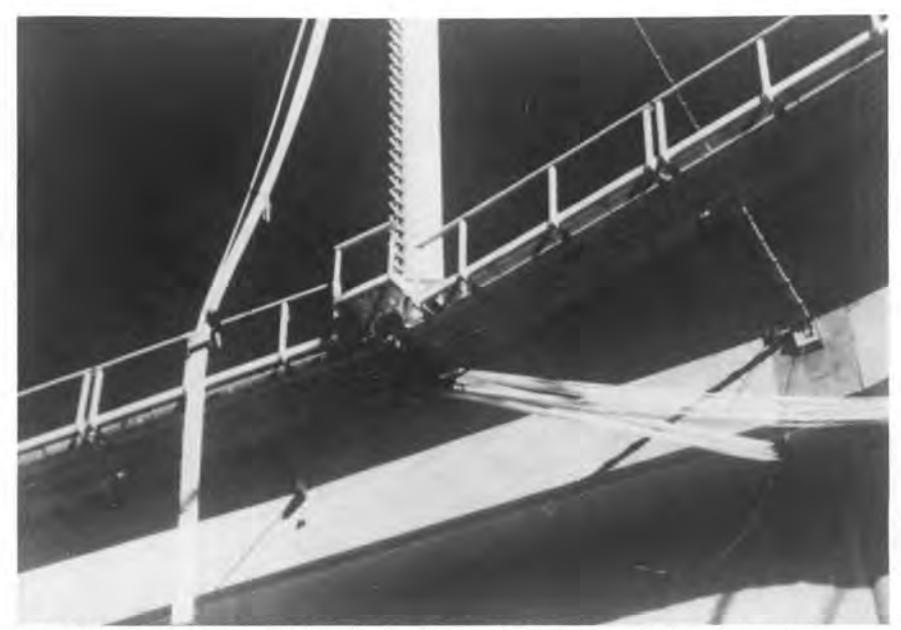
Fig. 17. Vertical roof post showing lower post-tensioned cables which are stressed to drive the post upward.

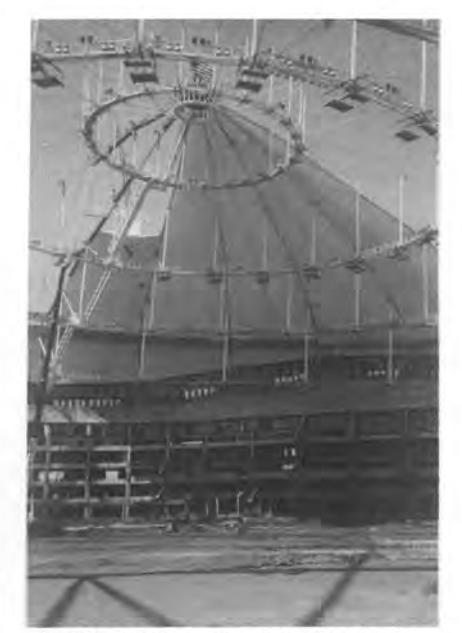
Fig. 18. Fabric roof being placed like a giant roll of tape.

beam and then rolled out to the center of the stadium, not unlike a giant roll of tape or toilet paper (Fig. 18). The roof seams were clamped at the ridge cables and the joints were heat sealed with a special seal and film to  $680^{\circ}$ F ( $360^{\circ}$ C). The cables were then tightened and adjusted to create the scalloped roof appearance.

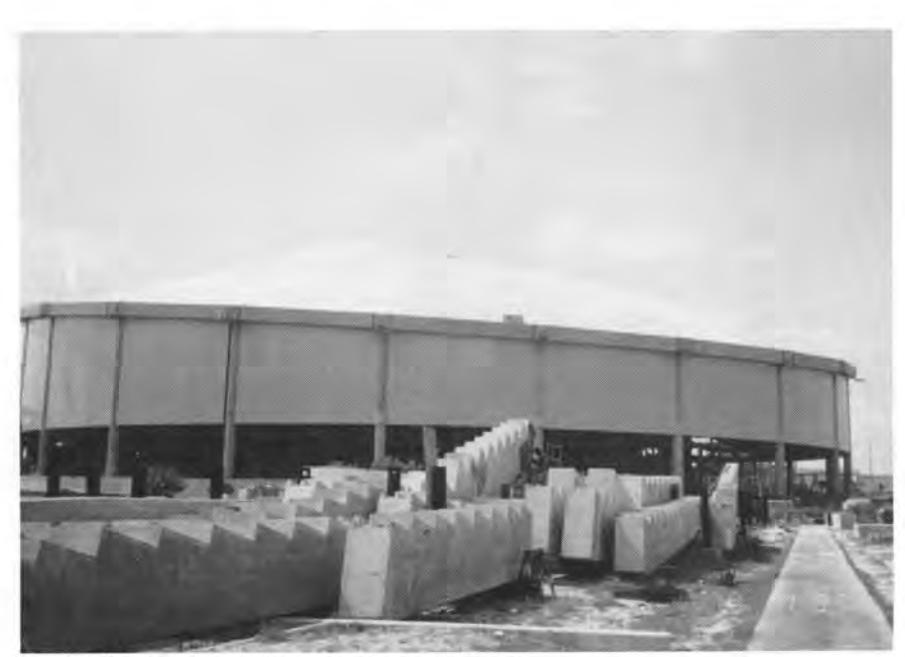
Fig. 19. Completed roof framing and cable roof.

Fig. 19 shows the completed roof framing and cable roof.

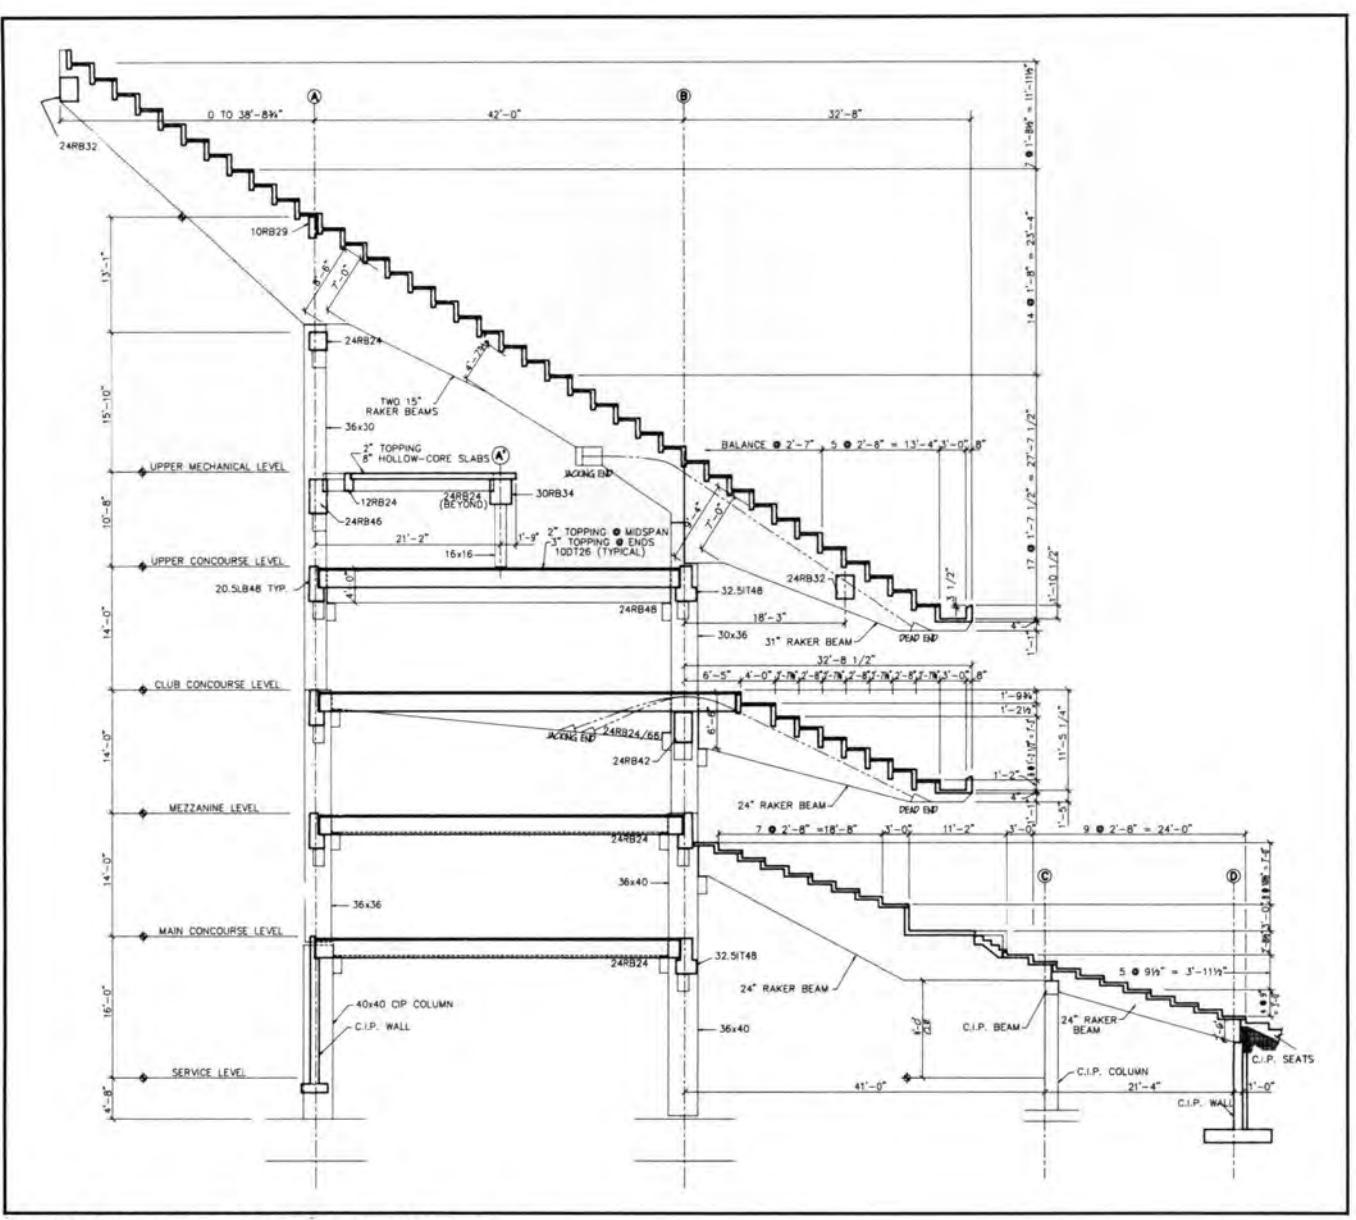
Fig. 20. Concourse and seating area framing.

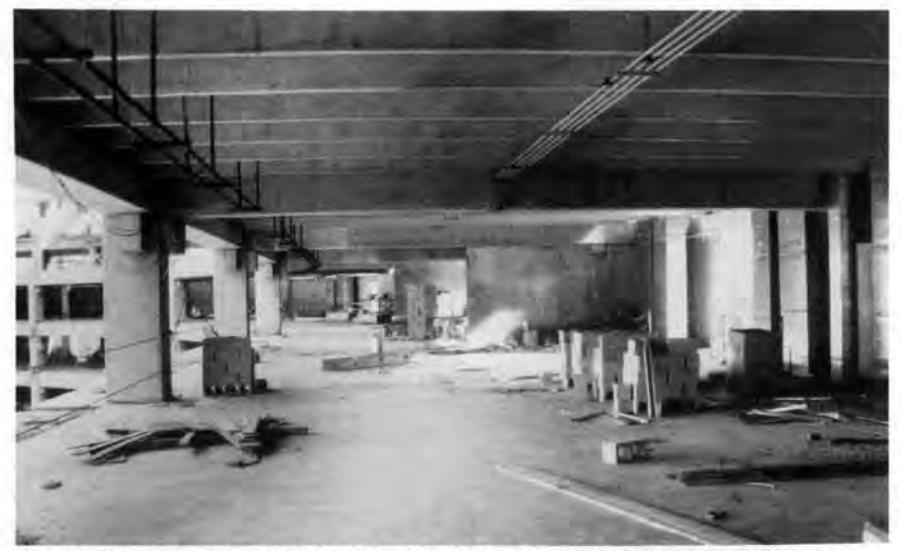
Fig. 21. Concourse framing for  $42 \times 42$  ft (13 x 13 m) bays showing double tees, ledger beams, rectangular beams, columns and shear walls.

(660 mm) deep double tees plus a 2 ft (0.61 m) filler beam are supported on 4 ft (1.22 m) deep ledger or rectangular beams as shown in Fig. 21. All concourse beams were prestressed. An angle connection on the beam top and a strap plate connection on the bottom were used to resist torsion.

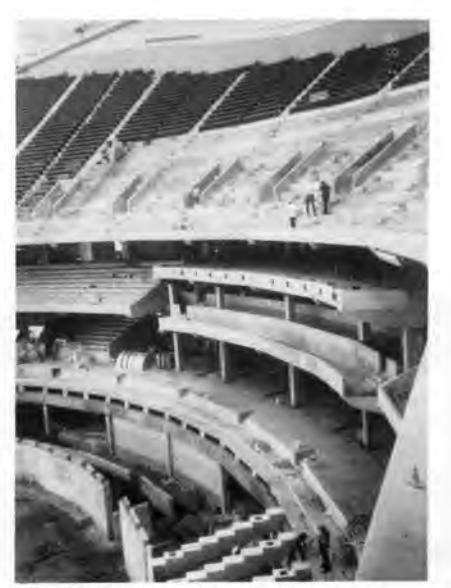
Fig. 22. Press area special framing.

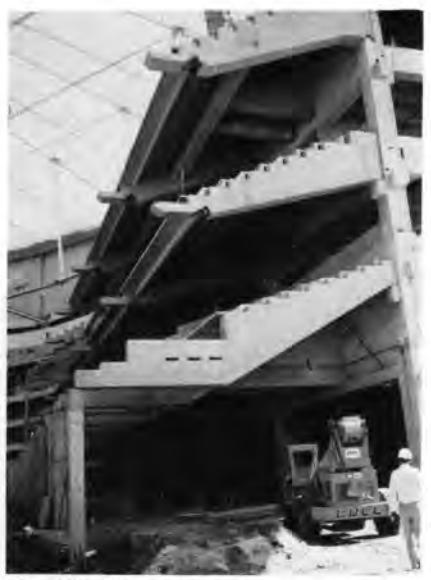
Fig. 23a. Raker beams.

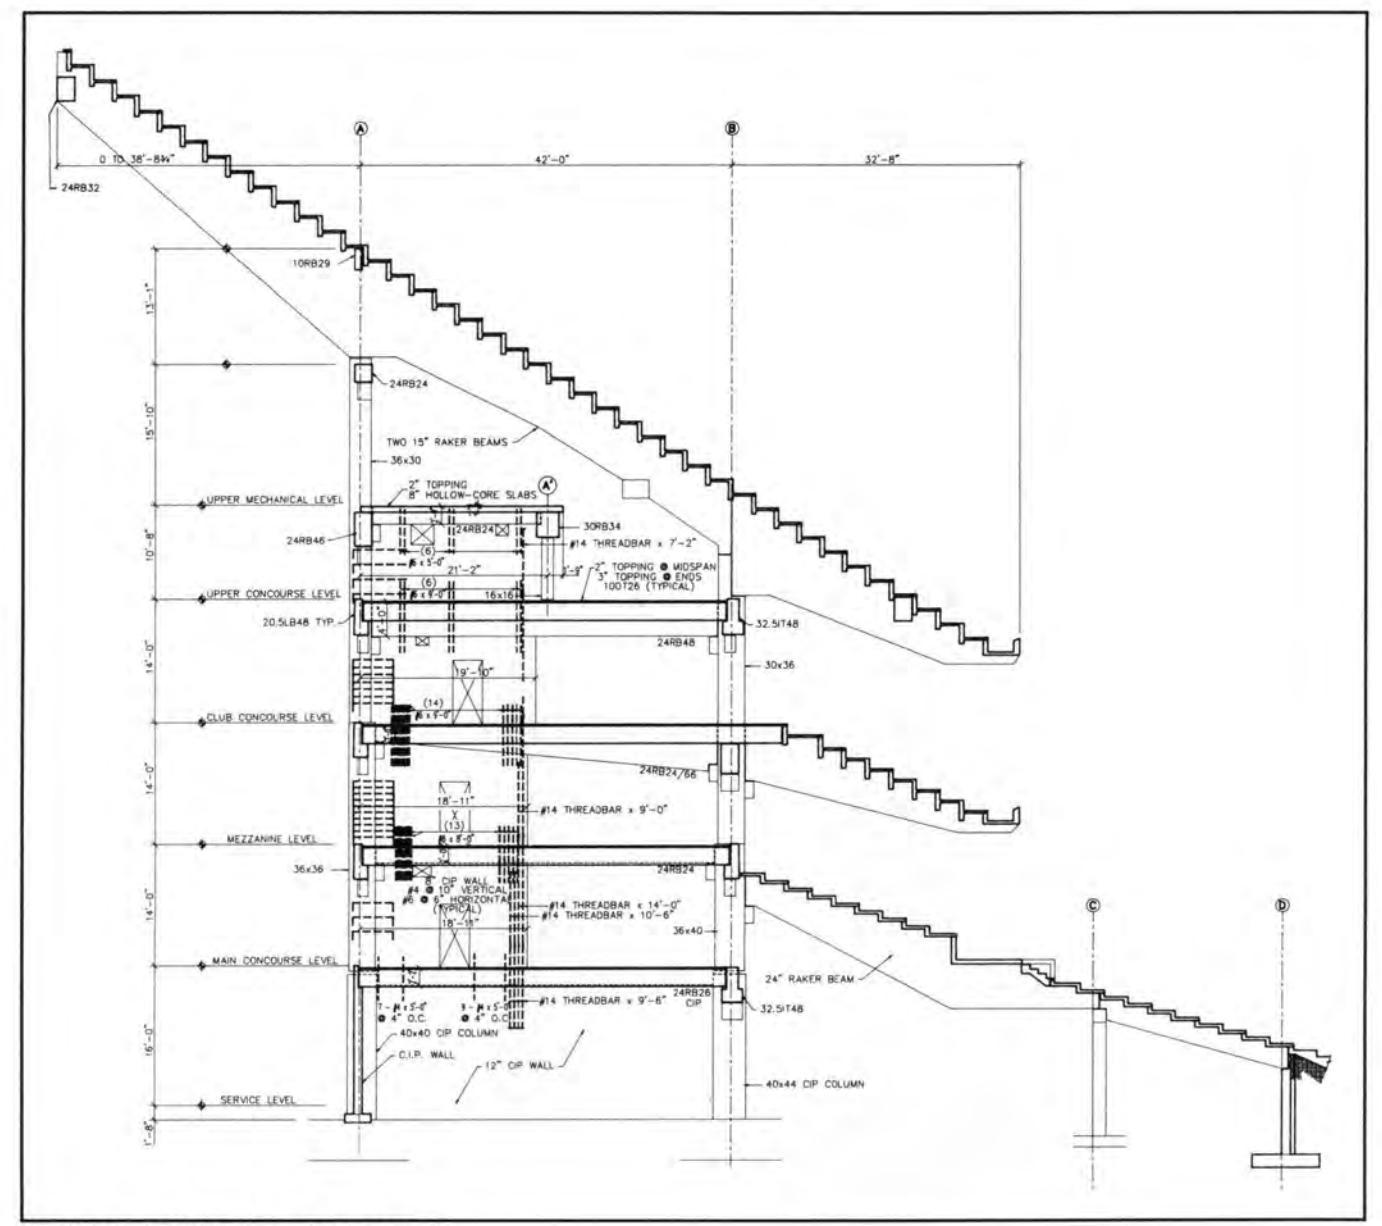
Fig. 23. Typical framing with shear wall.
