# The Florida Suncoast Dome

Describes the conceptual and structural design, production and erection of a \$100 million multipurpose stadium in St. Petersburg, Florida. This all precast prestressed concrete structure utilizes more than 7000 precast components weighing over 50,000 tons (45350 t). A large variety of precast products were used including columns, beams, raker beams, double tees, hollow-core slabs, ramp elements and stadium seats. The first part of the article discusses the structural and construction aspects of the ring beam framing while the second part discusses the concourse and seating area framing.

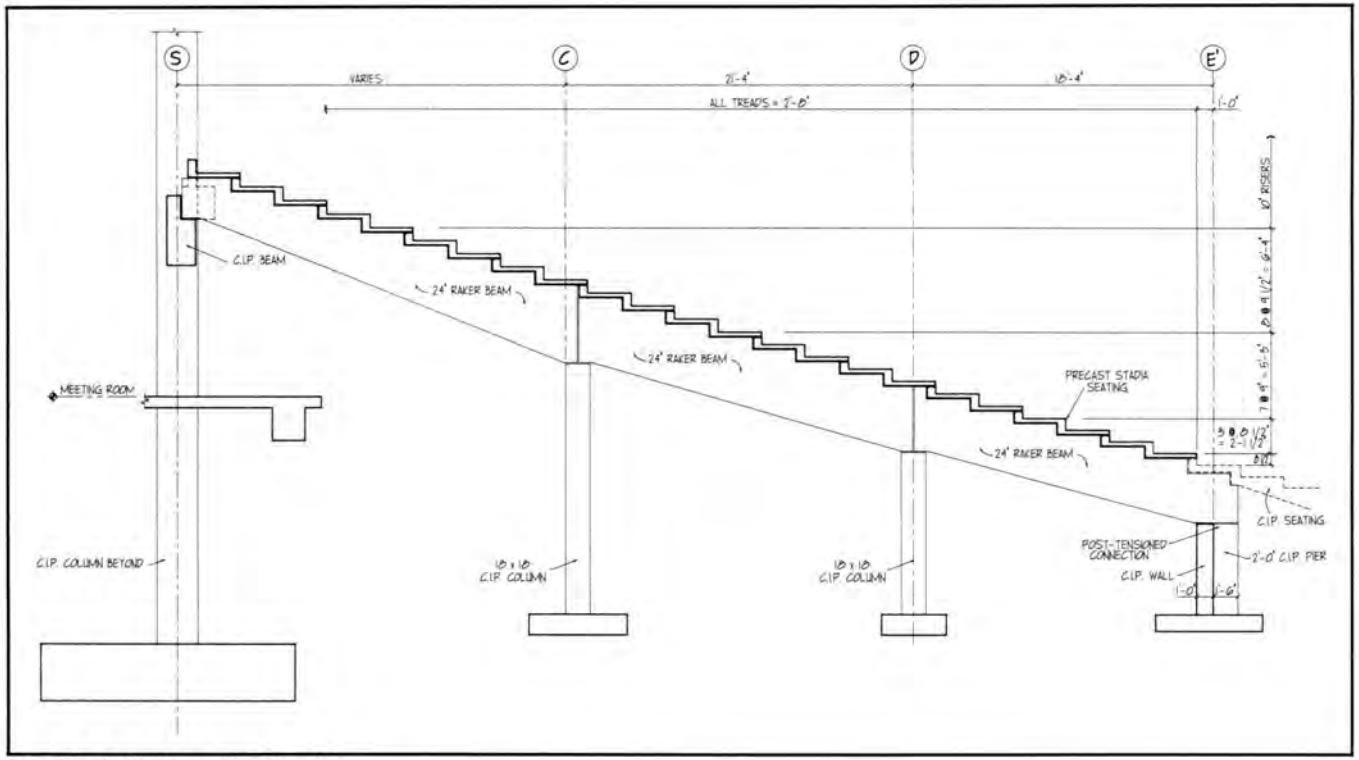
Fig. 24. Outfield seating framing.

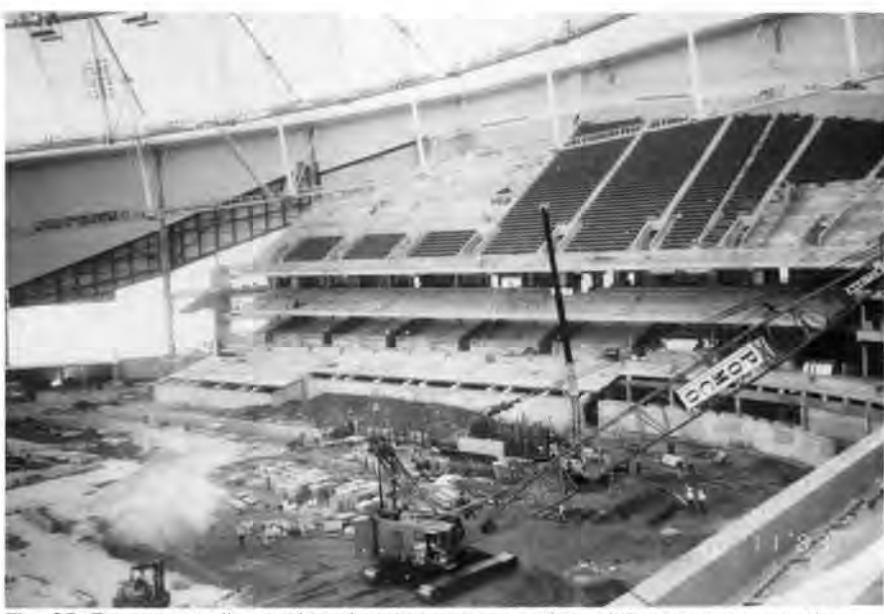
Fig. 25. Precast stadia seating showing upper seating, club concourse seating and lower seating.

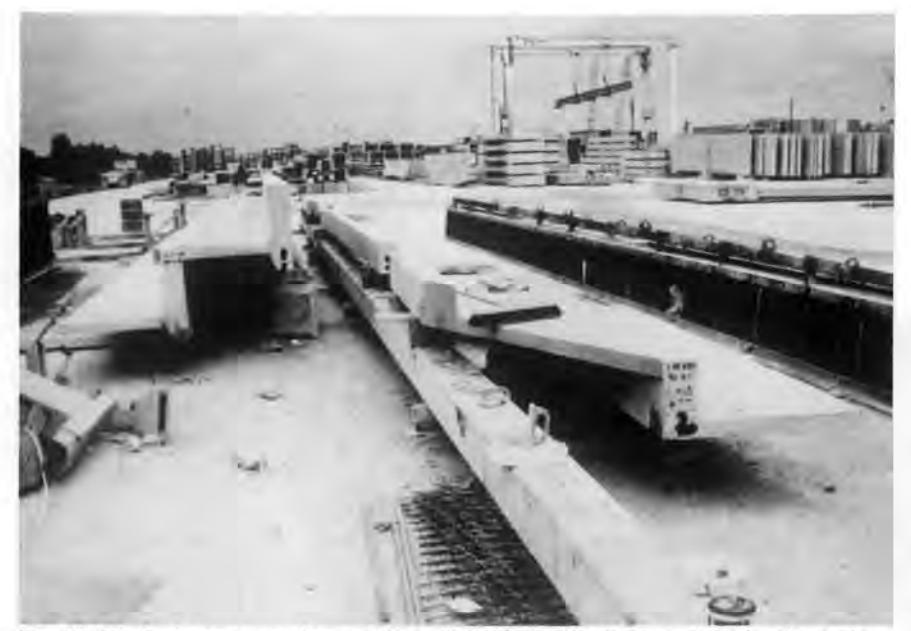
Fig. 26. Typical upper seating unit is on left. Note 5 in. (127 mm) projection below tread. Typical lower seating unit is on right.

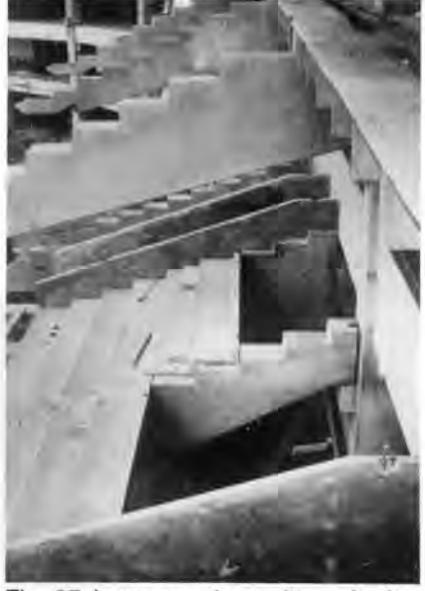
Fig. 27. Lower seating units and raker beams. Note the slender ends of club concourse raker beams at upper left.

The seating units bear directly on top of the raker beams and are connected by grouted pins as shown in Fig. 27. The holes for the pins are preformed in the seating units and field drilled into the raker beams. There are 1460 precast seating units with 525 dif-

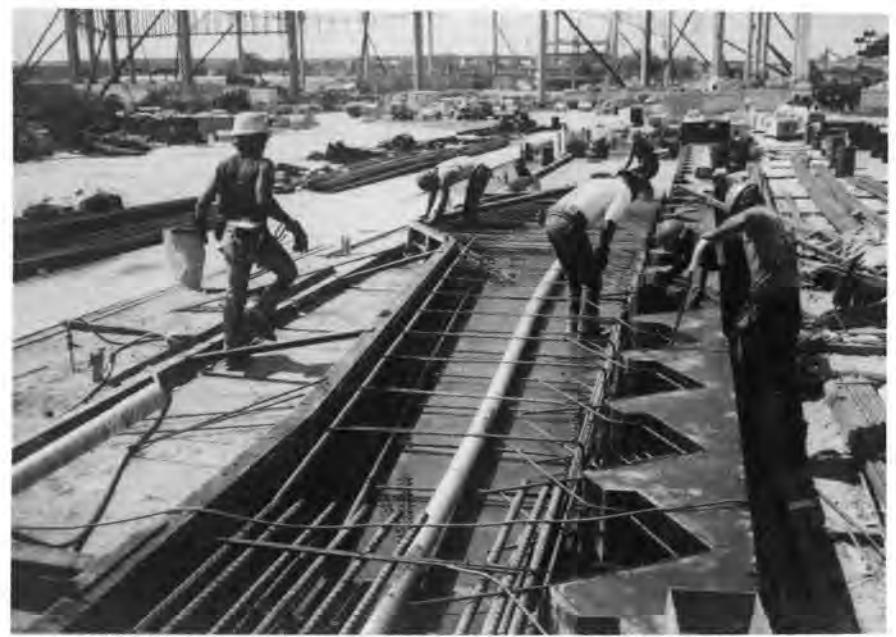
Fig. 28. Reinforcing bars and post-tensioning ducts being installed for an upper seating raker beam at POMCO's jobsite plant.

at the site plant as shown in Fig. 28. Originally designed as a 30 in. (762 mm) wide section, the raker beams are two 15 in. (381 mm) wide sections side by side in order that they could be erected. The heaviest weighs 60 tons (54 t) and is 100 ft (30.5 m) long. The front cantilever had to be erected later in order that the dome roof contractor could assemble the rings on the ground and lift them into position. The upper seating rakers are post-

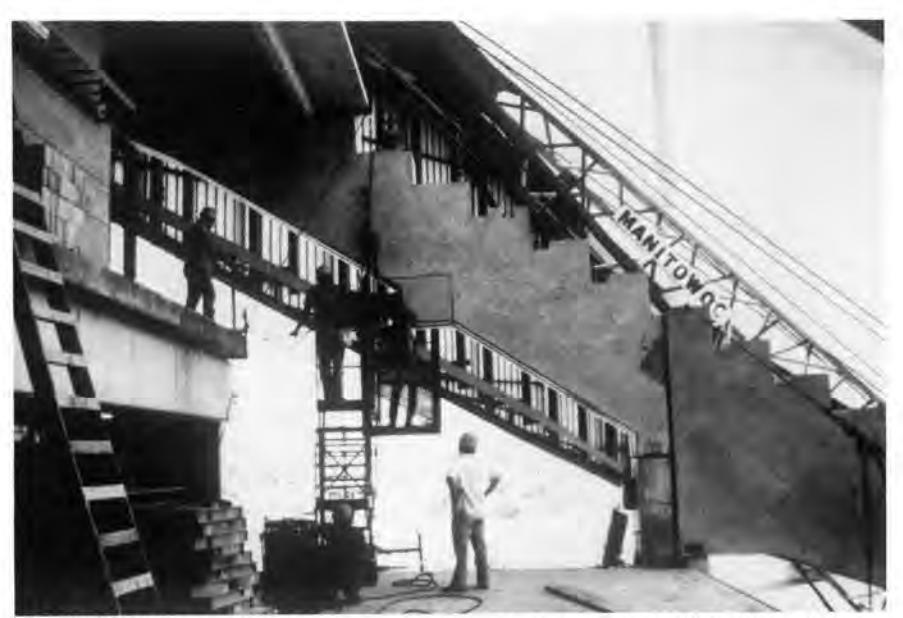
Fig. 29. Post-tensioning the precast cantilever raker beam (right) to the main span raker beam (left). Resistance to high compression stresses at this location were verified by a full scale test.

Geiger and HOK had specified a minimum 7 ft (2.13 m) depth for the main span of these rakers. Well into the design and shop drawing phase, they discovered a headroom problem and reduced the depth from 7 ft to 4 ft 6 in. (2.13 to 1.37 m). The front cantilever has two 31 strand tendons which are anchored in the main span as shown in Fig. 29. Also, the main span has either

two 24 or two 31 strand tendons. These four tendons cross each other near the end of the main span. The high cantilever moment is also at this location. Ultimate strength capacity could be obtained with the reduced depth, but compression stresses under service load far exceeded the code maximum of 0.45 times the concrete strength.

The upper raker beam performed well under the test. There was no bulging, bursting or compression failure, and deflections were less than anticipated. All of the cantilever rakers have been erected and post-tensioned, and there have been no problems due to the high compression stresses.

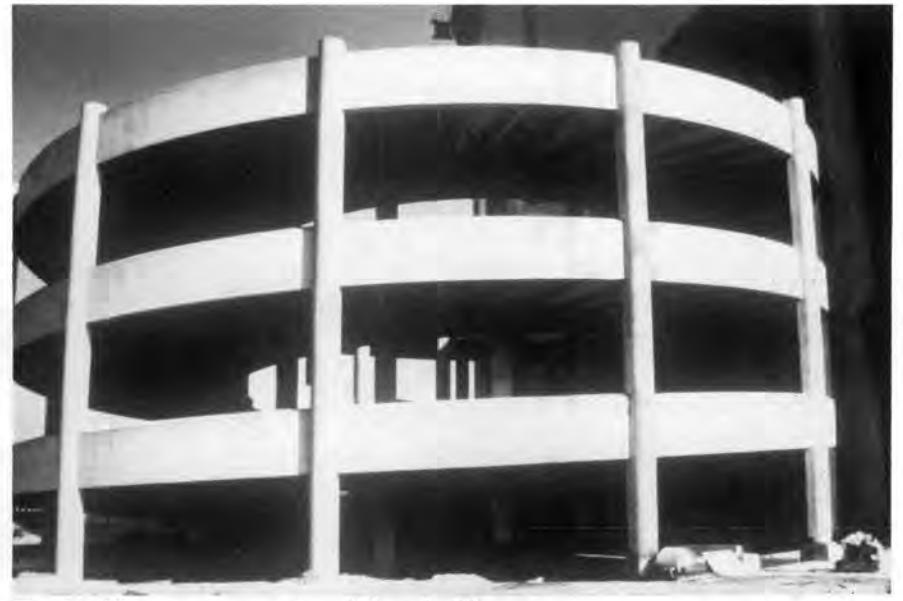
Fig. 30. All precast concrete spiral pedestrian ramp.

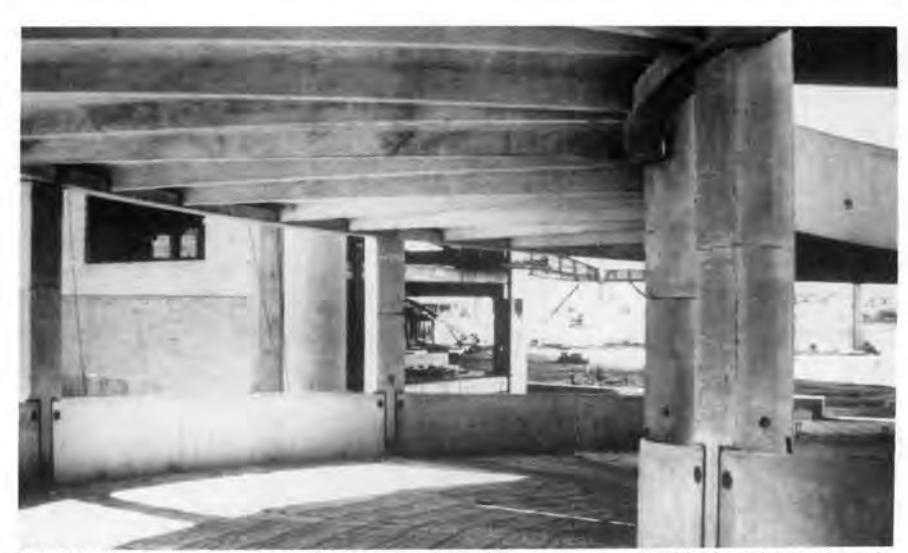
Fig. 31. Ramp framing includes warped double tees, spandrel ledger beams and half round columns.

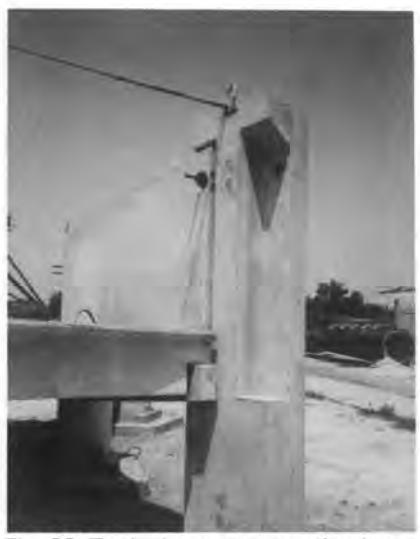
Fig. 32. Typical ramp connection has pocketed columns and coil rods.
