Precast Design Provides Structural Versatility

Precast structural system on skilled nursing center in Denver saves time and material while meeting all of the facility's specialized needs

The Center at Lincoln

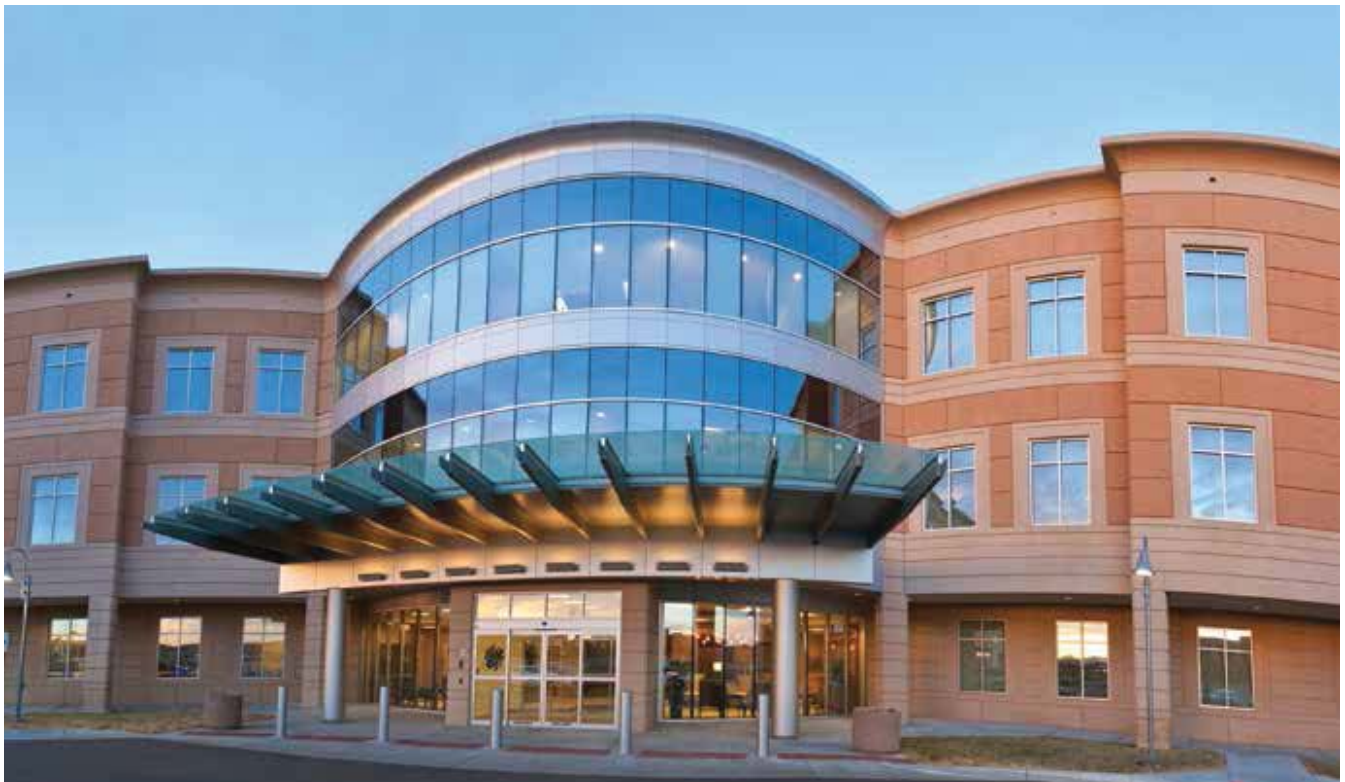
When the original steel and masonry design for The Center at Lincoln, a skilled nursing facility in Parker, Colo., proved economically unviable, a total precast concrete system was used. It consisted of 64-foot-long double tees, columns, beams, and load-bearing architectural wall panels. Photo: Rocky Mountain Prestress.

RMP provided 64-foot-long double tees with 24-inch stems, which added more benefits. "This design eliminated an entire beam and column line in each wing while creating virtually column-free

The design consists of precast concrete columns, beams, double tees, and related structural components supported with load-bearing architectural precast concrete panels with multiple finishes. "The load-bearing design provides vertical support plus lateral restraint," Hemberger explains. "This approach provides an efficient, durable design that's easy to erect and very attractive." The designers also used grouted couplers and intermediate shear walls to enhance foundation efficiencies.

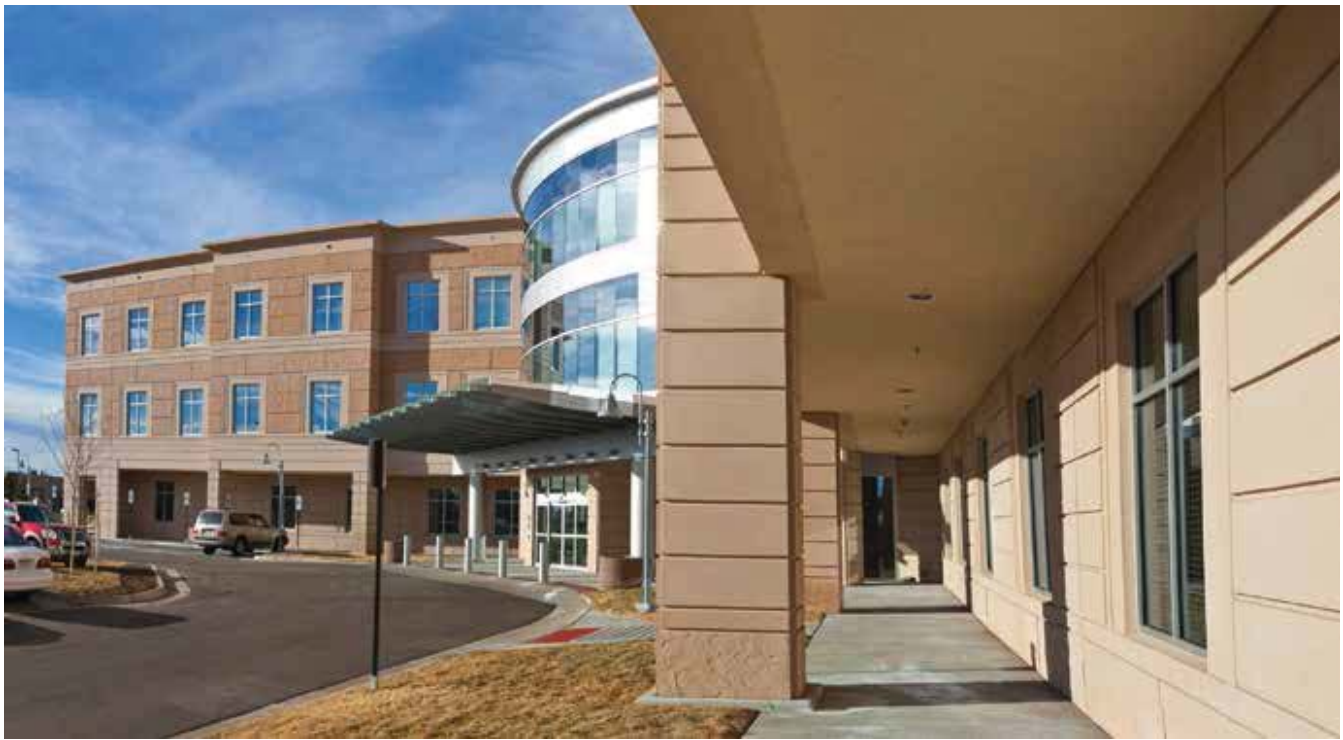
The two-story, upper-level panels feature a darker color in a flagstone texture, while the first floor used a buff-colored limestone look with wide reveals. The rectangular pattern continued onto all four sides of column covers on the entry colonnade. Photo: Rocky Mountain Prestress.

The three-story center features two concrete finishes, with a buff-colored, limestone-like appearance on the first level with wide reveals

creating block-like rectangles. These walls are supported by slab-on-grade foundations. The design continues onto column covers that support the entrance colonnade, with two architectural half-column panels integrated to form the structural column.

The upper two levels feature a flagstone finish in a darker hue, cast from one of RMP's standard formliners but turned in different directions to ensure no two adjacent blocks had similar textures. A complementary band of the buff-colored texture separates the two floors and lines the roof line, where an integral overhanging cornice provides definition. "The cornice detail is a standard feature we can provide, but we don't often get the opportunity," says Hemberger. "It adds a nice complex feature, and we enjoy adding those details whenever we can."

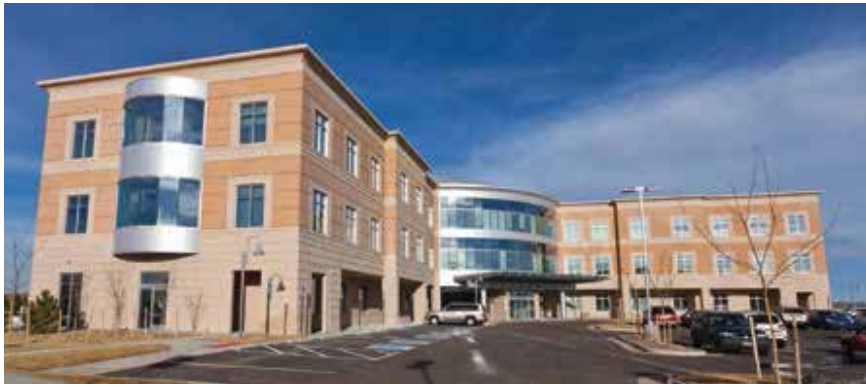
Two-story bay windows reflect the rounded curtain wall used at the entry. The windows rest on a curved precast concrete slab that cantilevers off the wall panels. Photo: Rocky Mountain Prestress.

This curved entryway is reflected in curved bay windows on the second and third levels of each wing end. The windows sit on cantilevered precast concrete slabs that match the curve of the window projections. Other fenestration in the center consists of punched windows that were installed once the precast concrete panels were erected.

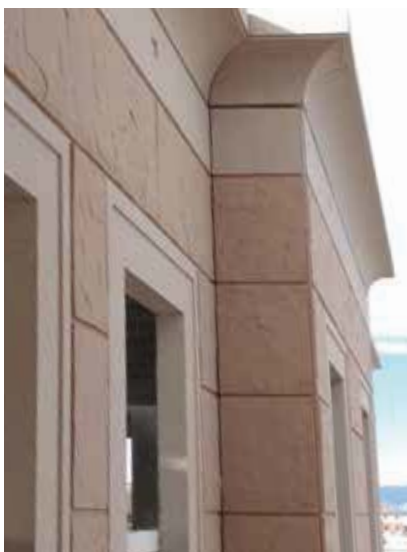
A curved cornice was added to the panels on the top floor, creating a distinctive roofline. Photo: FDG Inc.

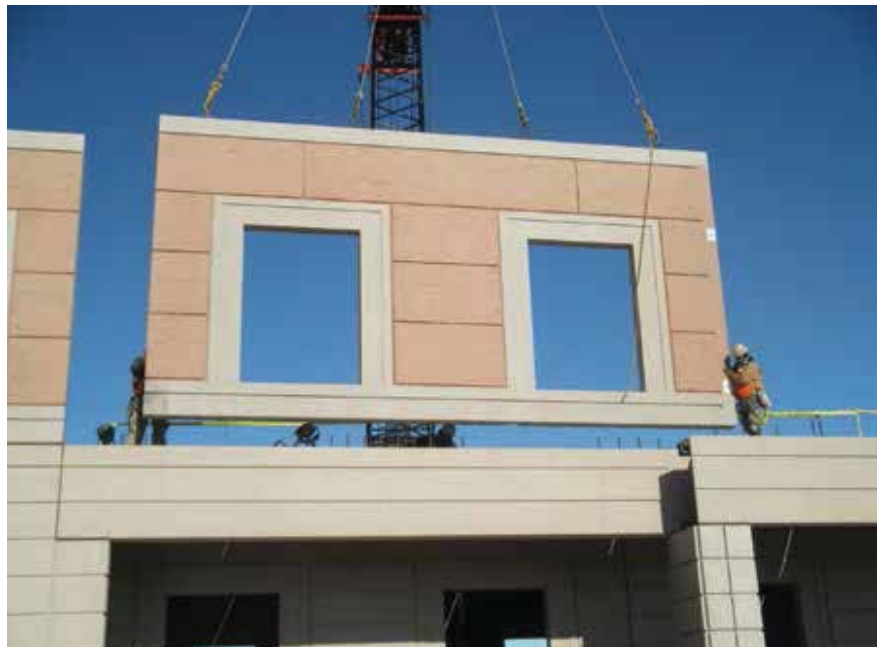
Panels feature several colors, reveals, and a variety of cutouts. Combining colors and textures into one panel reduced the piece count and sped up the erection process. Photo: FDG Inc.

The panels were cast to clad each floor separately, but many required several finishes, reveals, and cutouts. "We were able to cast panels with two colors and a variety of details without any problem, which created more efficient pieces to be picked and erected," says Hemberger.

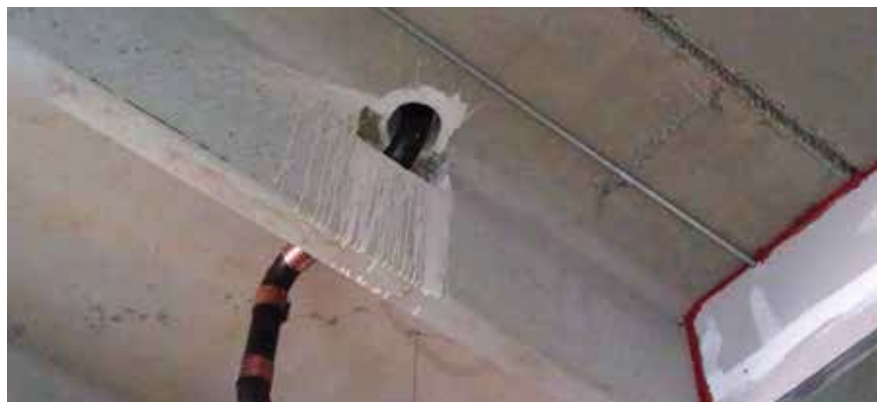
Blockouts were cast into some of the double tees to allow penetrations that plumbers could connect to an elbow, allowing plumbing to remain set in the design. Photo: FDG Inc.

could be moved, and we had to move stems to accommodate the plumbing,” Hambacher explains. To accomplish this, blockouts were cast into the stems at key locations, allowing plumbers access to the penetrations. They installed elbows that then ran alongside the stems.

In some cases, double-tee positioning was reworked. “We could adjust our modules if needed to create the floor penetrations they needed,” Hemberger says. “It worked very cleanly in the end.” The 10-foot-wide double tees were adjusted by as much as 2’2” in width to avoid any conflict of penetrations with the tee stems. “We can crop one wing and move it to accommodate whatever needs there are.”
