# Handling Prestressed Concrete Strand

*The wires used to make strand for prestressed concrete are much more complex than reinforcing steel bars and, in certain respects, must be treated with greater care. This article discusses the various material properties of strand that affect its performance and describes the procedures used in handling, placing and tensioning strand, and the effect concrete curing can have on tensioned strand.*

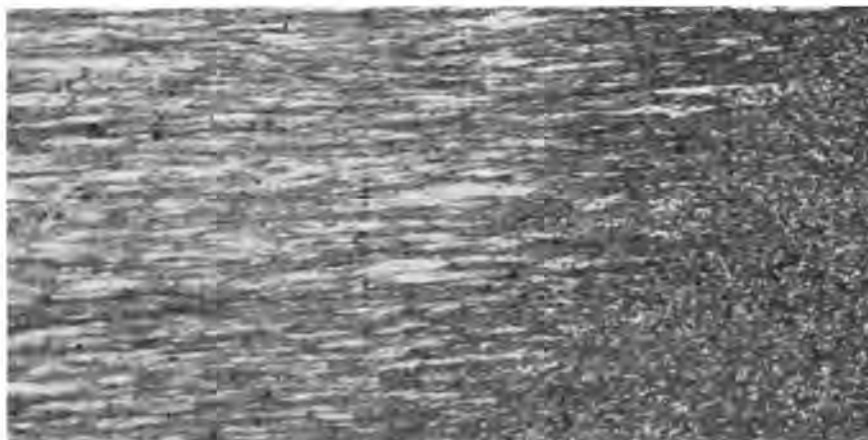
Fig. 1 was obtained by slicing a wire in half, polishing the sliced surface and taking photographs at a high magnification. It shows the fibrous structure of undamaged wire on the left and the recrystallized structure of an overheated portion on the right.

Fig. 1. Photomicrograph taken at 150X magnification. Note the transition from fibrous cold drawn structure on the left to granular heat affected structure on the right.

When a wire is subjected to excessive heat, the fibers revert to crystals which (since the cooling is not controlled as it is in heat treating) are identical to those in the original hot-rolled rod with an ultimate strength of about 140,000 psi (965 MPa).

Up to a point the intensity of heat required to cause damage is related to the duration of its application. A temperature of 750°F (398°C) applied for a considerable period of time will cause some loss of strength. Even briefly applied temperatures in excess of 1000°F (537°C) can cause the transition of fibers to crystals.
