## PROJECT SPOTLIGHT

### Tendons, precast concrete construction give Lehigh Valley Bridge several firsts

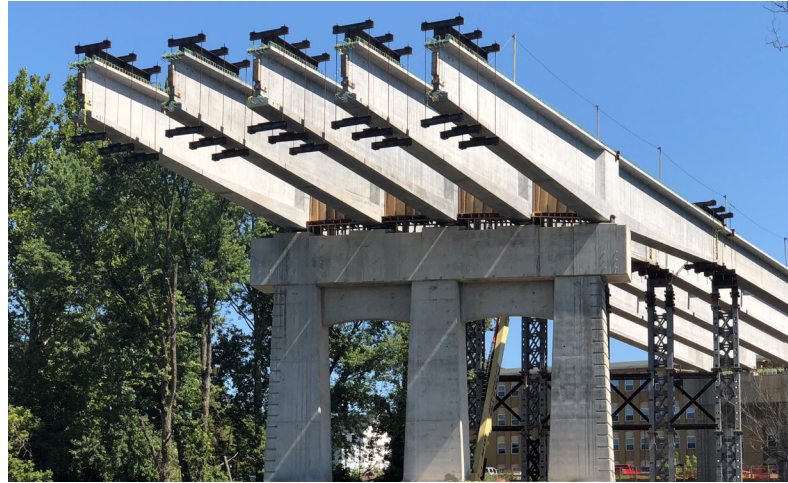
**The Lehigh Valley Bridge uses spliced girders to support bulb-tee beams. Photo by Danielle M. Fleagle.**

This project included a number of challenges, especially because of the innovative design and production requirements. In addition to using EITs, the project features prestressed and post-tensioned bulb-tee beam construction that includes spliced girders, the first use of this technology in Pennsylvania.

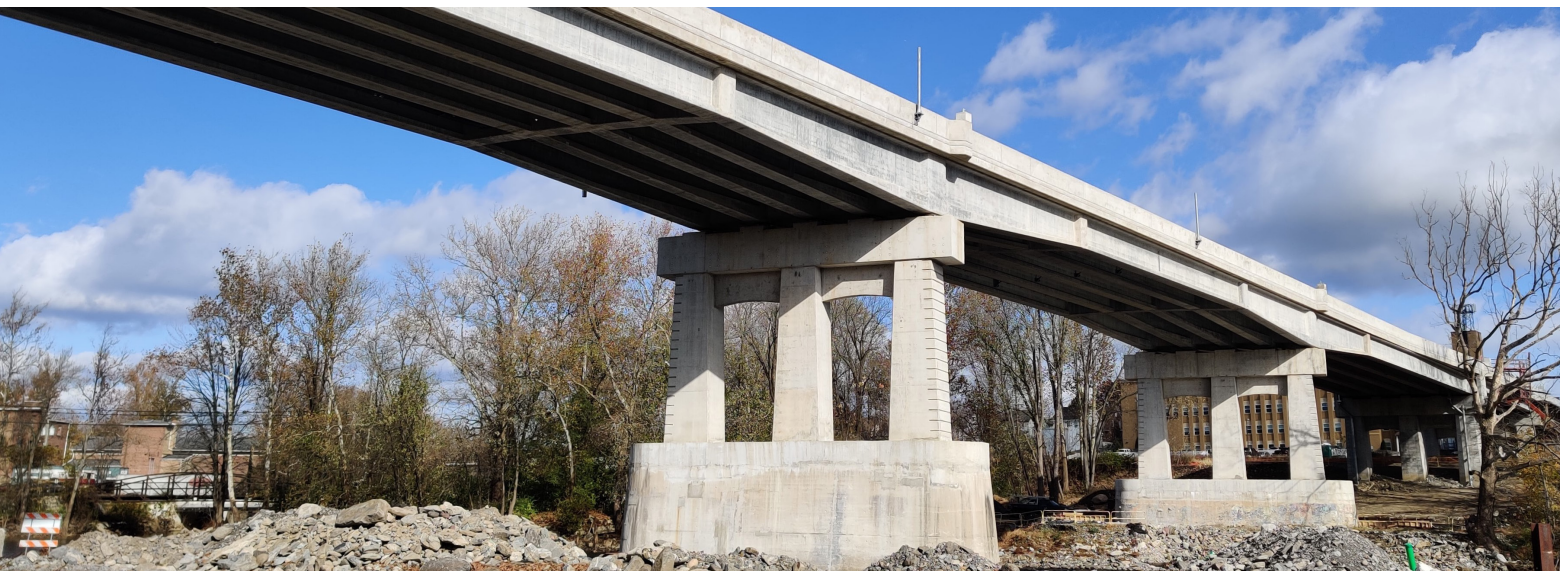
**The Lehigh Valley Bridge in Coplay, Pa., replaced a deteriorating 1930s-era structure with a bridge that uses prestressed and post-tensioned bulb-tee beam construction with spliced girders. The bridge is also the first in the United States to use electrically isolated tendons. Photo by Matt McSweeney.**

The 1124 ft (343 m) long bridge consists of three post-tensioned spans and five spans of prestressed beams. It replaces a bridge over the Lehigh River that was built in the 1930s. From a precast concrete perspective, it includes 27 prestressed bulb-tee beams and 25 prestressed and post-tensioned bulb-tee segments of various sizes.

The bridge is also the first project in the United States to use electrically isolated tendons (EITs). EITs allow for verification that the post-tensioned cables have been encapsulated according to the plans and specs and provide enhanced durability.

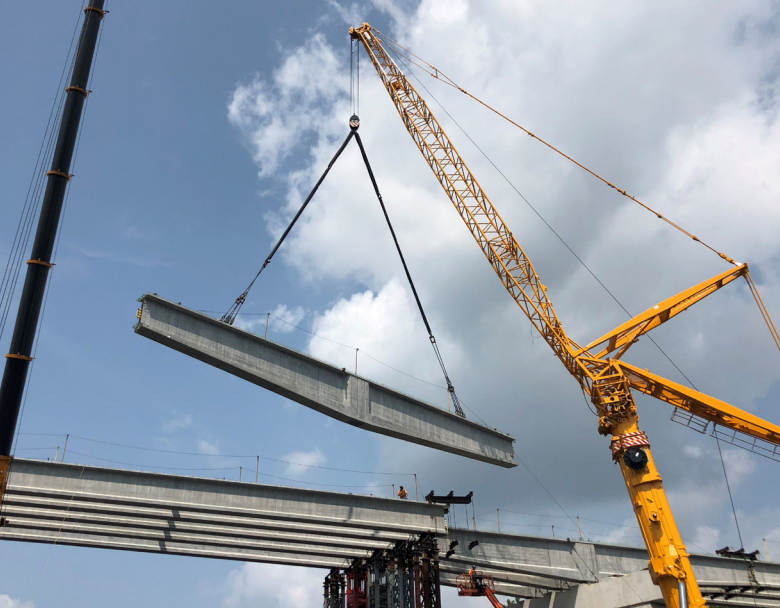
**A prestressed and post-tensioned bulb-tee beam is being lowered into place for the Lehigh Valley Bridge. Northeast Prestressed Products LLC of Cressona, Pa., manufactured and installed the precast concrete elements used in the project. Photo by Danielle M. Fleagle.**

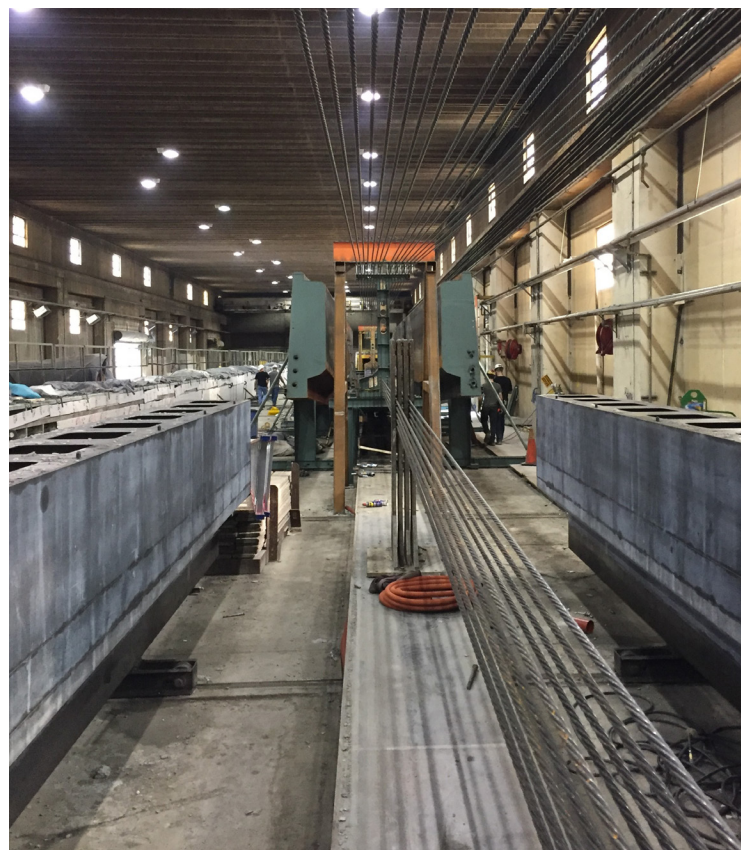
**Some beams for the Lehigh Valley Bridge are as deep as 10 ft, requiring the prestressing strands for the top flange to be positioned much higher than usual. Photo by Gary Lehman.**

Another challenge was that the center section of the bridge involved a variable-set bulb tee, which posed some challenges in the plant. Everyone had to do a lot of work to make sure that the strands were in the right location in the beams. “In the center of the bridge, the beams were about 10 feet deep,” says Gary Lehman, Northeast Prestressed Products plant manager. “The highest strands we had done in the past were about 5 feet, so we had to increase the strands to the top flange.”
