Project Spotlight

FDNY rescue facility made for wear and tear

Vermont rehabs four interstate bridges with minimal closures

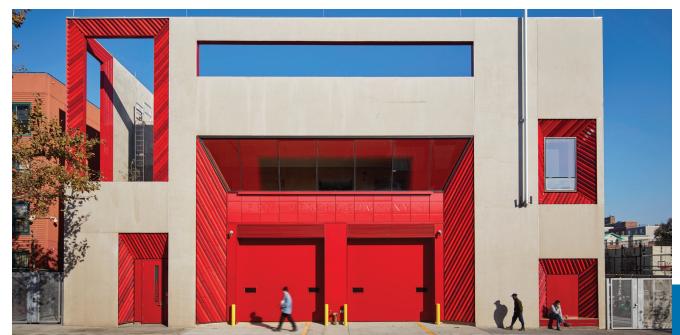
The new Fire Department of New York Firehouse Rescue No. 2 in Brooklyn, designed for training specialized fire and rescue workers, selected precast concrete for its durability and sustainability. Courtesy of High Concrete Group.

The three-story building is organized around two large interior voids and enclosed by precast concrete insulated sandwich wall panels, strategically punctured by windows and openings. These interior voids and facade openings enable the fire company to practice multiple rescue scenarios and to mimic conditions and emergency situations that can occur in urban environments.

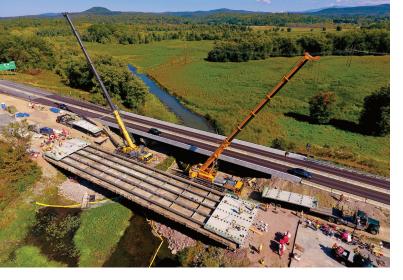
Four Interstate 89 bridges in Colchester, Vt., were rehabilitated and had their decks replaced over the course of just four weekends using precast concrete and careful planning. Courtesy of Kubricky Construction Corp./The Fort Miller Co. Inc.

In an extremely busy region of Vermont, four Interstate 89 (I-89) bridges that had become severely deteriorated, were rehabilitated and decks were completely replaced over the course of just four weekend closures. In addition, it took just six weekends to complete the entire project, including substructure and steel repairs. The scope of work included deck replacement, steel repairs, and replacement of backwalls, approach slabs, and sleeper slabs.

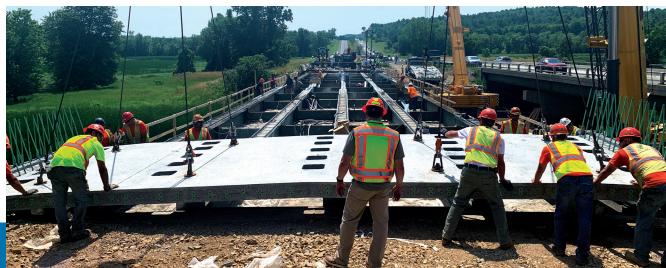
Match casting allowed for quick placement in the field during the rehabilitation of four Interstate 89 bridges in Colchester, Vt. Courtesy of Kubricky Construction Corp./The Fort Miller Co. Inc.

The precast concrete panels were match cast in the precaster's production facility with interlocking shear keys to provide reliable shear transfer. The shear keys also self-aligned when being installed, thereby allowing for rapid field setting. During installation, the panels were compressed together by jacking against the girders on the bridge, thereby leaving the completed decks in compression and without cracks. This satisfied the goal of extending the life of the bridge decks by an estimated 40 years. In all, Fort Miller manufactured 23,535 ft² (286 m^2) of bridge deck panels, representing 58 panels, 32 precast concrete approach slabs, 8 precast concrete sleeper slabs, and 32 precast concrete backwalls for the project.

"Manufacturing was done in a long-line match-cast configuration, which provided a higher degree of accuracy for the final product," says John Gonyea, the estimator who worked on the project. "By match casting, every other panel was cast, and then the panels between the previously cast panels were cast." The process was relatively simple, but attention to detail was essential. Casting in this manner allowed for checking the geometry prior to stripping the panels from the casting bed. The matchcast process also allowed the panels to self-align during the installation process, contributing to quick placement in the field.
