SCDOT Wando River 2018 Bridge Closure

M. Kevin Turner
District 6 Bridge Engineer

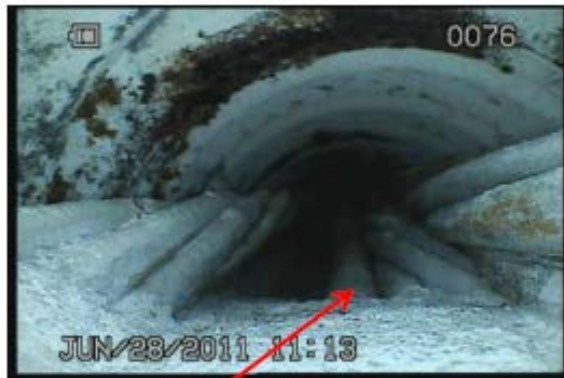
Same wire as above, but deeper into the void.

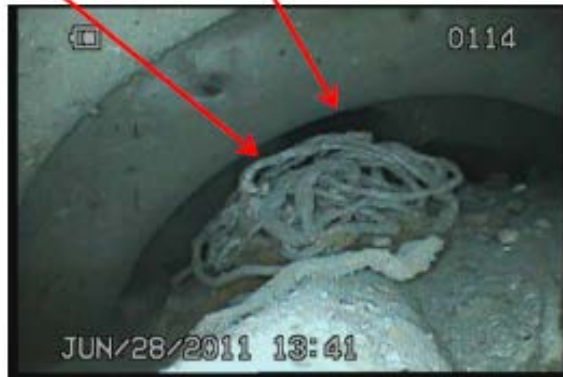
Bottom of grout vent tube.

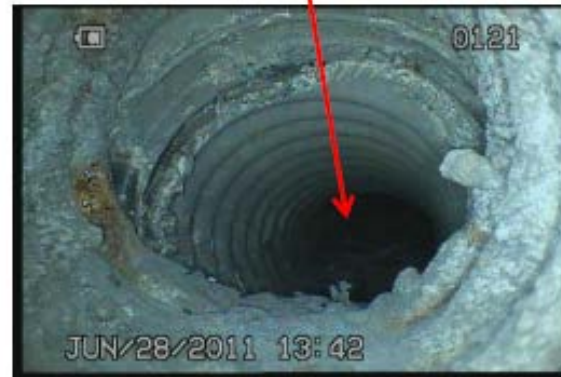
Inside grout vent tube.

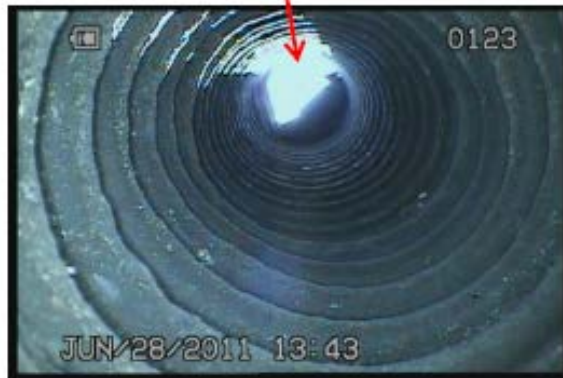
Grout vent tube open to the top of the deck.

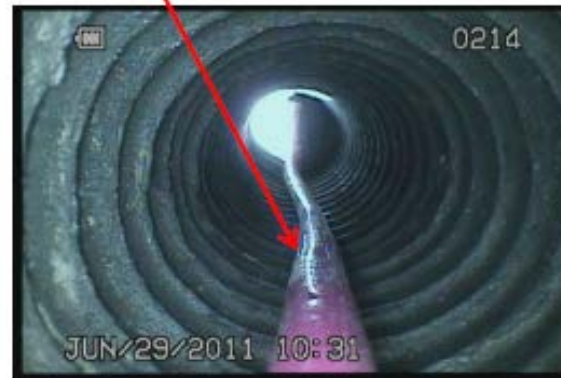
Wire fed through grout vent tube.
